Final Report on

Development of Digital Elevation Model (DEM) and delineation of
Catchment boundaries for Polders 43/2A,
Polder 43/2B, Polder 43/2D and Polder 43/2E of Blue Gold Program

Patuakhali O&M Division

November 2016

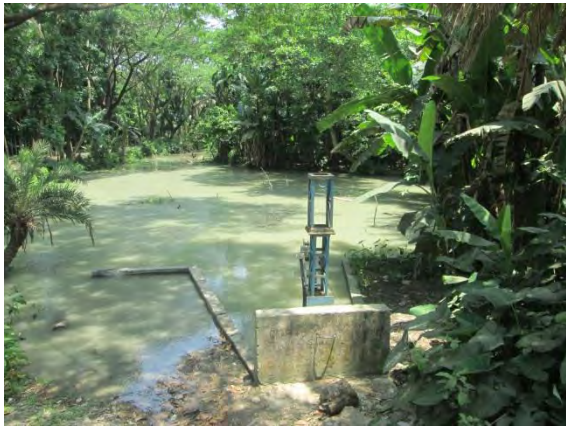
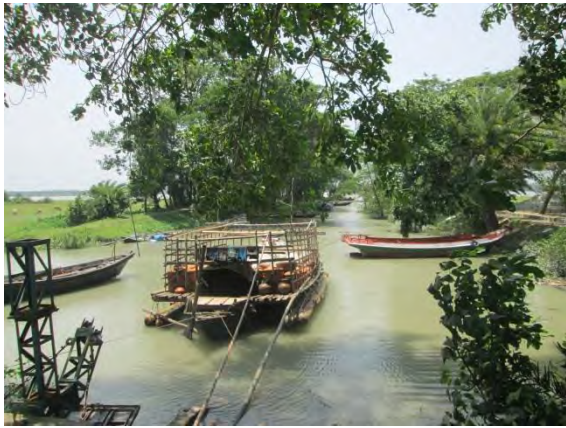
<p>Figure: C/S of Katakhalı Sluice</p>	<p>Figure: Outfall of Katakhalı catchment</p>

Catchment Name	Cat-02 (Katakhali catchment)
Location	Part of Chhota Bighai (223 ha) mauza of Chhota Bighai union
Catchment area (ha)	223
Drainage Outlet	Katakhali sluice, DS-2 at Ch. 9.650 km (1V- 0.9m X 1.2m)
Main Drainage Canal	Katakhali Khal (Average Top width: about 14m to 18m)
Land elevation of Catchment (m PWD)	Max: 2.96 Min: 1.35
Length of Stream within catchment (Km)	2.19
Drainage Density (m/ha)	9.81
Catchment Description	<ul style="list-style-type: none"> ➤ <i>Outfall</i> <ul style="list-style-type: none"> • Outfall Khal: Payra river • Condition: Partially Active ➤ <i>Condition of Drainage Khal</i> <ul style="list-style-type: none"> • Main drainage Khal: Highly silted up • Branch Khal: <i>Nayankhali Khal</i> and <i>Bilair Khal</i> are moderately silted up ➤ <i>Drainage Congestion</i> <ul style="list-style-type: none"> • <u>Problem</u>: Severe, usually takes 6-7 days to properly drain out rain water • Due to sedimentation, the outfall bed level (C/S portion adjacent to the regulator) of Katakhali khal is comparatively higher than the upstream. As such, during ebbing water cannot drain out properly. Moreover, encroachment (several cross bundh on Katakhali khal) made by the local people interrupts the natural drainage system.

<ul style="list-style-type: none"> • Re-excavation of Katakhalı khal (about 1 Km) and removing encroachments may reduce drainage congestion. • Permanent Water logging: Not observed ➤ <i>Agricultural condition</i> <ul style="list-style-type: none"> • Crop damage: Major due to drainage congestion (mainly affects Lt Aman and HYV Aman during seed bed preparation). • Re-excavation of Katakhalı khal may reduce the crop damage. • Water Scarcity: Partially found ➤ <i>Hydraulic structure condition</i> <ul style="list-style-type: none"> • Partially functional • Loose Apron both R/S and C/S is damaged.

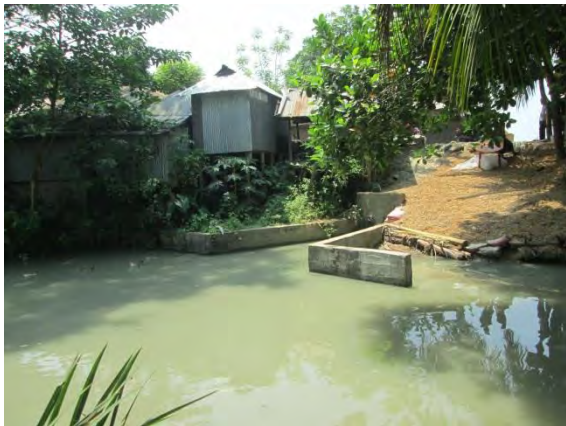
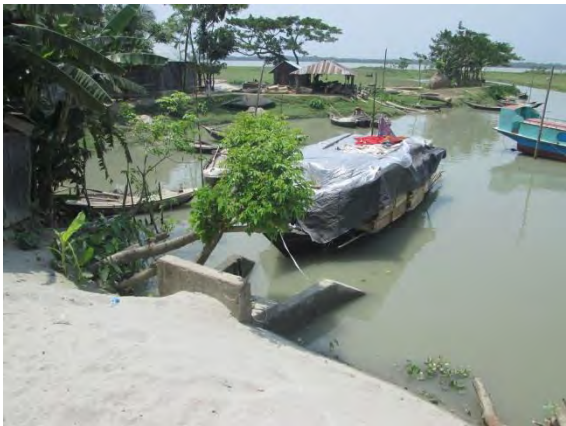
<p>Figure: C/S of Matibhanga Sluice</p>	<p>Figure: Outfall of Matibhanga catchment</p>

<p>Catchment Description</p>	<ul style="list-style-type: none"> ➤ <i>Outfall</i> <ul style="list-style-type: none"> • Outfall Khal: Payra river • Condition: Active ➤ <i>Condition of Drainage Khal</i> <ul style="list-style-type: none"> • Main drainage Khal: Moderately silted up ➤ <i>Drainage Congestion</i> <ul style="list-style-type: none"> • <u>Problem</u>: Moderate, usually takes 3-4 days to properly drain out rain water. • Vent size of Matibhanga Sluice is inadequate for efficient drainage. • Construction of new drainage outlet at Dhanger khal may reduce drainage congestion. • Permanent Water logging: Not found. ➤ <i>Agricultural condition</i> <ul style="list-style-type: none"> • Crop damage: Moderate • Water Scarcity: Observed (Mainly affects Rabi crops and HYV Aman during seed bed preparation) ➤ <i>Hydraulic structure condition</i> <ul style="list-style-type: none"> • Partially functional (Loose Apron damaged both R/S and C/S) • Capacity of sluice is inadequate

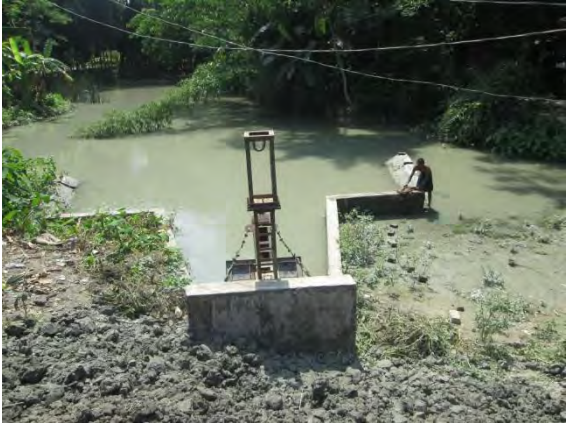
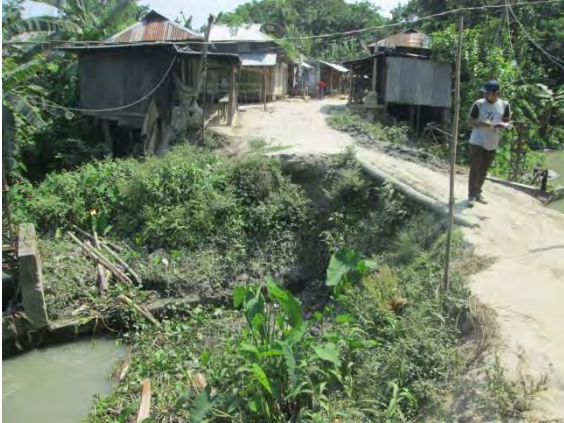
<p>Figure: C/S of Matherbunia sluice</p>	<p>Figure: Damaged barrel at Matherbunia sluice</p>

<ul style="list-style-type: none"> • Major repairing/reconstruction is required. <p>➤ <i>Erosion</i></p> <ul style="list-style-type: none"> • Around 3.0 km embankment from Bhajna primary school to Nandipara is vulnerable to river bank erosion.

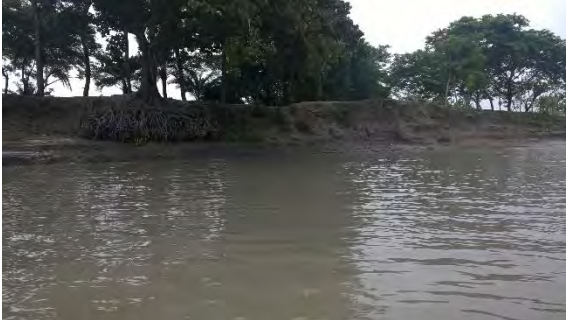
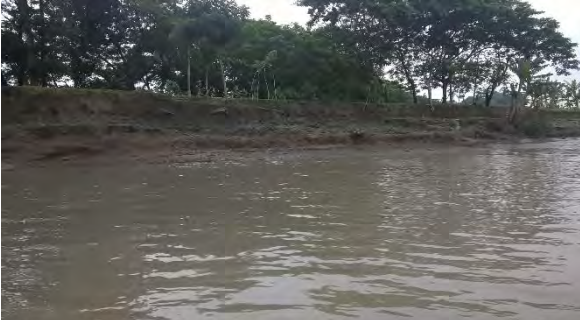
<p>Figure: Embankment erosion at Matibhanga and Nandipara of polder 43/2A</p>

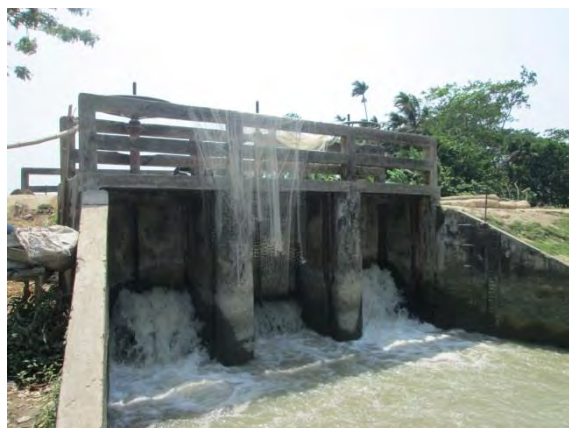
Figure: C/S of Khatasia sluice

<ul style="list-style-type: none"> ➤ <i>Agricultural condition</i> <ul style="list-style-type: none"> • Crop damage: Moderate (mainly affects Lt Aman and Rabi crops) • Water Scarcity: Observed, Northern part of Dakshin Bighai mauza is affected by irrigation scarcity during winter season (mainly affects Robi crops) • Re-excavation of Karamjatala khal and Zintola khal with water retention provision will ensure water availability for irrigation. ➤ <i>Hydraulic structure condition</i> <ul style="list-style-type: none"> • Damaged <ul style="list-style-type: none"> ▪ Main structure is partially tilted and settled down ▪ Gates are corroded and rubber seals are damaged which caused leakage. • Similar capacity (3V- 1.5 m X 1.8 m) new Sluice is required. ➤ <i>Erosion</i> <ul style="list-style-type: none"> • Around 600m embankment at Paschim Kewabania mauza is partially eroded. (Retired embankment is completed).

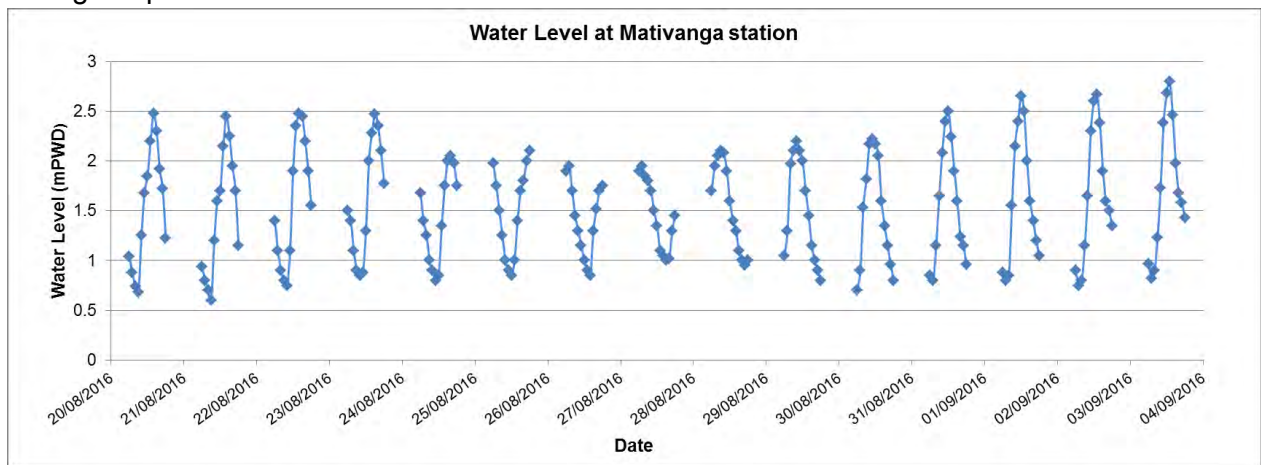
Daily water level data were collected on an hourly basis. Water level hydrographs were plotted as water level versus time. The water level hydrograph at Mativanga, Titkata, Kazirhat and Morichbunia stations are shown in Figure 2.7 to 2.10 respectively. The highest water level is found to be about +3.0 m PWD and the lowest water level to be about +0.3 m PWD. During spring tide, maximum tidal variation is about 3 meters while it is about 2 meters during neap tide.

Figure 2.7: Water level analysis at Mativanga station

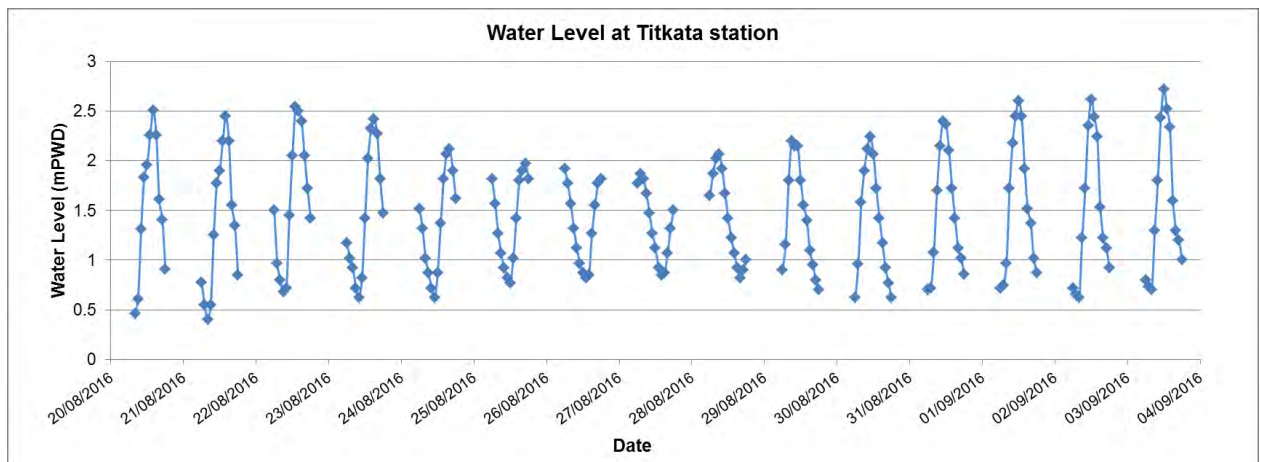
Figure 2.8: Water level analysis at Titkata station

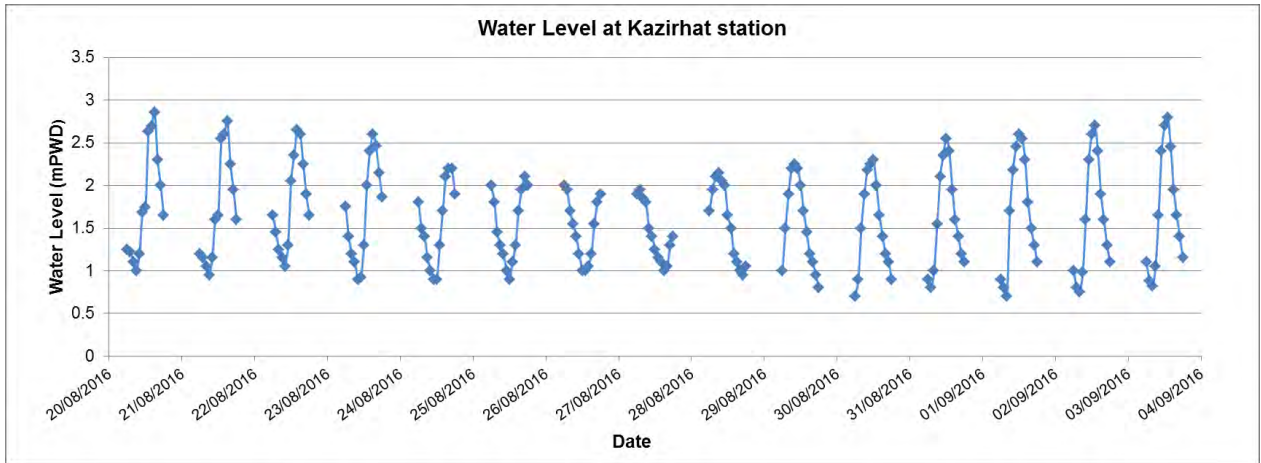
Figure 2.9: Water level analysis at Kazirhat station

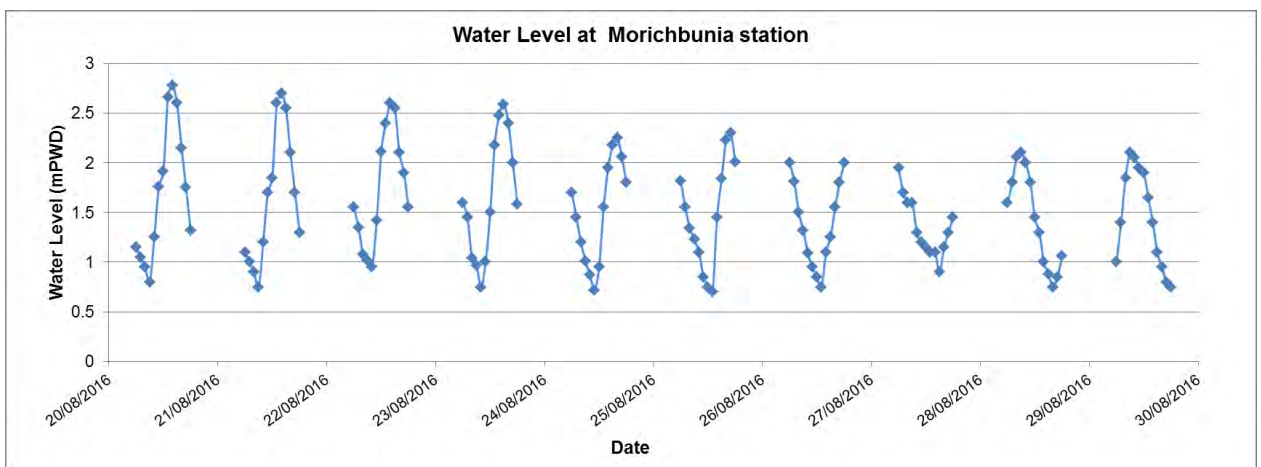
Figure 2.10: Water level analysis at Morichbunia station

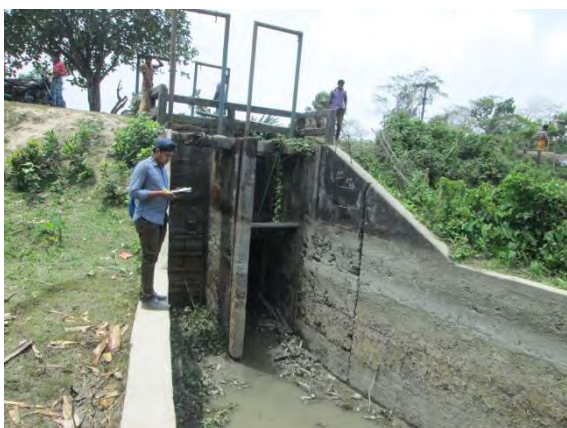
Figure: C/S of Badura Sluice

- **Partially functional**
 - Gates are corroded and rubber seals are damaged
 - Gates and its hoisting arrangement repairing is required

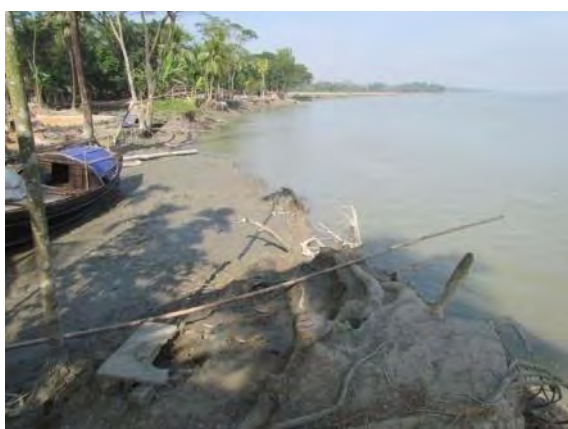
Catchment Name	Cat-05 (Masuakhali Catchment)
Location	Northern part of Uttar Badura (296 ha) and southern part of Balaikati (116 ha) mauza of Auliapur union and small portion of Dakshin Balaikati (4 ha) mauza of Amkhola union
Catchment area (ha)	416
Drainage Outlet	Masuakhali Sluice, DS - 5 at Ch. 25.098 km (1V – 1.5m X 1.8 m)
Main Drainage Canal	Masuakhali khal (Average top width: about 16m to 24m)
Land elevation of Catchment (m PWD)	Max: 3.42 Min: 1.17
Length of Stream within catchment (Km)	8.0
Drainage Density (m/ha)	24.7
Catchment Description	<ul style="list-style-type: none"> ➤ <i>Outfall</i> <ul style="list-style-type: none"> • Outfall Khal: Gorai River • Condition: Highly silted up ➤ <i>Condition of Drainage Khal</i> <ul style="list-style-type: none"> • Main drainage Khal: Moderately Silted up (about 5.0 km khal needs re-excavation) • Branch khal: <i>Boloikathi Khal</i> and <i>Mredhabarir Khal</i> are Moderately silted up ➤ <i>Drainage Congestion</i> <ul style="list-style-type: none"> • Drainage congestion problem: Minor (usually takes 2-3 days to properly drain out rain water) • Permanent Water logging: Not found ➤ <i>Agricultural condition</i> <ul style="list-style-type: none"> • Crop damage: Minor • Water Scarcity: Southern part of Uttar Badura are affected by water scarcity during February to April (mainly affects Rabi crops) ➤ <i>Hydraulic structure condition</i> <ul style="list-style-type: none"> • Functional ➤ <i>Erosion</i> <ul style="list-style-type: none"> • A breach of about 300 m was found (27+500 km to Ch. 27+800 km) at the north-east corner along Galachipa River. About 300 m (Ch. 29+200 km to 29+500 km) at southern part of Balaikati Mauza is affected by river bank erosion. Therefore, about 100 ha area at northern part of this catchment is open which allow tidal water inside the polder and eventually may cause severe river erosion in near future.

Figure: Embankment erosion at Dari Baherchar (Boloikati Village)

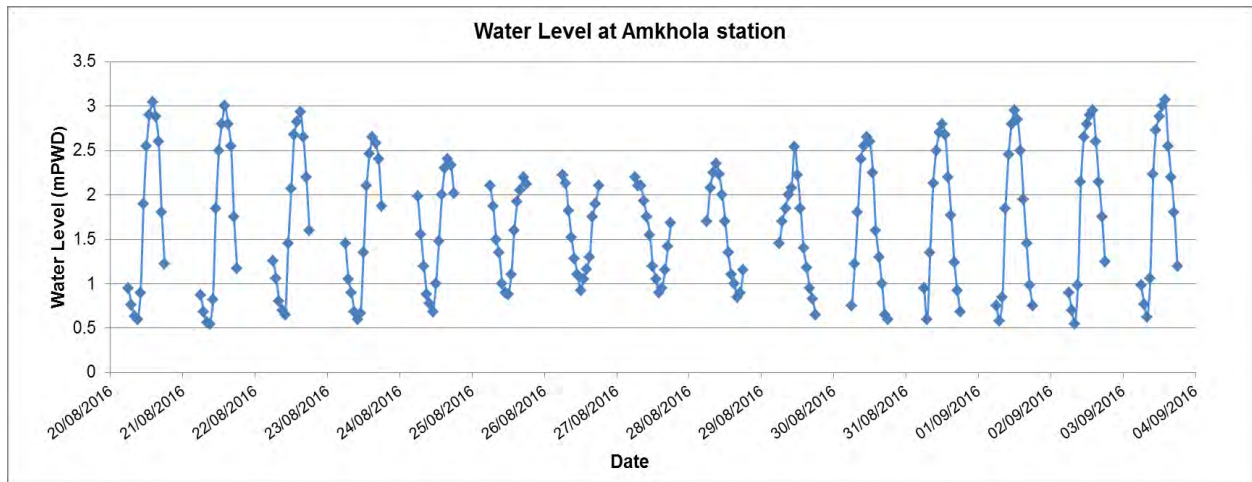
Daily water level data were collected on an hourly basis. Water level hydrographs were plotted as water level versus time. The water level hydrograph at Badura, Amkhola and Amtola stations are shown in Figure 2.15 to 2.17 respectively.

Figure 2.15: Water level analysis at Amkhola station

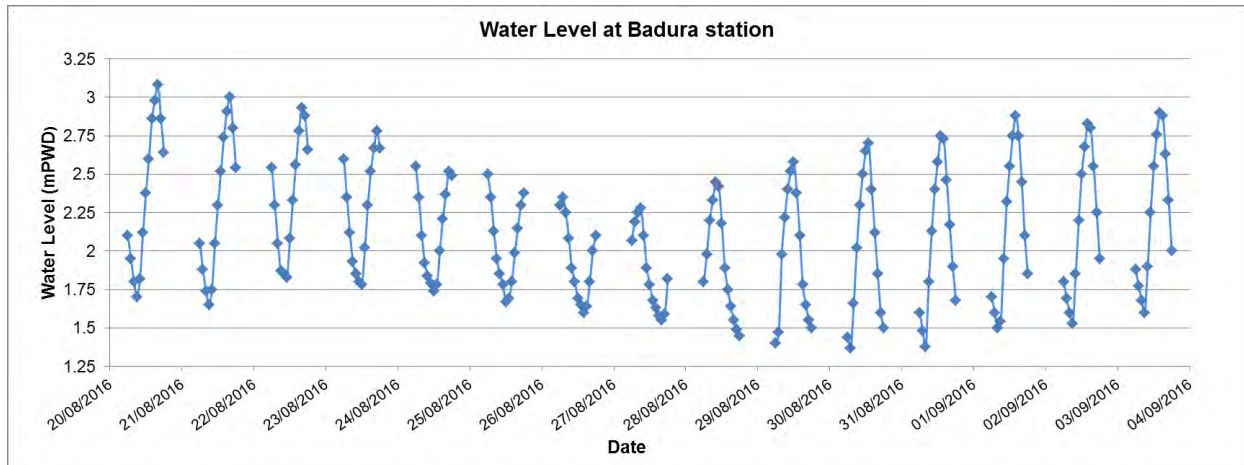
Figure 2.16: Water level analysis at Badura station

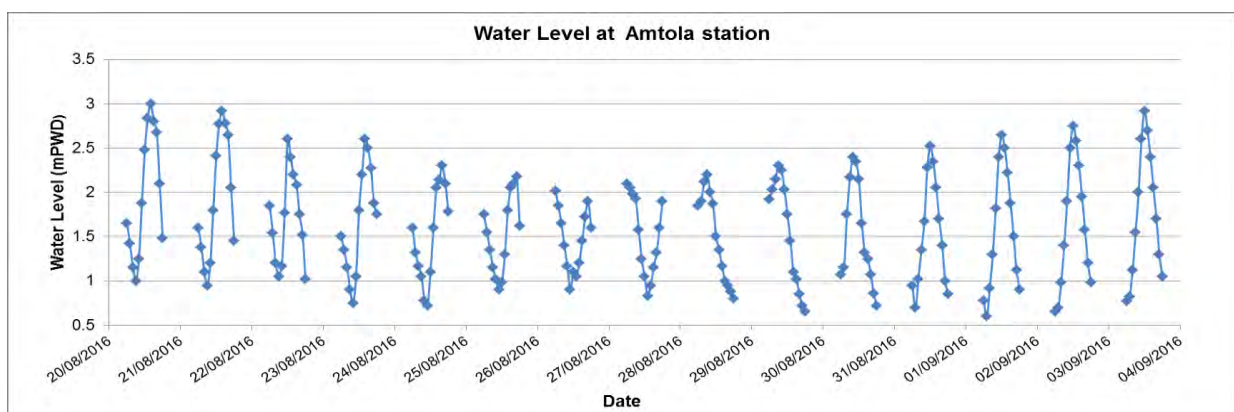
Figure 2.17: Water level analysis at Amtola station

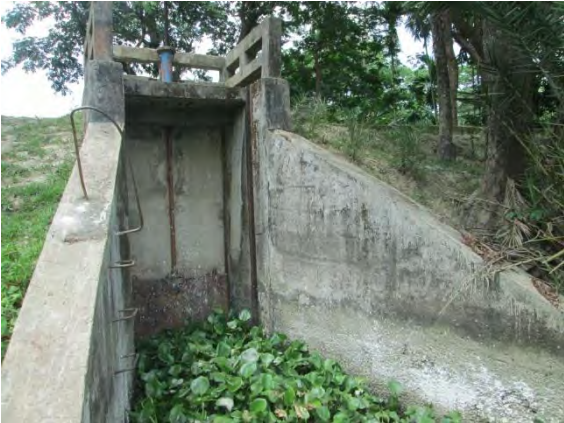
<p>Figure: C/S of Charabunia Sluice</p>

<p>and HYV Aman)</p> <ul style="list-style-type: none"> • Water Scarcity: Not found <p>➤ <i>Hydraulic structure condition</i></p> <ul style="list-style-type: none"> • Partially functional <ul style="list-style-type: none"> ▪ Gates are corroded and collapsed ▪ Rubber seals are damaged which caused leakage • Repairing/replacement of Gates and its hoisting arrangement is required

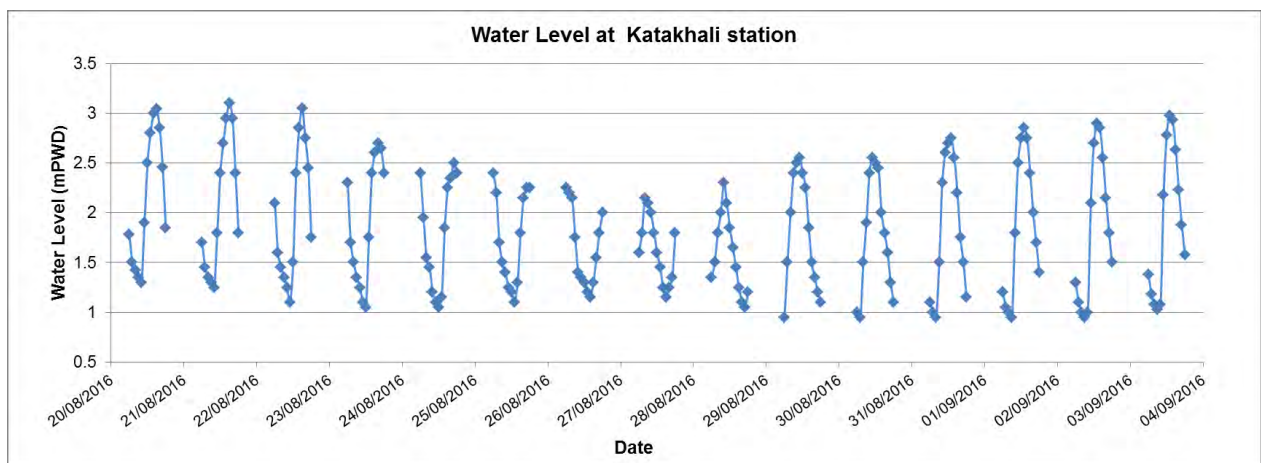
Daily water level data were collected on an hourly basis. Water level hydrographs were plotted as water level versus time. The water level hydrograph at Kazirhat, Morichbunia, Badura and Katakali stations are shown in Figure 2.22 to 2.25 respectively.

Figure 2.22: Water level analysis at katakhali station

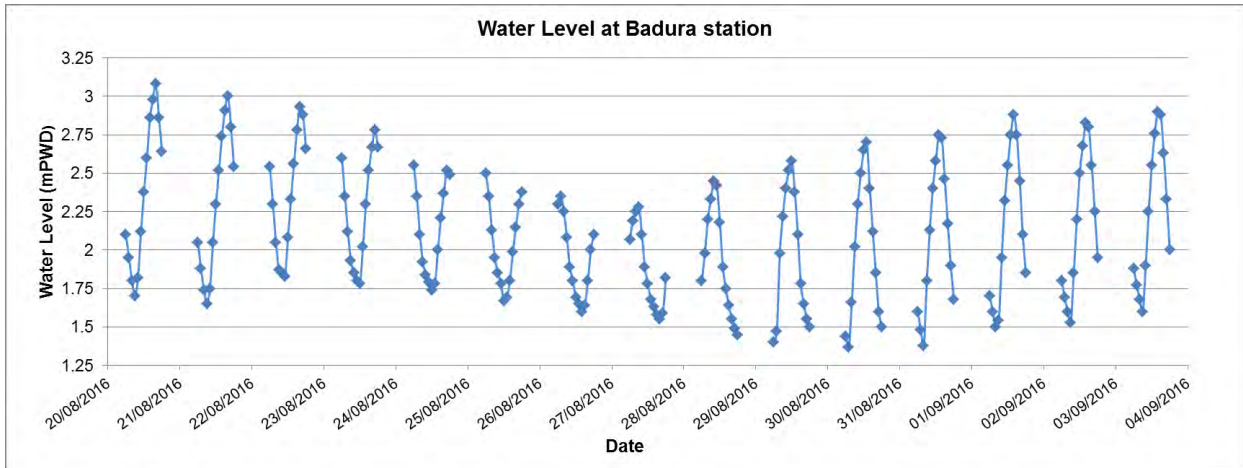
Figure 2.23: Water level analysis at Badura station

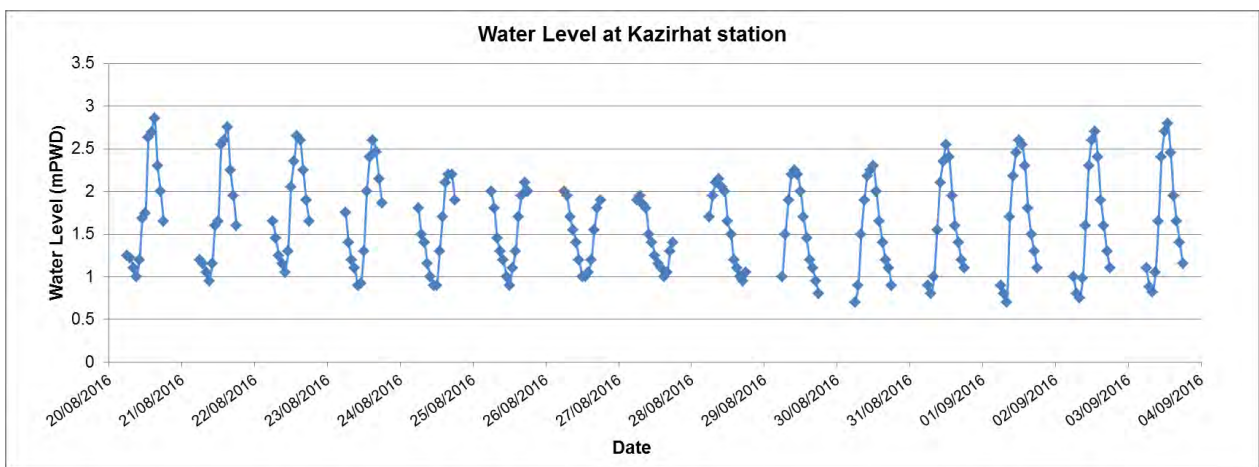
Figure 2.24: Water level analysis at Kazirhat station

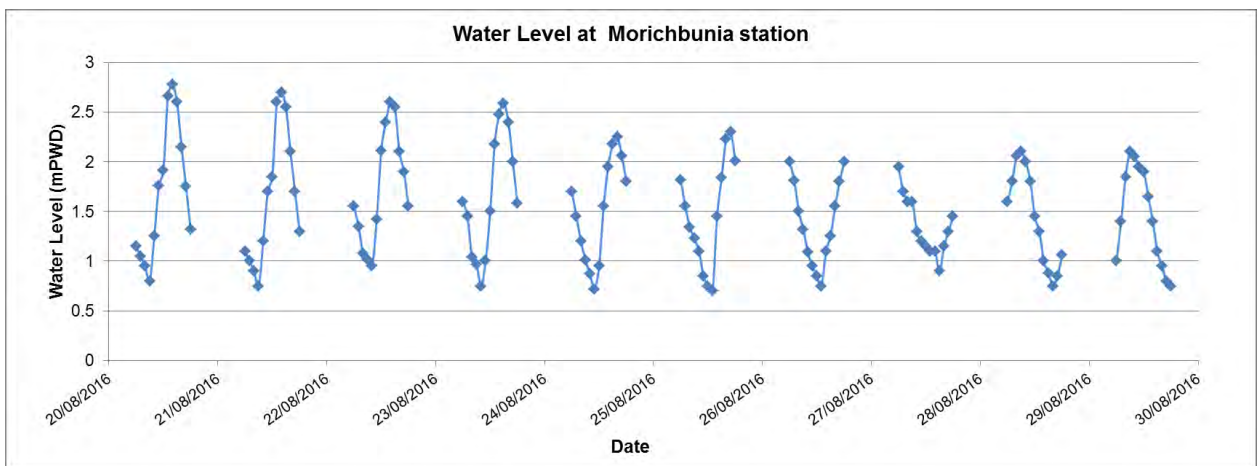
Figure 2.25: Water level analysis at Morichbunia station

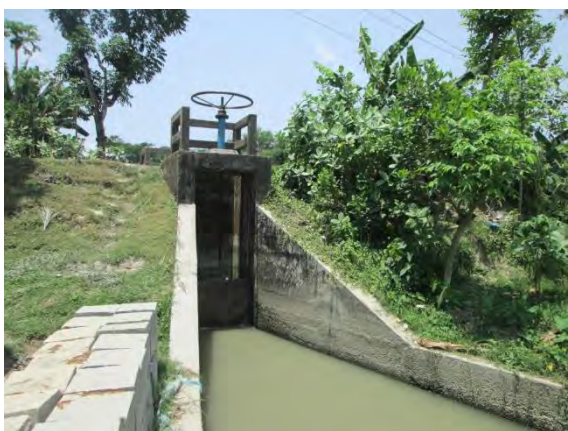
Figure: Natuar khal Sluice

<p>northern part of Natuar khal remains waterlogged for 1 month.</p> <ul style="list-style-type: none"> • Re-excavation of Natuar khal and Chandanbaria Khal (outside khal) will reduce the drainage congestion and water logging issue. <p>➤ <i>Agricultural condition</i></p> <ul style="list-style-type: none"> • Crop damage: High (HYV Aman affected by drainage congestion) • Water Scarcity: Not found <p>➤ <i>Hydraulic structure condition</i></p> <ul style="list-style-type: none"> • Partially functional (R/S and C/S flap gate is damaged)
--	--

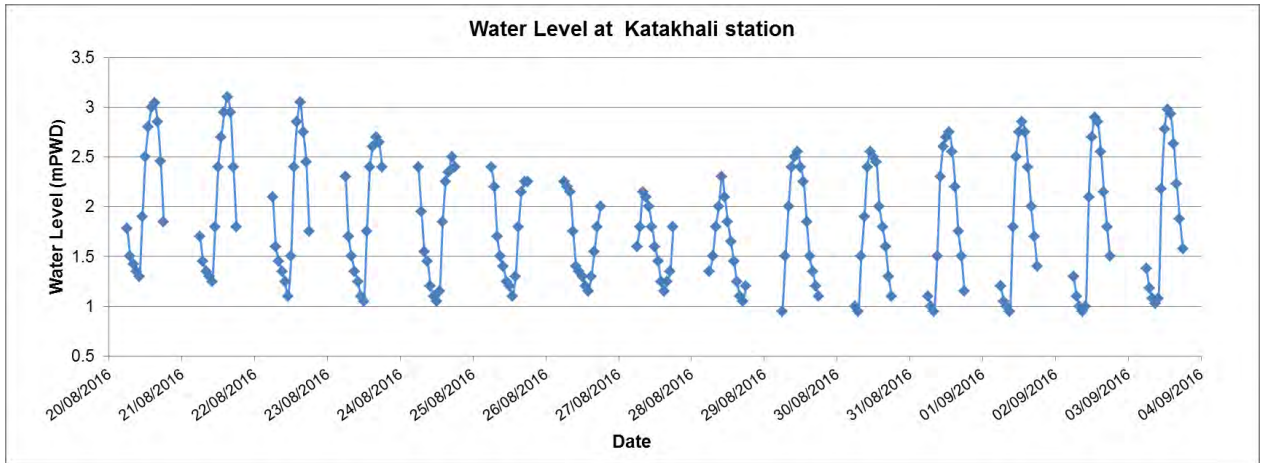
Figure 2.30: Water level analysis at katakhali station

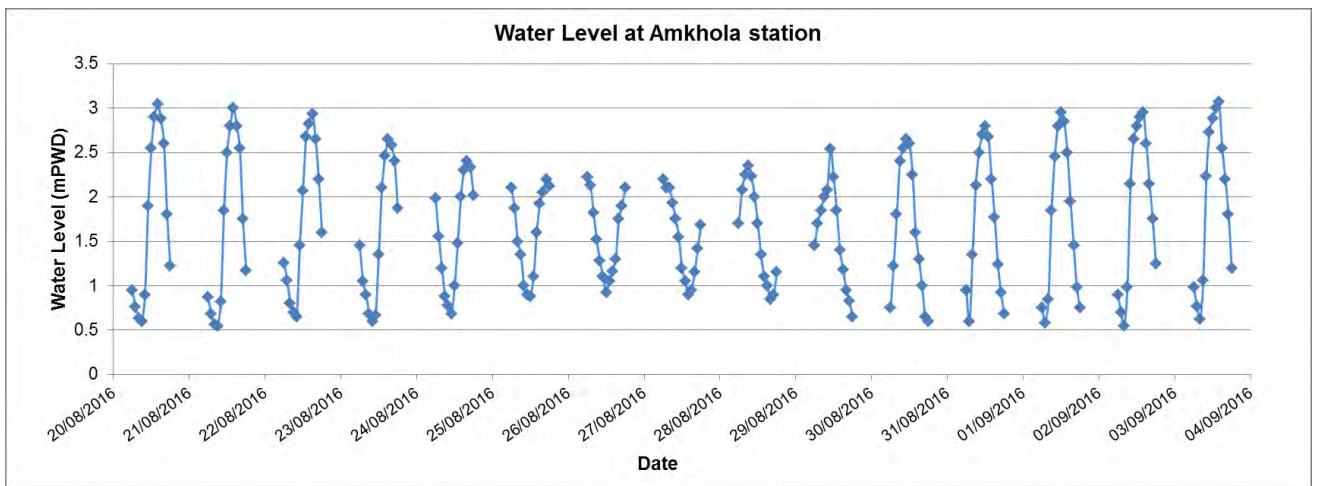
Figure 2.31: Water level analysis at Amkhola station

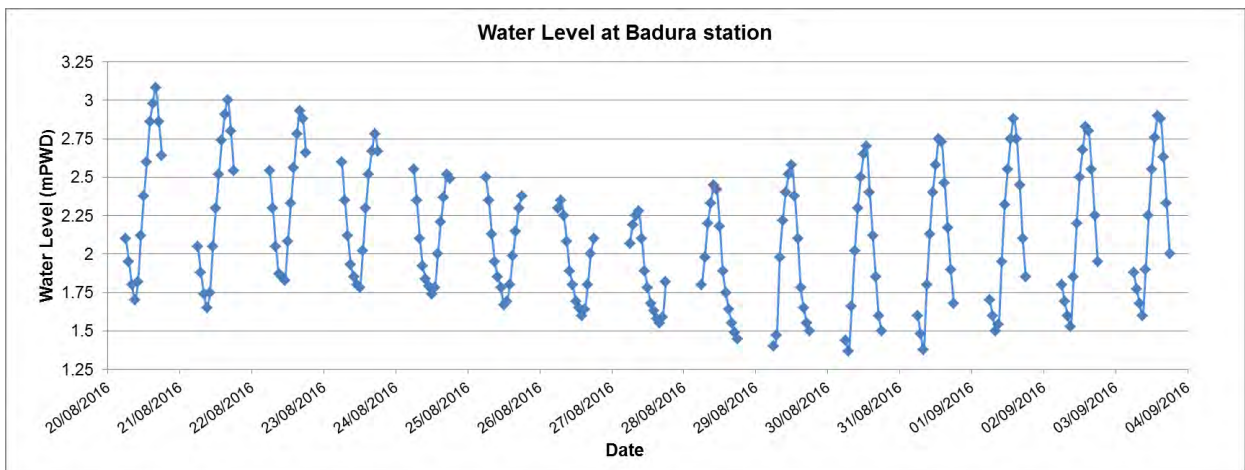
Figure 2.32: Water level analysis at Badura station
