# Final Report On

## Development of Digital Elevation Model and Delineation of Catchment Boundaries (DEM) for Polder 29 and Polder 30 of Blue Gold Program

Khulna O&M Division

### Blue Gold Program

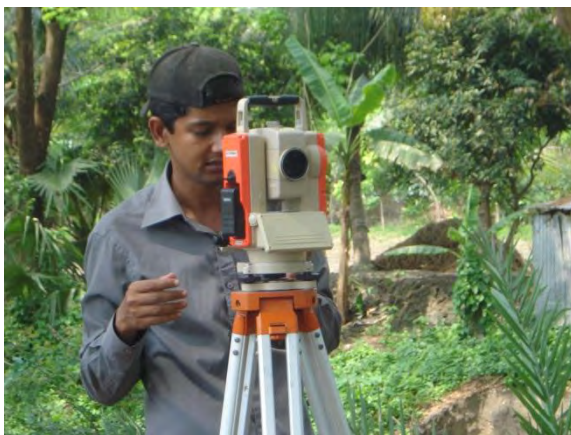
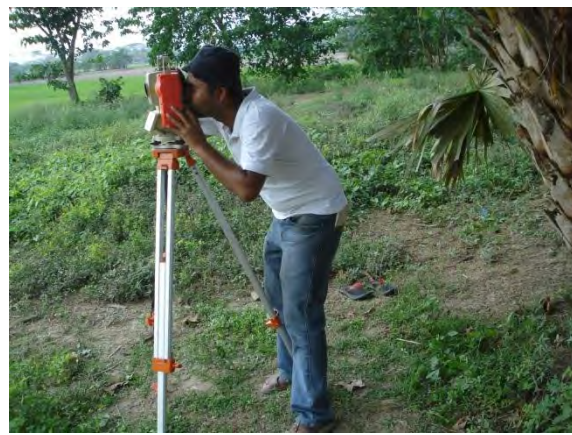
Topographic survey has been conducted using state-of-the-art survey techniques and equipment such as, GPS and Total Station (TS). The survey activities included collecting the land elevations, drainage divides and canals, homesteads, water bodies etc. This survey has been done taking the spot heights at 50 ~ 60 meter interval (closer spacing at major structure locations, at high and low points) and other important features.

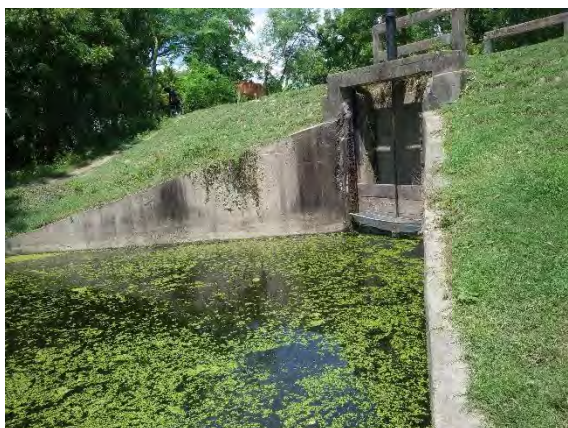
<b>Catchment Name</b>	Cat – 1 (Katakhali catchment)
<b>Location</b>	Banda (121 ha), Sitarampur (33 ha), Nalghona (25 ha), Lahaidanda (5 ha) of Bhandar Para union, Arazi Sajara (5 ha), Dumuria (143 ha) of Dumuria union and Chingra (10 ha) of Sobhana union.
<b>Catchment area (ha)</b>	342 ha
<b>Drainage Outlet</b>	Katakhali Sluice at Ch. 2+319 km (1V- 1.5 m X1.8 m)
<b>Main Drainage Canal</b>	Katakhali khal
<b>Land elevation of Catchment (m PWD)</b>	Max: 3.54 Min: 0.06
<b>Length of Stream within catchment (Km)</b>	6.54
<b>Drainage Density (m/ha)</b>	19.11
<b>Catchment Description</b>	<ul style="list-style-type: none"> <li>➤ <i>Outfall</i> <ul style="list-style-type: none"> <li>• Outfall Khal: <b>Salta River</b> Condition: <b>Moderately Silted up</b></li> </ul> </li> <li>➤ <i>Condition of Drainage Khal</i> <ul style="list-style-type: none"> <li>• Main drainage Khal: <b>Partially silted up</b></li> <li>• Branch khal: <b>Moderately</b> silted up</li> </ul> </li> <li>➤ <i>Drainage Congestion</i> <ul style="list-style-type: none"> <li>• Drainage congestion problem: <b>Moderate</b> (usually takes 3-4 days to properly drain out rain water)</li> <li>• Permanent Water logging: <b>Not found.</b></li> </ul> </li> <li>➤ <i>Agricultural condition</i> <ul style="list-style-type: none"> <li>• Crop damage: <b>Minor</b> (Lt Aman and sesame affected by drainage congestion)</li> <li>• Water Scarcity: <b>Not found</b></li> </ul> </li> <li>➤ <i>Hydraulic structure condition</i> <ul style="list-style-type: none"> <li>• <b>Partially functional</b> (Vertical lift gate is corroded)</li> <li>• Sluice repairing is required</li> </ul> </li> </ul>

Figure: C/S of Katakhal Sluice

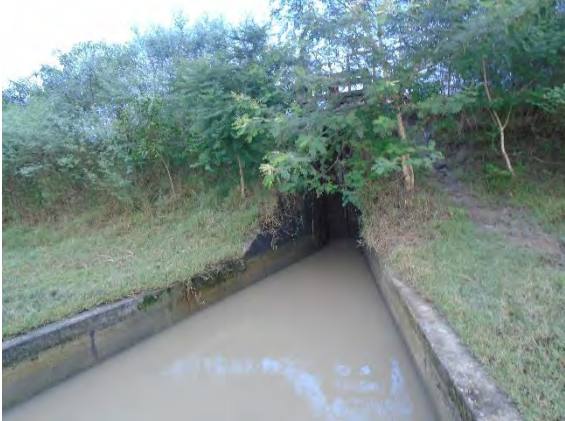
<ul style="list-style-type: none"> <li>• <b>Re-excavation of Kata khal, Aura/Taner khal</b> and its connecting branch khal will available irrigation water for Rabi crops.</li> <li>➤ <i>Hydraulic structure condition</i> <ul style="list-style-type: none"> <li>• <b>Partially functional</b> (Vertical lift gate is corroded)</li> <li>• Sluice repairing is required</li> </ul> </li> </ul>

Figure: C/S of Kanaidanga Sluice	Figure: R/S of Kanaidanga catchment

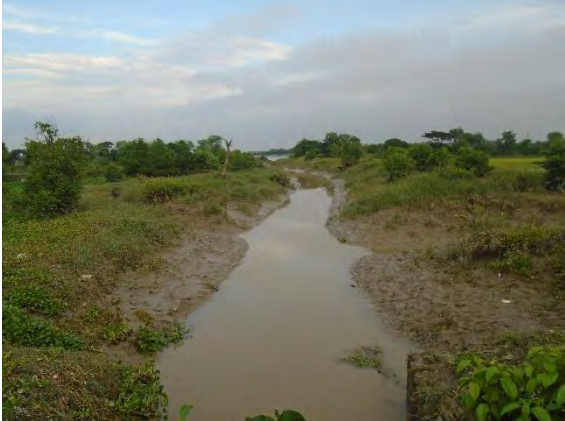
<b>Catchment Name</b>	Cat – 2 (Kanaidanga Catchment)
<b>Location</b>	Kusarhula (56 ha), Purba Kanaidanga (86 ha), Britti Kanaidanga (89 ha), Ghona Taltala (23 ha), Dhanibunia (49 ha) of Bhandar Para union.
<b>Catchment area (ha)</b>	303 ha
<b>Drainage Outlet</b>	Kanaidanga Sluice at Ch. 7+895 km (1V- 0.9 m X1.2 m)
<b>Main Drainage Canal</b>	Kata khal
<b>Land elevation of Catchment (m PWD)</b>	Max: 2.23 Min: 0.03
<b>Length of Stream within catchment (Km)</b>	7.07 km
<b>Drainage Density (m/ha)</b>	23.33
<b>Catchment Description</b>	<ul style="list-style-type: none"> <li>➤ <i>Outfall</i> <ul style="list-style-type: none"> <li>• Outfall Khal: <b>Salta River</b> Condition: <b>Active</b></li> </ul> </li> <li>➤ <i>Condition of Drainage Khal</i> <ul style="list-style-type: none"> <li>• Main drainage Khal: <b>Moderately</b> silted up</li> <li>• Branch khal: <b>Moderately</b> silted up</li> </ul> </li> <li>➤ <i>Drainage Congestion</i> <ul style="list-style-type: none"> <li>• Drainage congestion problem: <b>Minor</b> (usually takes 2-3 days to properly drain out rain water)</li> <li>• Permanent Water logging: <b>Not found</b>.</li> </ul> </li> <li>➤ <i>Agricultural condition</i> <ul style="list-style-type: none"> <li>• Crop damage: <b>Minor</b> (Lt Aman and sesame affected by drainage congestion)</li> <li>• Water Scarcity: <b>Observed</b>, Britti Kanaidanga area is affected by water scarcity during winter season (mainly affects Rabi crops).</li> </ul> </li> </ul>

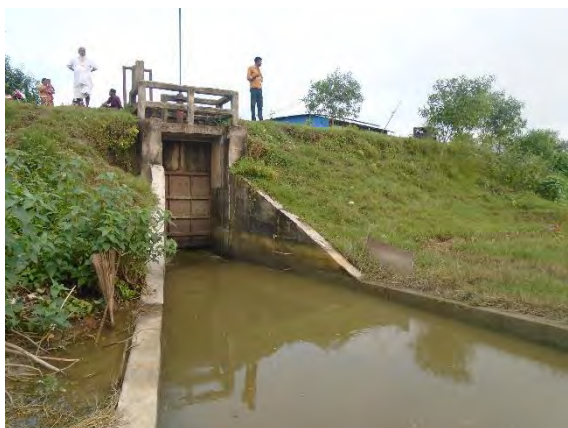
<ul style="list-style-type: none"> <li>• <b>Re-excavation of Bakultala Khal</b> will reduce the drainage congestion problem and available irrigation water for Rabi crops</li> <li>• Permanent Water logging: <b>Not found.</b></li> </ul> <p>➤ <i>Agricultural condition</i></p> <ul style="list-style-type: none"> <li>• Crop damage: <b>Moderate</b> (Lt Aman, HYV Aman and sesame affected by drainage congestion)</li> <li>• Water Scarcity: <b>Observed</b>, Chak Sonadanga area is affected by water scarcity during winter season (mainly affects Rabi crops).</li> </ul> <p>➤ <i>Hydraulic structure condition</i></p> <ul style="list-style-type: none"> <li>• <b>Partially Functional</b></li> <li>• Gates are corroded and rubber seals are damaged</li> <li>• Embankment has piping issue, which caused leakage.</li> <li>• Sluice repairing is required</li> </ul>
--	--

Figure: C/S of Bakultola Sluice

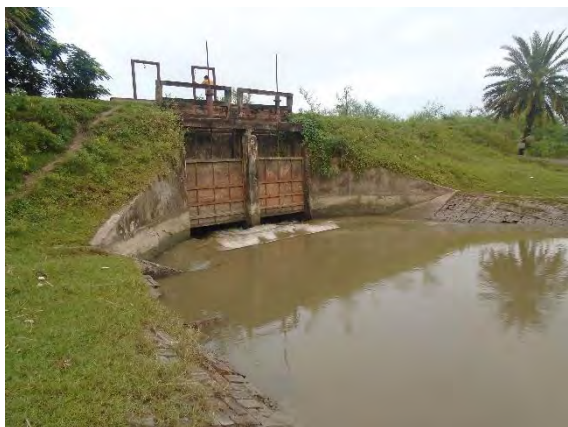
Land elevation of Catchment (m PWD)	Max: 3.18 Min: 0.01
Length of Stream within catchment (Km)	29.98
Drainage Density (m/ha)	22.24
Catchment Description	<ul style="list-style-type: none"> <li>➤ <i>Outfall</i> <ul style="list-style-type: none"> <li>• Outfall Khal: <b>Salta River</b> Condition: <b>Active</b></li> </ul> </li> <li>➤ <i>Condition of Drainage Khal</i> <ul style="list-style-type: none"> <li>• Main drainage Khal: <b>Moderately silted up</b></li> <li>• Branch khal: <b>Moderately silted up</b></li> </ul> </li> <li>➤ <i>Drainage Congestion</i> <ul style="list-style-type: none"> <li>• Drainage congestion problem: <b>Minor</b> (usually takes 2-3 days to properly drain out rain water)</li> <li>• Permanent Water logging: <b>Not found.</b></li> </ul> </li> <li>➤ <i>Agricultural condition</i> <ul style="list-style-type: none"> <li>• Crop damage: <b>Minor</b> (Lt Aman, HYV Aman and sesame affected by drainage congestion)</li> <li>• Water Scarcity: <b>Partially observed</b>, Rajnagar, Perikhali and Chak Angurkata area is affected by water scarcity during winter season (mainly affects Rabi crops).</li> <li>• <b>Re-excavation of Kanchannagar / Hazibunia Khal</b> with water retention provision will ensure water availability for irrigation.</li> </ul> </li> <li>➤ <i>Hydraulic structure condition</i> <ul style="list-style-type: none"> <li>• <b>Partially functional</b></li> <li>• Loose Apron both R/S and C/S is damaged</li> <li>• Block pitching work in ongoing</li> </ul> </li> </ul>

Figure: C/S of Kanchannagar Sluice

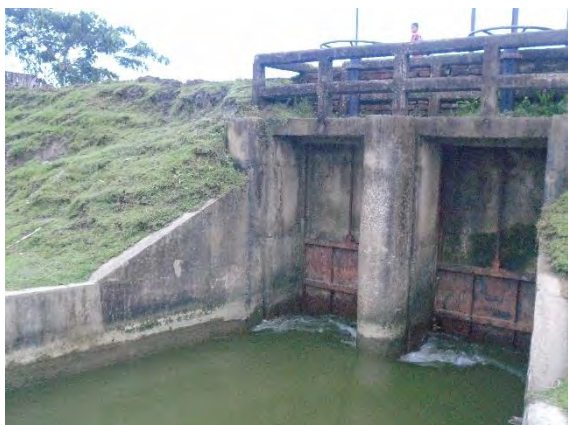
<ul style="list-style-type: none"> <li>• Water Scarcity: <b>Partially observed</b>, Telikhali, Noakati, Gajendrapur, Sahas and Pakhirbadal area is affected by water scarcity during winter season (mainly affects Rabi crops).</li> <li>➤ <i>Hydraulic structure condition</i> <ul style="list-style-type: none"> <li>• <b>Partially Functional</b></li> <li>• Vertical lift gate are corroded</li> <li>• Sluice repairing is required</li> </ul> </li> </ul>
--	--

Figure: C/S of Telikhali Sluice

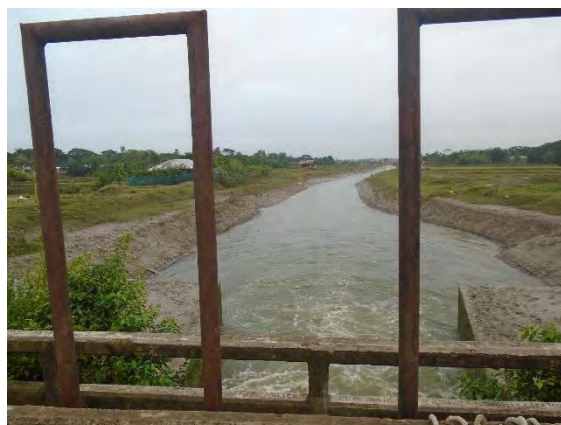
Figure: Outfall of Telikhali catchment

<b>Drainage Density (m/ha)</b>	19.30
<b>Catchment Description</b>	<ul style="list-style-type: none"> <li>➤ <i>Outfall</i> <ul style="list-style-type: none"> <li>• Outfall Khal: <b>Bhadra River</b> Condition: <b>Partially active</b>; Telikhali new sluice was constructed about 700m away from Bhadra river. Therefore, Telikhali khal is silted up during post monsoon period.</li> <li>• Construction of temporary cross band at the outfall of Telikhali khal may reduce the siltation problem.</li> </ul> </li> <li>➤ <i>Condition of Drainage Khal</i> <ul style="list-style-type: none"> <li>• Main drainage Khal: <b>Moderately silted up</b></li> <li>• Branch khal: <b>Moderately</b> silted up</li> </ul> </li> <li>➤ <i>Drainage Congestion</i> <ul style="list-style-type: none"> <li>• Drainage congestion problem: <b>Moderate</b> (usually takes 3-4 days to properly drain out rain water)</li> <li>• Joykhali (4V-1.5m X 1.8m) sluice is fully damaged, as such, this catchment area has changed and drains into Telikhali catchment.</li> <li>• <b>Re-excavation of Telikhali Khal, Bhadra Nadi</b> and its connecting branches khal will reduce the drainage congestion problem and available irrigation water for Rabi crops.</li> </ul> </li> <li>➤ <i>Agricultural condition</i> <ul style="list-style-type: none"> <li>• Crop damage: <b>Moderate</b> (Lt Aman, HYV Aman and sesame affected by drainage congestion)</li> </ul> </li> </ul>

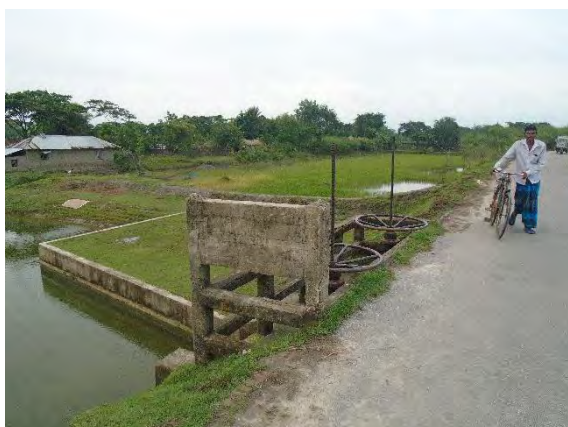
Figure: Telikhali (Old) sluice

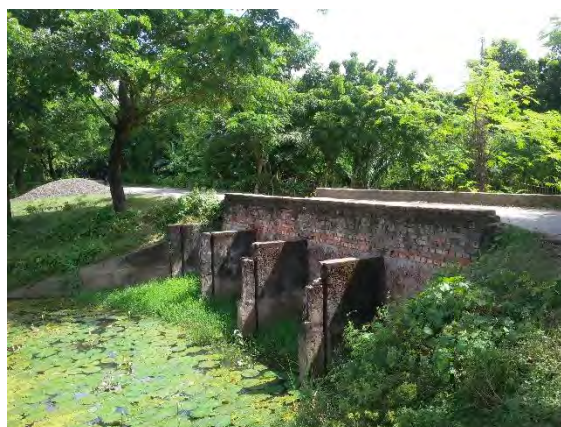
Figure: Abandon Joykhali Sluice

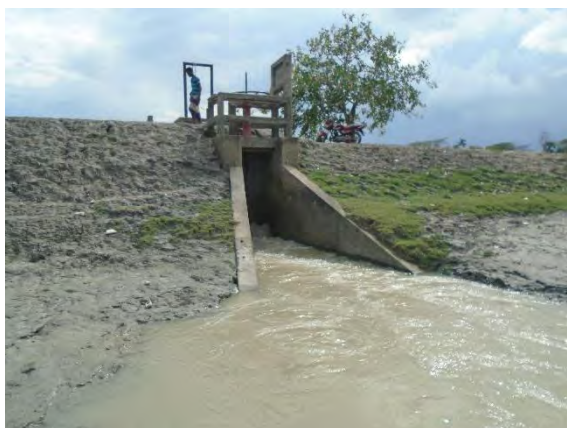
<b>Catchment (m PWD)</b>	
<b>Length of Stream within catchment (Km)</b>	6.18
<b>Drainage Density (m/ha)</b>	18.63
<b>Catchment Description</b>	<ul style="list-style-type: none"> <li>➤ <i>Outfall</i> <ul style="list-style-type: none"> <li>• Outfall Khal: <b>Bhadra River</b> Condition: <b>Active</b></li> </ul> </li> <li>➤ <i>Condition of Drainage Khal</i> <ul style="list-style-type: none"> <li>• Main drainage Khal: <b>Moderately silted up</b></li> <li>• Branch khal: <b>Moderately</b> silted up</li> </ul> </li> <li>➤ <i>Drainage Congestion</i> <ul style="list-style-type: none"> <li>• Drainage congestion problem: <b>Minor</b> (usually takes 2-3 days to properly drain out rain water)</li> <li>• Permanent Water logging: <b>Not found</b></li> </ul> </li> <li>➤ <i>Agricultural condition</i> <ul style="list-style-type: none"> <li>• Crop damage: <b>Minor</b></li> <li>• Water Scarcity: <b>Not found</b></li> </ul> </li> <li>➤ <i>Hydraulic structure condition</i> <ul style="list-style-type: none"> <li>• <b>Partially Functional</b></li> <li>• Loose Apron both R/S and C/S is damaged</li> <li>• Sluice repairing is required</li> </ul> </li> <li>➤ <i>Erosion</i> <ul style="list-style-type: none"> <li>• Around 1100m embankment at Chandghar and Sundar Mahal mauza is vulnerable to river bank erosion and tidal flooding. At the end of July 2015, around 300m of embankment was breached at Chandgarh area consequently about 90 to 100 ha area of Sundar Mahal, Akra and Chandghar mauza were frequently inundated by diurnal tide from July 2015 to July 2016.</li> <li>• In July 2016, BWDB has constructed an earthen retired embankment inside the actual polder alignment, which prevents tidal water from entering the polder.</li> <li>• Around 20 ha lands have been eroded from the floodplain portions of Jaliakhali area. Mora Badra Nadi and agricultural land at Sundar Mahal and Chandgarh was silted up.</li> <li>• Permanent bank protection works are required at the vulnerable locations.</li> </ul> </li> </ul>

Figure: C/S of Jaliakhali Sluice

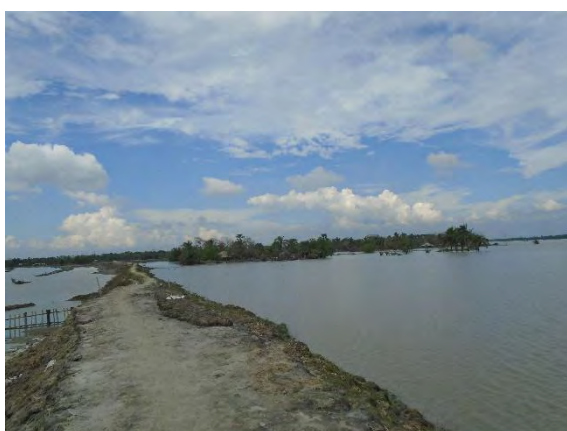
Figure: Retired embankment at  
Chadghar/Jalilakhali

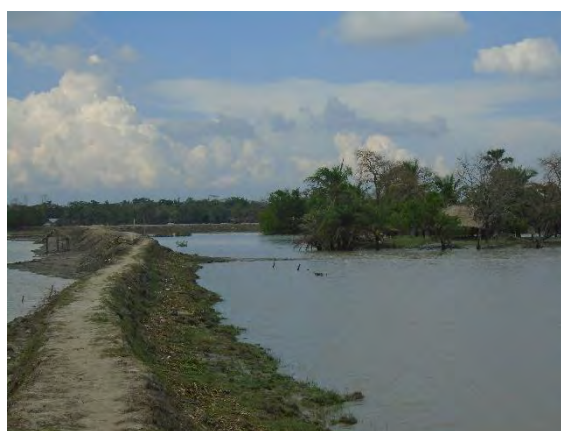
Figure: Erosion at Chadghar/Jaliakhali

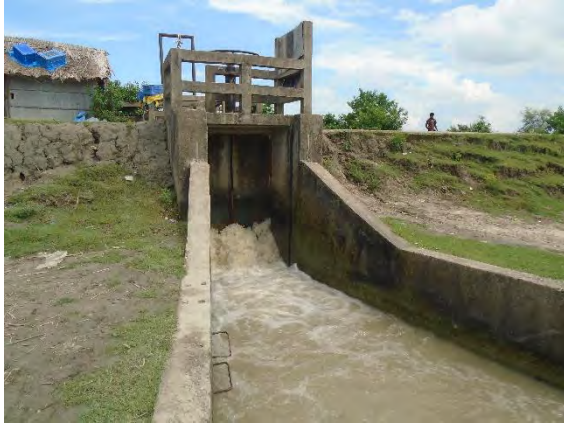
Figure: C/S of Ruhitmara Sluice

<p><b>Catchment Description</b></p>	<p>Condition: <b>Active</b></p> <ul style="list-style-type: none"> <li>➤ <i>Condition of Drainage Khal</i> <ul style="list-style-type: none"> <li>• Main drainage Khal: <b>Partially silted up</b></li> <li>• Branch khal: <b>Moderately</b> silted up</li> </ul> </li> <li>➤ <i>Drainage Congestion</i> <ul style="list-style-type: none"> <li>• Drainage congestion problem: <b>Minor</b> (usually takes 2-3 days to properly drain out rain water)</li> <li>• Permanent Water logging: <b>Not found</b></li> </ul> </li> <li>➤ <i>Agricultural condition</i> <ul style="list-style-type: none"> <li>• Crop damage: <b>Minor</b></li> <li>• Water Scarcity: Partially observed, Ruhitmara and Bara Aria area is affected by water scarcity during winter season (mainly affects Rabi crops)</li> <li>• Re-excavation of Ruhitmara khal with water retention provision will ensure water availability for irrigation.</li> </ul> </li> <li>➤ <i>Hydraulic structure condition</i> <ul style="list-style-type: none"> <li>• Ruhitmara catchment has two drainage/ pour points namely Ruhitmara sluice and Kudlar khal pipe sluice, which are closer to each other. Kudlar khal pipe sluice is a <b>damaged</b> old hydraulic structure, while Ruhitmara sluice is a <b>fully functional</b> newly constructed structure.</li> <li>• Kudlar khal accumulates major portion of this catchment's water which is drained out through the damaged pipe sluice while the remaining smaller portion of water of this catchment is accumulated in Ruhitmara khal, which is drained out through the fully functional Ruhitmara sluice.</li> <li>• As the Kundlar khal pipe sluice is damaged, drainage congestion occurs in the area during monsoon season which may be prevented by letting the water accumulated in Kudlar khal to pass through the nearby Ruhitmara sluice. This can be achieved by constructing a connecting canal from Kundlar khal to Ruhitmara khal at a nearby the outlet location. A major rehabilitation or dismantling of the Kudlar khal sluice is also required.</li> <li>• Kodla Motbari area is affected by water logging during monsoon period. Hence, construction of Kodla Motbari drainage Sluice (1V- 0.9m X 1.2m) is required to reduce this problem.</li> </ul> </li> <li>➤ <i>Erosion</i> <ul style="list-style-type: none"> <li>• Around 500m embankment at Baro Aria is vulnerable to river bank erosion and tidal flooding. This location is situated at the common confluence of Badhra and Gengrail river which is unstable and is being eroded for some 8~10 years. Around 100 ha of lands have been eroded from the Baro aria point in last 26 years.</li> <li>• BWDB has constructed retired embankment at Baro Aria, however, the setback distance is decreasing</li> </ul> </li> </ul>

every year. Permanent bank protection works by placing geo-bags with launching apron are required at the vulnerable locations.

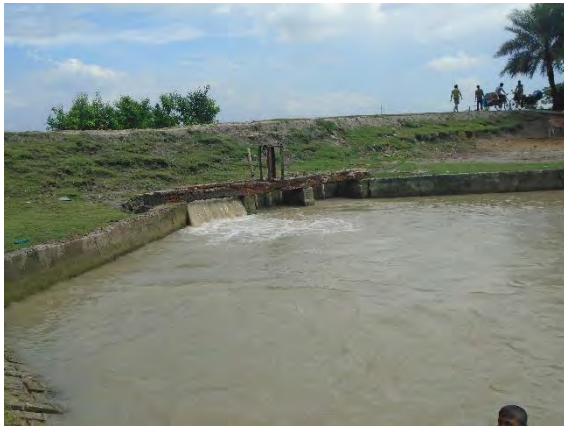
Figure: C/S of Kudlar khal Sluice (damaged)

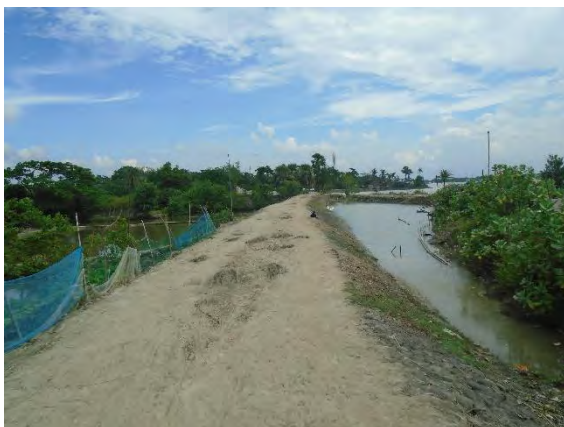
Figure: Retired embankment at Baro Auria

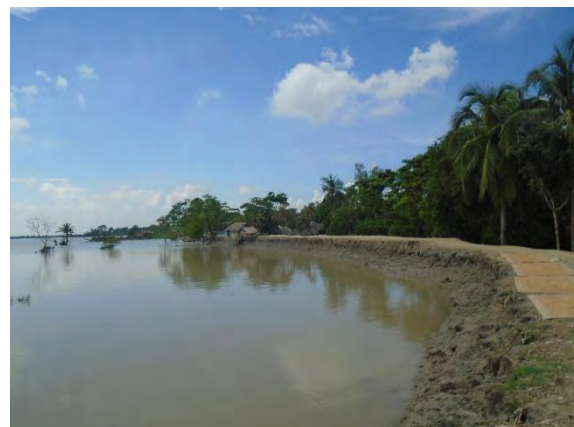
Figure: Embankment Erosion at Baro Auria

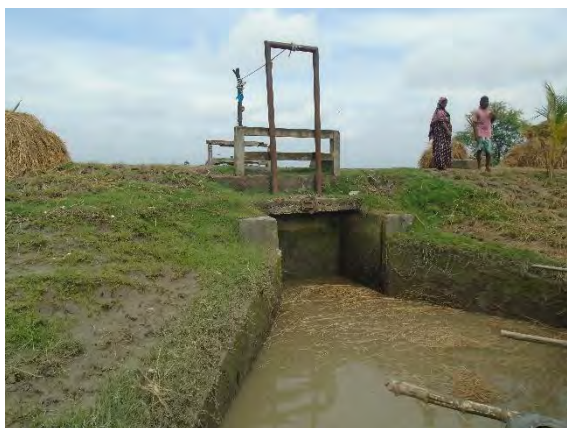
<b>Catchment Name</b>	Cat – 8 (Ratankhali Catchment)
<b>Location</b>	Kalikapur (88 ha), Britti Bhulbaria (186 ha), Jhaltala (64 ha), Bhulbaria (44 ha), Bazeafti Bhulbaria (36 ha), Ratankhali (135 ha), Akra (25 ha), Bahir Akra (53 ha), Chandgarh (16 ha), Taiabpur (60 ha) and Sarappur (100 ha) of Sarappur union.
<b>Catchment area (ha)</b>	807 ha
<b>Drainage Outlet</b>	Ratankhali Sluice at Ch. 32+903 km (1V- 1.38 m X1.22 m)
<b>Main Drainage Canal</b>	Sitalmari Khal
<b>Land elevation of Catchment (m PWD)</b>	Max: 2.69 Min: 0.08
<b>Length of Stream within catchment (Km)</b>	10.21
<b>Drainage Density (m/ha)</b>	23.98
<b>Catchment Description</b>	<ul style="list-style-type: none"> <li>➤ <i>Outfall</i> <ul style="list-style-type: none"> <li>• Outfall Khal: <b>Gangrail River</b> Condition: <b>Active</b></li> </ul> </li> <li>➤ <i>Condition of Drainage Khal</i> <ul style="list-style-type: none"> <li>• Main drainage Khal: <b>Partially silted up</b></li> <li>• Branch khal: <b>Moderately</b> silted up</li> </ul> </li> <li>➤ <i>Drainage Congestion</i> <ul style="list-style-type: none"> <li>• Drainage congestion problem: <b>Minor</b> (usually takes 2-3 days to properly drain out rain water)</li> <li>• Permanent Water logging: <b>Not Found</b></li> </ul> </li> <li>➤ <i>Agricultural condition</i> <ul style="list-style-type: none"> <li>• Crop damage: <b>Minor</b></li> <li>• Water Scarcity: <b>Partially observed</b>, Britti Bhulbaria and Ratankhali area is affected by water scarcity during winter season (mainly affects Rabi crops)</li> <li>• <b>Re-excavation of Jhaltola khal</b> and its connecting branch khals with water retention provision will ensure water availability for irrigation</li> </ul> </li> <li>➤ <i>Hydraulic structure condition</i> <ul style="list-style-type: none"> <li>• <b>Partially functional</b></li> <li>• Vertical lift gate is collapsed and rubber seals are damaged which caused leakage</li> <li>• Barrel wall and railing is damaged</li> <li>• Major repairing is required</li> </ul> </li> </ul>

Figure: R/S of Ratankhali Sluice

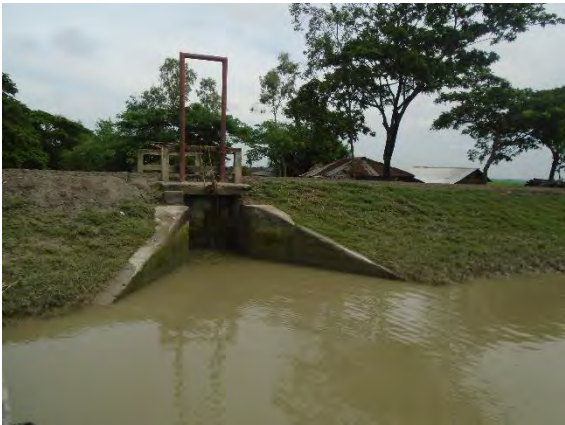
<ul style="list-style-type: none"> <li>• Gates are corroded and rubber seals are damaged which caused leakage</li> <li>• Sluice repairing is required</li> </ul>

Figure: R/S of Asannagar Sluice	Figure: C/S of Asannagar catchment

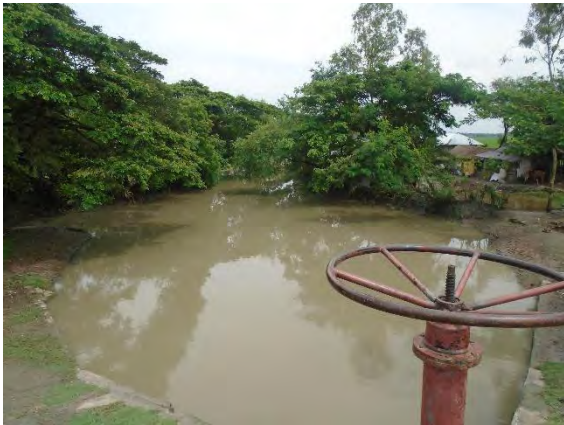
<b>Catchment Name</b>	Cat – 9 (Asannagar Catchment)
<b>Location</b>	Keakhali (50 ha), Kalikapur (203 ha), Kalikapur Badhurghachha (47 ha), Asannagar (92 ha), Jhaltala (34 ha) of Sarappur union.
<b>Catchment area (ha)</b>	426 ha
<b>Drainage Outlet</b>	Asannagar Sluice at Ch. 35+002 km (1V- 1.07 m X1.35 m)
<b>Main Drainage Canal</b>	Asannagar Khal
<b>Land elevation of Catchment (m PWD)</b>	Max: 2.49 Min: 0.10
<b>Length of Stream within catchment (Km)</b>	10.21
<b>Drainage Density (m/ha)</b>	23.98
<b>Catchment Description</b>	<ul style="list-style-type: none"> <li>➤ <i>Outfall</i> <ul style="list-style-type: none"> <li>• Outfall Khal: <b>Gangrail River</b> Condition: <b>Active</b></li> </ul> </li> <li>➤ <i>Condition of Drainage Khal</i> <ul style="list-style-type: none"> <li>• Main drainage Khal: <b>Active</b> (about 3.5 km Asannagar keyakhali khal was re-excavated under Bluegold program in 2015)</li> <li>• Branch khal: <b>Partially</b> silted up</li> </ul> </li> <li>➤ <i>Drainage Congestion</i> <ul style="list-style-type: none"> <li>• Drainage congestion problem: <b>Minor</b> (usually takes 2-3 days to properly drain out rain water)</li> <li>• Permanent Water logging: <b>Not Found</b></li> </ul> </li> <li>➤ <i>Agricultural condition</i> <ul style="list-style-type: none"> <li>• Crop damage: <b>Minor</b></li> <li>• Water Scarcity: <b>Not found</b></li> </ul> </li> <li>➤ <i>Hydraulic structure condition</i> <ul style="list-style-type: none"> <li>• <b>Partially functional</b></li> </ul> </li> </ul>

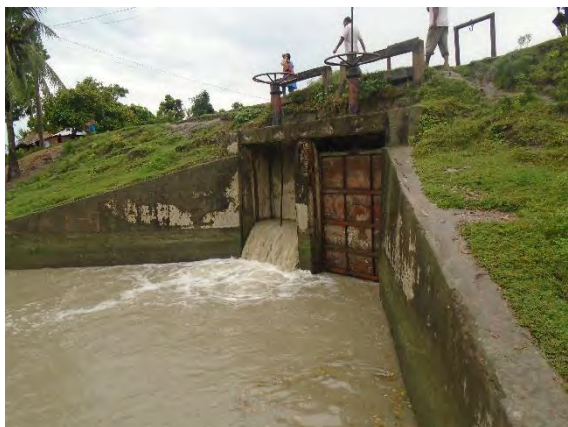
<p>catchment area was changed and drains into Chatchotia sluice through Ramakhali khal.</p> <ul style="list-style-type: none"> <li>• <b>Re-excavation of Ramakhali Khal, Aro khal, Hogolbunia khal</b> and its connecting branches khal will reduce the drainage congestion problem and available irrigation water for Rabi crops.</li> <li>• Permanent Water logging: <b>Not Found</b></li> </ul> <p>➤ <i>Agricultural condition</i></p> <ul style="list-style-type: none"> <li>• Crop damage: <b>Moderate</b> (Lt Aman, sesame and Sun-flower affected by drainage congestion)</li> <li>• Water Scarcity: <b>Partially observed</b>; Golaimari, Dighalia, Baghdari, Khutakhali and Chhota Banda area is affected by water scarcity during winter season (mainly affects Rabi crops)</li> </ul> <p>➤ <i>Hydraulic structure condition</i></p> <ul style="list-style-type: none"> <li>• <b>Damaged</b> <ul style="list-style-type: none"> <li>▪ Loose apron are damaged both C/S and R/S.</li> <li>▪ Gates are corroded and collapsed</li> <li>▪ Hoisting arrangement of vertical lift gate is damaged</li> </ul> </li> <li>• Sluice repairing is required</li> </ul>

Figure: C/S of Chatchatia Sluice

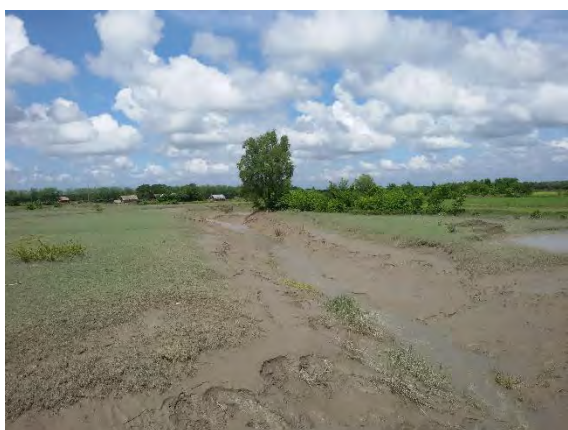
Figure: Siltrated up Offtake of Golaimari Sluice

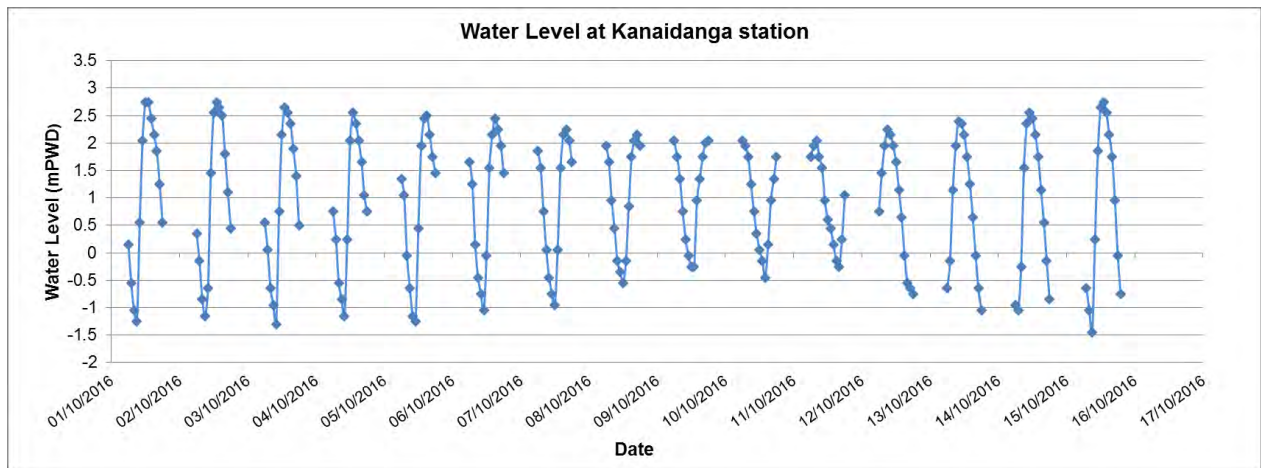
Figure 2.7: Water level analysis at Kanaidanga station

Daily water level data were collected on an hourly basis. Water level hydrographs were plotted as water level versus time. The water level hydrograph at Kakmari, Chatchotia, Baro Auria, Parbotiaghata and Kanaidanga stations are shown in Figure 2.7 to 2.11 respectively.

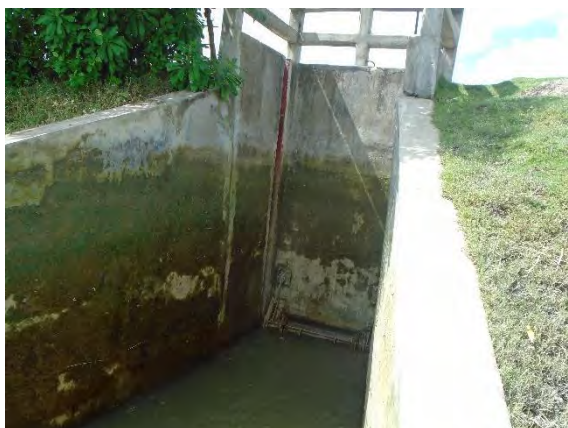
Figure: C/S of Kismat Fultala Sluice

<b>Catchment Name</b>	Cat – 1 (Kismat Fultala Catchment)
<b>Location (mauza wise)</b>	Hetalbunia (152 ha), Kismat Phultala (148 ha), Bherandabunia (51 ha), Madia Asannagar (108 ha) of Batiaghata union.
<b>Catchment area (ha)</b>	459
<b>Drainage Outlet</b>	Kismat Fultala Sluice at Ch. 1+933 km (1V- 1.5 m X1.8 m)
<b>Main Drainage Canal</b>	Kismat Fultala khal
<b>Land elevation of Catchment (m PWD)</b>	Max: 2.49 Min: 0.62
<b>Length of Stream within catchment (Km)</b>	11.96
<b>Drainage Density (m/ha)</b>	26.05
<b>Catchment Description</b>	<ul style="list-style-type: none"> <li>➤ <i>Outfall</i> <ul style="list-style-type: none"> <li>• Outfall Khal: <b>Kazi Bacha River</b> Condition: <b>Active</b></li> </ul> </li> <li>➤ <i>Condition of Drainage Khal</i> <ul style="list-style-type: none"> <li>• Main drainage Khal: <b>Partially</b> silted up</li> <li>• Branch khal: <b>Moderately</b> silted up</li> </ul> </li> <li>➤ <i>Drainage Congestion</i> <ul style="list-style-type: none"> <li>• Drainage congestion problem: <b>Moderate</b> (usually takes 3-4 days to properly drain out rain water)</li> <li>• Permanent Water logging: <b>Not found.</b></li> </ul> </li> <li>➤ <i>Agricultural condition</i> <ul style="list-style-type: none"> <li>• Crop damage: <b>Moderate</b> (Lt Aman, sesame, watermelon and Sun-flower affected by heavy rainfall &amp; drainage congestion)</li> <li>• Water Scarcity: <b>Not found.</b></li> </ul> </li> <li>➤ <i>Structure Condition</i> <ul style="list-style-type: none"> <li>• <b>Functional</b></li> </ul> </li> </ul>

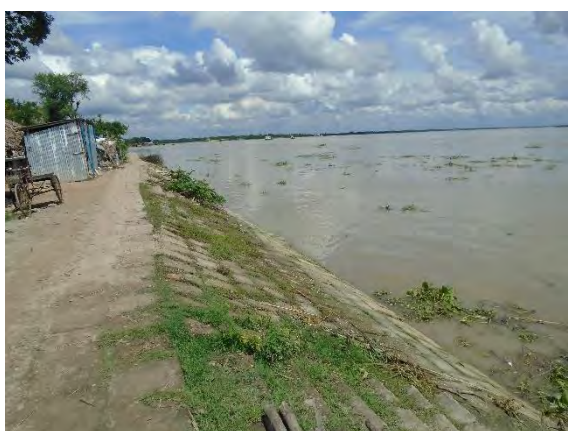
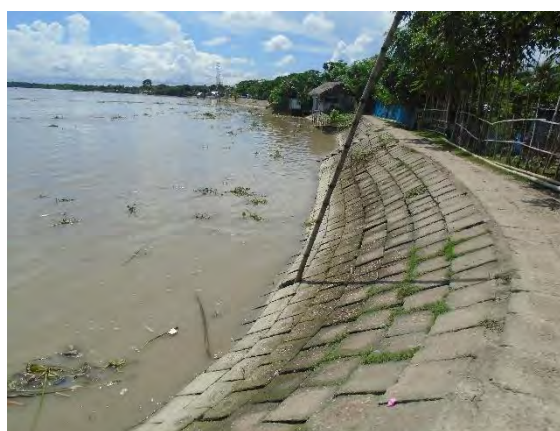
Figure: Bank protective work at Botiaghata

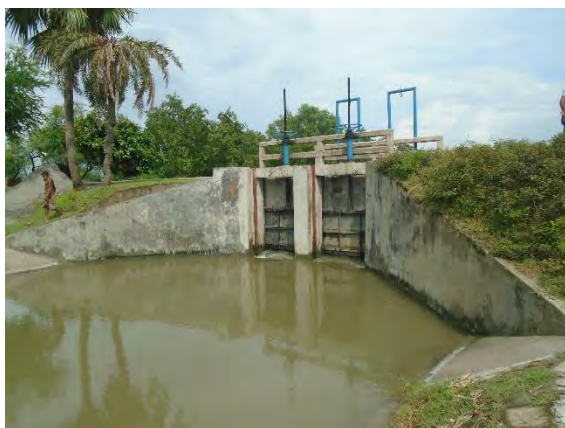
Figure: C/S of Khorla Sluice

- *Outfall*
  - Outfall Khal: **Kazi Bacha River**  
Condition: **Active**
- *Condition of Drainage Khal*
  - Main drainage Khal: **Moderately** silted up
  - Branch khal: **Moderately** silted up
- *Drainage Congestion*
  - Drainage congestion problem: **Moderate** (usually takes 3-4 days to properly drain out rain water)
  - Re-excavation of Khorla khal and its connecting branches khal will reduce the drainage congestion problem and available irrigation water for Rabi crops.
  - Permanent Water logging: **Not found.**
- *Agricultural condition*
  - Crop damage: **Moderate** (about 15- 20% area of Lt Aman, sesame, watermelon and Sun-flower crops are damaged by heavy rainfall & drainage congestion)
  - Water Scarcity: **Partially observed.**
- *Structure Condition*
  - **Functional**
  - C/S block pitching and gate repairing (mechanical) work has been done by BWDB in 2015.

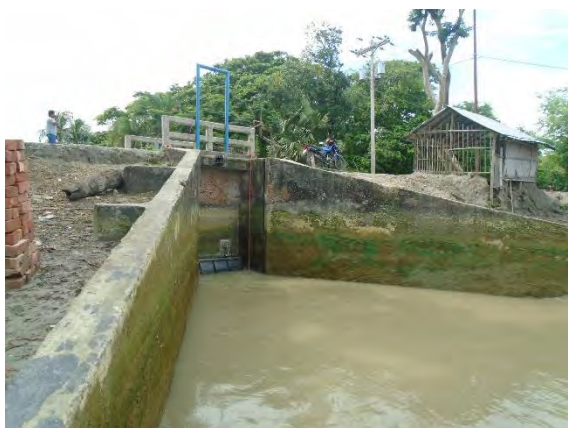
Figure: R/S of Katialangla Sluice

<b>Catchment Name</b>	Cat – 3 (Katianangla Catchment)
<b>Location (mauza wise)</b>	Katianangla (178 ha), Katamari (56 ha), Gangarampur (3 ha), Kaemkhola (4 ha) of Gangarampur union.
<b>Catchment area (ha)</b>	241 ha
<b>Drainage Outlet</b>	Katianangla Sluice at Ch. 8+533 km (1V- 1.5 m X1.8 m)
<b>Main Drainage Canal</b>	Katianangla khal
<b>Land elevation of Catchment (m PWD)</b>	Max: 3.27 Min: 0.85
<b>Length of Stream within catchment (Km)</b>	6.27
<b>Drainage Density (m/ha)</b>	26.02
<b>Catchment Description</b>	<ul style="list-style-type: none"> <li>➤ <i>Outfall</i> <ul style="list-style-type: none"> <li>• Outfall Khal: <b>Kazi Bacha River</b> Condition: <b>Active</b></li> </ul> </li> <li>➤ <i>Condition of Drainage Khal</i> <ul style="list-style-type: none"> <li>• Main drainage Khal: <b>Active</b></li> <li>• Branch khal: <b>Partially</b> silted up</li> </ul> </li> <li>➤ <i>Drainage Congestion</i> <ul style="list-style-type: none"> <li>• Drainage congestion problem: <b>Minor</b> (usually takes 2-3 days to properly drain out rain water)</li> <li>• Permanent Water logging: <b>Not found.</b></li> </ul> </li> <li>➤ <i>Agricultural condition</i> <ul style="list-style-type: none"> <li>• Crop damage: <b>Minor</b></li> <li>• Water Scarcity: <b>Not found.</b></li> </ul> </li> <li>➤ <i>Structure Condition</i> <ul style="list-style-type: none"> <li>• <b>Functional</b> (R/S loose apron is damaged)</li> <li>• C/S block pitching and gate repairing (mechanical) work has been done by BWDB in 2015.</li> </ul> </li> </ul>

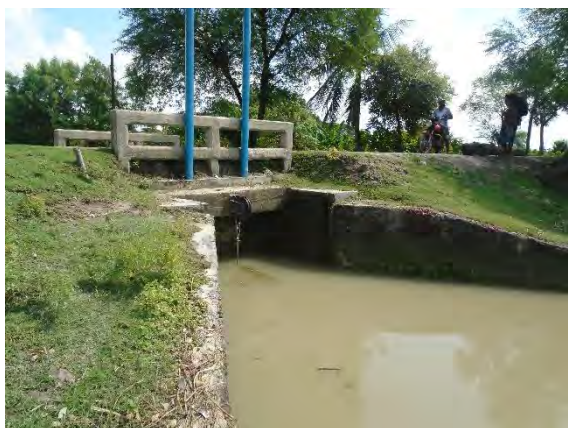
Figure: C/S of Moisher Danga Sluice

<b>Catchment Name</b>	Cat – 4 (Mashiardanga Catchment)
<b>Location (mauza wise)</b>	Katianangla (11 ha), Katamari (279 ha), Gangarampur (5 ha), Kaemkhola (79 ha), Kasiadanga (17 ha), Barun Para (162 ha), Kayemkholar Hula (73 ha) of Gangarampur union.
<b>Catchment area (ha)</b>	626 ha
<b>Drainage Outlet</b>	Mashiardanga Sluice at Ch. 13+660 km (1V- 1.5 m X1.8 m)
<b>Main Drainage Canal</b>	Mashiardanga khal
<b>Land elevation of Catchment (m PWD)</b>	Max: 4.38 Min: 0.76
<b>Length of Stream within catchment (Km)</b>	13.142
<b>Drainage Density (m/ha)</b>	20.99
<b>Catchment Description</b>	<ul style="list-style-type: none"> <li>➤ <i>Outfall</i> <ul style="list-style-type: none"> <li>• Outfall Khal: <b>Manga River</b> Condition: <b>Active</b></li> </ul> </li> <li>➤ <i>Condition of Drainage Khal</i> <ul style="list-style-type: none"> <li>• Main drainage Khal: <b>Active</b></li> <li>• Branch khal: <b>Partially</b> silted up</li> </ul> </li> <li>➤ <i>Drainage Congestion</i> <ul style="list-style-type: none"> <li>• Drainage congestion problem: <b>Minor</b> (usually takes 2-3 days to properly drain out rain water)</li> <li>• Permanent Water logging: <b>Not found.</b></li> </ul> </li> <li>➤ <i>Agricultural condition</i> <ul style="list-style-type: none"> <li>• Crop damage: <b>Minor</b></li> <li>• Water Scarcity: <b>Not found.</b></li> </ul> </li> <li>➤ <i>Structure Condition</i> <ul style="list-style-type: none"> <li>• <b>Functional</b> (R/S loose apron is damaged)</li> <li>• C/S block pitching and gate repairing (mechanical) work has been done by BWDB in 2015</li> </ul> </li> <li>➤ <i>Erosion</i> <ul style="list-style-type: none"> <li>• Around 250m embankment at Barun para is vulnerable to river bank erosion and tidal flooding.</li> <li>• Temporary bank protection work has been done by installing bamboo fencing and placing geo-bags at the vulnerable locations.</li> </ul> </li> </ul>

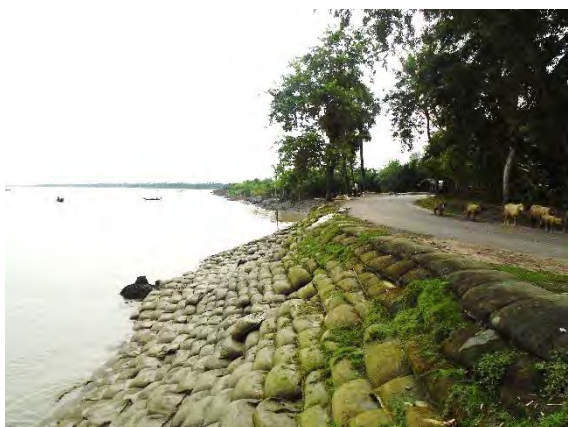
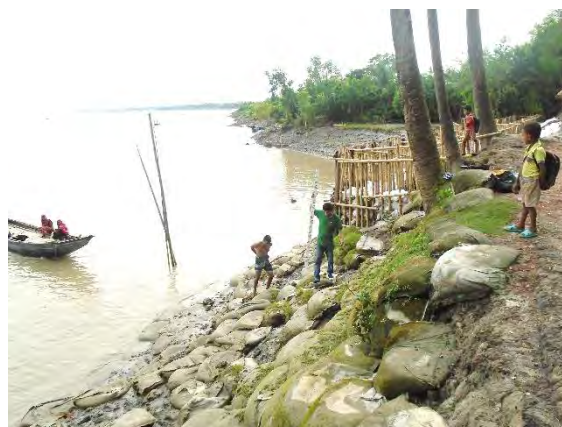
Figure: River bank Erosion at Barunpara

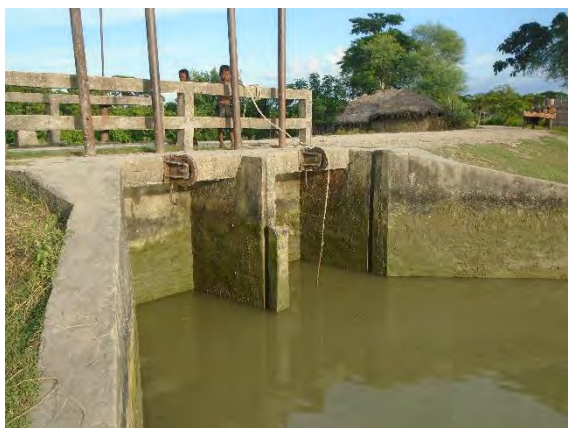
- Water Scarcity: **Not found.**
- *Structure Condition*
  - **Partially Functional**
  - Loose Apron both R/S and C/S is damaged
  - Gates are corroded and damaged

Figure: R/S of Amtola Sluice

- Sluice repairing is required

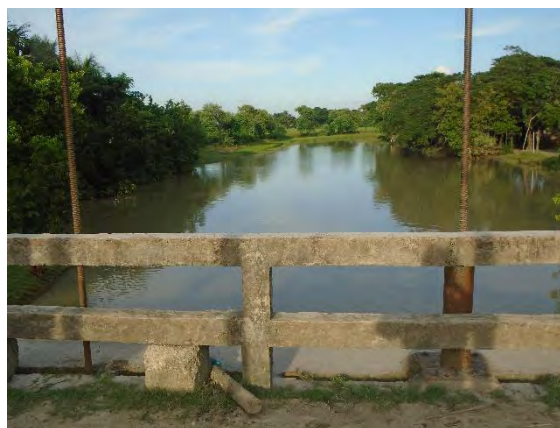
Figure: R/S of Amtola Sluice

- *Outfall*
  - Outfall Khal: **Jhop Jhopia River**  
Condition: **Highly Silted up**
- *Condition of Drainage Khal*
  - Main drainage Khal: **Moderately** silted up

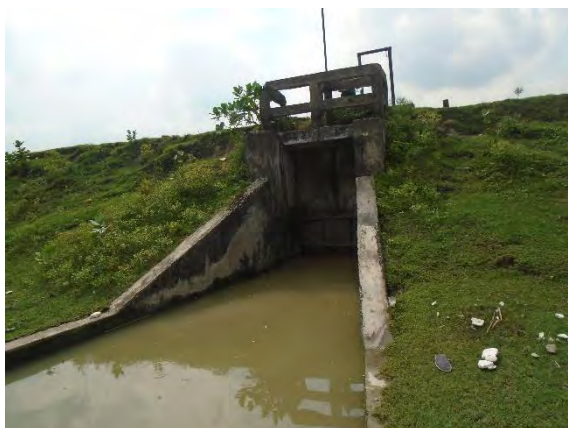
Figure: C/S of Aushkhali Sluice

<b>Catchment Name</b>	Cat – 6 (Aushkhali Catchment)
<b>Location (mauza wise)</b>	Mathbhanga (10 ha), Mailmara (80 ha), Balabunia (41 ha), Aushkhali (48 ha) of Batiaghata union and Boyarbhangra (147 ha), Titukhali (61 ha), Par Titukhali (71 ha), Charkhali Machalia (42 ha), Par Salua (102 ha), Salua (61 ha), Britti Khalsebunia (65 ha) of Gangarampur union.
<b>Catchment area (ha)</b>	726 ha
<b>Drainage Outlet</b>	Aushkhali Sluice at Ch. 25+115 km (1V- 1.5 m X1.8 m)
<b>Main Drainage Canal</b>	Aushkhali khal
<b>Land elevation of Catchment (m PWD)</b>	Max: 2.42 Min: 0.54
<b>Length of Stream within catchment (Km)</b>	22.59
<b>Drainage Density (m/ha)</b>	31.11
<b>Catchment Description</b>	<ul style="list-style-type: none"> <li>➤ <i>Outfall</i> <ul style="list-style-type: none"> <li>• Outfall Khal: <b>Salta River</b> Condition: <b>Active</b></li> </ul> </li> <li>➤ <i>Condition of Drainage Khal</i> <ul style="list-style-type: none"> <li>• Main drainage Khal: <b>Moderately</b> silted up</li> <li>• Branch khal: <b>Moderately</b> silted up</li> </ul> </li> <li>➤ <i>Drainage Congestion</i> <ul style="list-style-type: none"> <li>• Drainage congestion problem: <b>Severe</b> (usually takes 5-6 days to properly drain out rain water)</li> <li>• The Kalatala-Narikeltala khal drains the internal water to the Jhop Jhopia River. The Jhop Jhopia River is highly silted up and raised the bed level by 1.5~2 m above the invert level of the kolatola regulator. Therefore, Kolatola catchment area was diverted/changed and shared with Aushkhali and Khorla catchment through Kalatala-Narikeltala khal. The capacity of Aushkhali Sluice is inadequate for efficient drainage (726 ha), which cause severe drainage congestion.</li> <li>• During heavy rainfall, water pumping provision at Kalatala sluice is required to reduce drainage congestion problem.</li> </ul> </li> <li>➤ <i>Agricultural condition</i> <ul style="list-style-type: none"> <li>• Crop damage: Crop damage: <b>Major</b> (Lt Aman, sesame, watermelon and Sun-flower crops are damaged by heavy rainfall &amp; severe drainage congestion)</li> <li>• Water Scarcity: <b>Not found.</b></li> </ul> </li> <li>➤ <i>Structure Condition</i> <ul style="list-style-type: none"> <li>• <b>Functional.</b></li> </ul> </li> </ul>

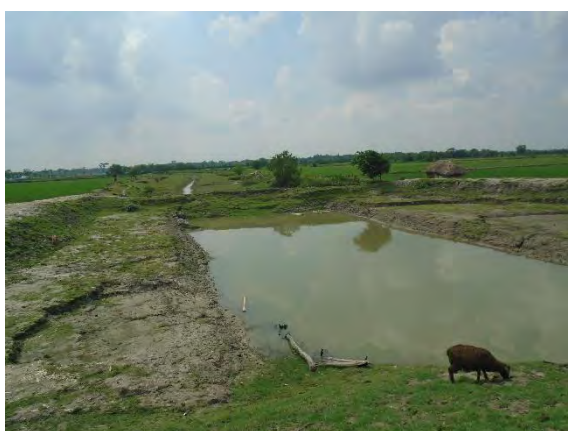
Figure: cross bund on the outfall of kolatola Sluice

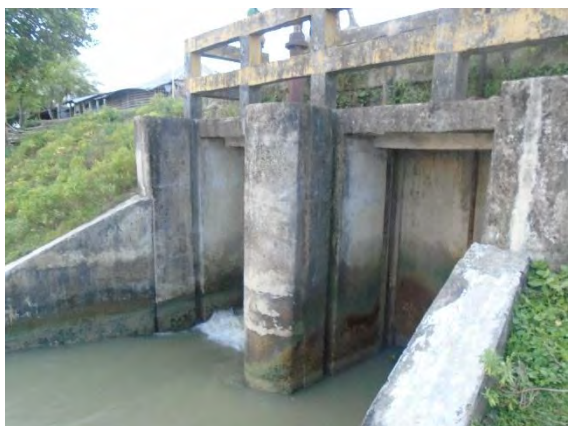
- *Structure Condition*
  - **Damaged**
  - Loose apron are damaged both C/S and R/S.
  - One C/S vertical lift gate and both R/S flap gate are corroded and rubber seals are damaged

Figure: C/S of Parbotiaghata Sluice

- Hoisting arrangement of vertical lift gate is damaged
  - Replacement of gates and other necessary major repairing works is required.

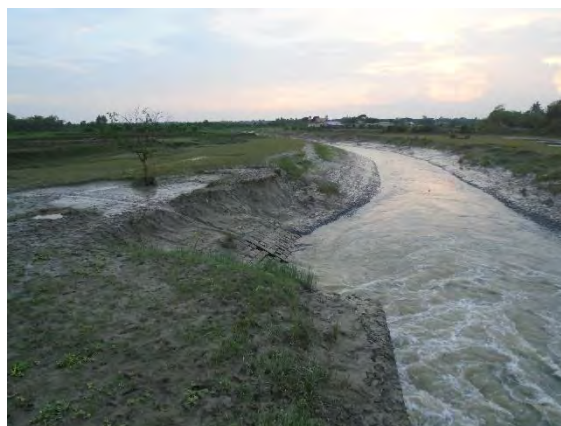
Figure: Outfall of Parbotiaghata catchment

- *Condition of Drainage Khal*
  - Main drainage Khal: **Partially** silted up
  - Branch khal: **Moderately** silted up
- *Drainage Congestion*
  - Drainage congestion problem: : **Moderate** (usually takes 3-4 days to properly drain out rain water)

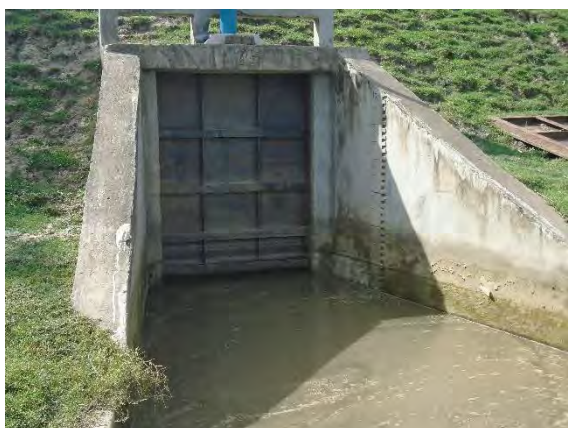
Figure: C/S of Kholishabunia Sluice

<b>Catchment Name</b>	Cat – 8 (Kholishabunia Catchment)
<b>Location (mauza wise)</b>	Khalsibunia (74 ha), Baguladanga Patharghata (31 ha), Hatbati (Baro) (5 ha) of Batiaghata union.
<b>Catchment area (ha)</b>	207 ha
<b>Drainage Outlet</b>	Kholishabunia Sluice at Ch. 30+080 km (1V- 1.5 m X1.8 m)
<b>Main Drainage Canal</b>	Kholishabunia khal
<b>Land elevation of Catchment (m PWD)</b>	Max: 2.06 Min: 0.46
<b>Length of Stream within catchment (Km)</b>	4.26
<b>Drainage Density (m/ha)</b>	20.61
<b>Catchment Description</b>	<ul style="list-style-type: none"> <li>➤ <i>Outfall</i> <ul style="list-style-type: none"> <li>• Outfall Khal: <b>Salta River</b> Condition: <b>Active</b></li> </ul> </li> <li>➤ <i>Condition of Drainage Khal</i> <ul style="list-style-type: none"> <li>• Main drainage Khal: <b>Active</b></li> <li>• Branch khal: <b>Partially</b> silted up</li> </ul> </li> <li>➤ <i>Drainage Congestion</i> <ul style="list-style-type: none"> <li>• Drainage congestion problem: <b>Minor</b> (usually takes 2-3 days to properly drain out rain water)</li> <li>• Permanent Water logging: <b>Not found.</b></li> </ul> </li> <li>➤ <i>Agricultural condition</i> <ul style="list-style-type: none"> <li>• Crop damage: <b>Minor</b></li> <li>• Water Scarcity: <b>Not found.</b></li> </ul> </li> <li>➤ <i>Structure Condition</i> <ul style="list-style-type: none"> <li>• <b>Functional</b></li> <li>• Block pitching and gate repairing (mechanical) work has been done by BWDB in 2015</li> </ul> </li> </ul>

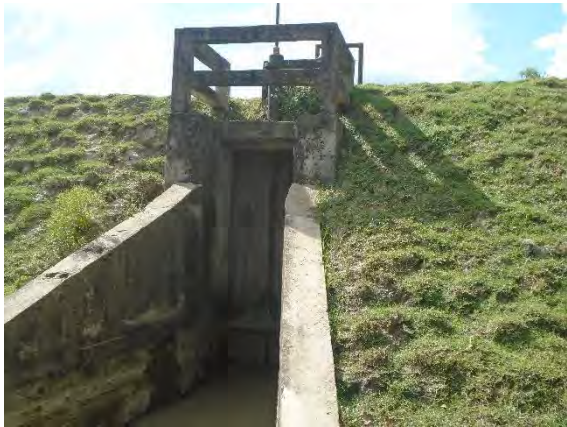
Figure: C/S of Beeler khal Sluice

<b>Catchment Name</b>	Cat – 9 (Beeler khal Catchment)
<b>Location (mauza wise)</b>	Chak Solemari (172 ha), Batiaghata Hogolbunia (43 ha), Batiaghata Khalsibunia (48 ha) of Batiaghata union.
<b>Catchment area (ha)</b>	263
<b>Drainage Outlet</b>	Beeler khal Sluice at Ch. 30+935 km (1V- 0.9 m X1.2 m)
<b>Main Drainage Canal</b>	Beeler khal
<b>Land elevation of Catchment (m PWD)</b>	Max: 2.29 Min: 0.29
<b>Length of Stream within catchment (Km)</b>	5.6
<b>Drainage Density (m/ha)</b>	21.29
<b>Catchment Description</b>	<ul style="list-style-type: none"> <li>➤ <i>Outfall</i> <ul style="list-style-type: none"> <li>• Outfall Khal: <b>Salta River</b> Condition: <b>Active</b></li> </ul> </li> <li>➤ <i>Condition of Drainage Khal</i> <ul style="list-style-type: none"> <li>• Main drainage Khal: <b>Active</b></li> <li>• Branch khal: Hanira Khal is <b>Moderately</b> silted up, (<i>Hanira khal is proposed for re-excavation under Bluegold program</i>)</li> </ul> </li> <li>➤ <i>Drainage Congestion</i> <ul style="list-style-type: none"> <li>• Drainage congestion problem: <b>Minor</b> (usually takes 2-3 days to properly drain out rain water)</li> <li>• Permanent Water logging: <b>Not found.</b></li> </ul> </li> <li>➤ <i>Agricultural condition</i> <ul style="list-style-type: none"> <li>• Crop damage: <b>Minor</b></li> <li>• Water Scarcity: <b>Not found.</b></li> </ul> </li> <li>➤ <i>Structure Condition</i> <ul style="list-style-type: none"> <li>• <b>Functional</b></li> </ul> </li> <li>➤ <i>Erosion</i> <ul style="list-style-type: none"> <li>• Around 500m embankment at Chak Sholmari is vulnerable to river bank erosion and tidal flooding. About 30m of land area was eroded in last 5 years and Setback distance is reducing every year.</li> <li>• Low cost/Temporary bank protection works would be required by installing bamboo fencing and placing geo-bags at the vulnerable locations.</li> </ul> </li> </ul>

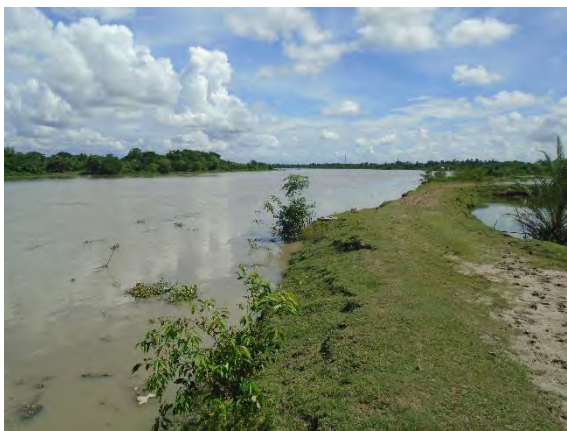
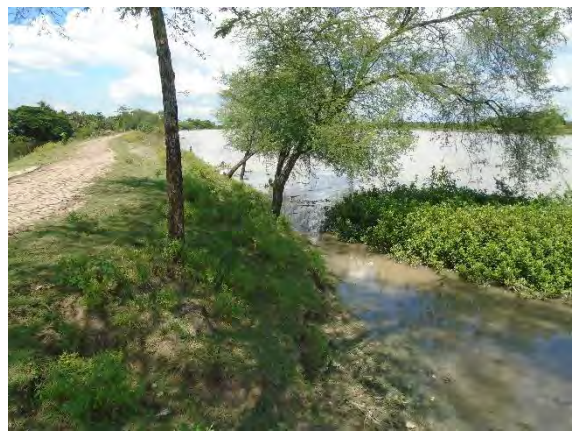
Figure: Chalk Sailmari Erosion

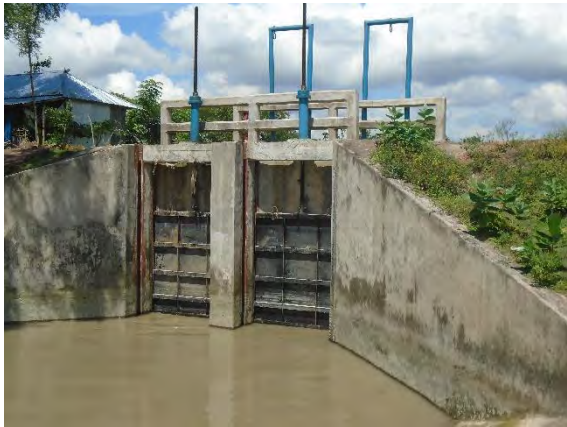
Figure: R/S of Hogolbunia Sluice

<b>Catchment Name</b>	Cat – 10 (Hogolbunia Catchment)
<b>Location (mauza wise)</b>	Chak Solemari (53 ha), Hogolbunia (369 ha), Khalsibunia (4 ha), Hatbati (Baro) (120 ha) of Batiaghata union.
<b>Catchment area (ha)</b>	546 ha
<b>Drainage Outlet</b>	Hogolbunia Sluice at Ch. 37+515 km (1V- 1.5 m X1.8 m)
<b>Main Drainage Canal</b>	Hogolbunia khal
<b>Land elevation of Catchment (m PWD)</b>	Max: 2.17 Min: 0.41
<b>Length of Stream within catchment (Km)</b>	12.11
<b>Drainage Density (m/ha)</b>	22.18
<b>Catchment Description</b>	<ul style="list-style-type: none"> <li>➤ <i>Outfall</i> <ul style="list-style-type: none"> <li>• Outfall Khal: <b>Sailmari River</b> Condition: <b>Active</b></li> </ul> </li> <li>➤ <i>Condition of Drainage Khal</i> <ul style="list-style-type: none"> <li>• Main drainage Khal: <b>Moderately</b> silted up</li> <li>• Branch khal: <b>Moderately</b> silted up</li> </ul> </li> <li>➤ <i>Drainage Congestion</i> <ul style="list-style-type: none"> <li>• Drainage congestion problem: <b>Moderate</b> (usually takes 3-4 days to properly drain out rain water)</li> <li>• Re-excavation of Hogolbunia khal and connecting branch khal will reduce the drainage congestion problem</li> <li>• Permanent Water logging: <b>Not found.</b></li> </ul> </li> <li>➤ <i>Agricultural condition</i> <ul style="list-style-type: none"> <li>• Crop damage: <b>Moderate</b> (about 10- 15% area of Lt Aman, sesame, watermelon and Sun-flower crops are damaged by heavy rainfall &amp; drainage congestion)</li> <li>• Water Scarcity: <b>Not found.</b></li> </ul> </li> <li>➤ <i>Structure Condition</i> <ul style="list-style-type: none"> <li>• <b>Functional</b></li> </ul> </li> <li>➤ <i>Erosion</i> <ul style="list-style-type: none"> <li>• Around 650m embankment at Hogolbunia is vulnerable to river bank erosion and tidal flooding.</li> <li>• Low cost/Temporary bank protection works would be required by installing bamboo fencing and placing geo-bags at the vulnerable locations. A small launching apron will be prepared with the geo-bags in place and bamboo fencing would be provided along the toe of the embankment.</li> </ul> </li> </ul>

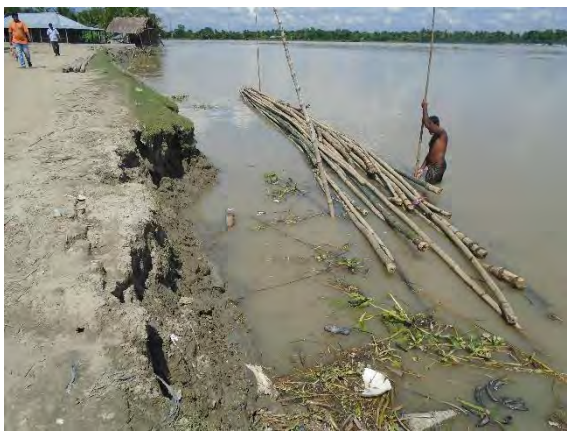
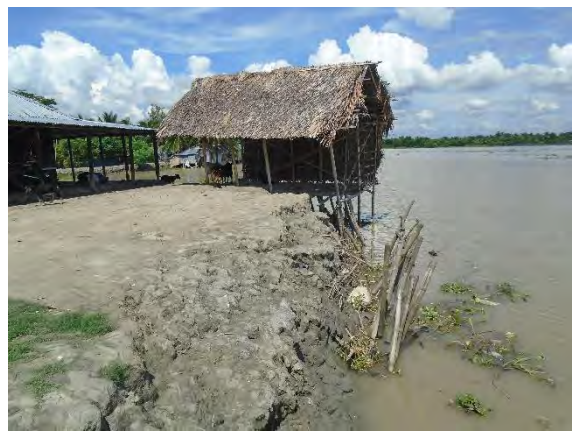
Figure: Hogolbunia Erosion

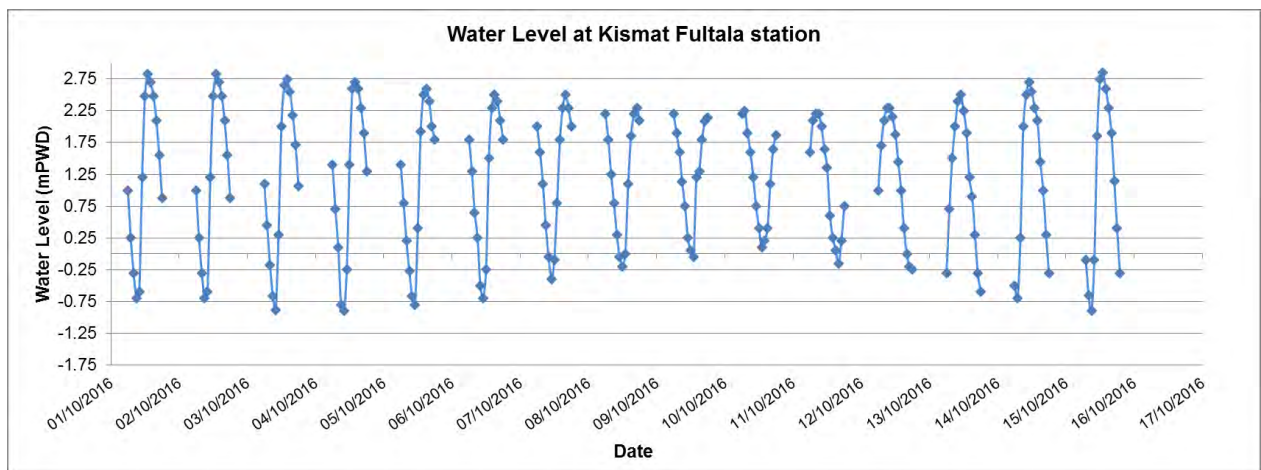
Figure 2.16: Water level analysis at Kismat Fultala station

Daily water level data were collected on an hourly basis. Water level hydrographs were plotted as water level versus time. The water level hydrograph at Kismat Fultala, Barunpara, Surkhali, Parbotiaghata and Kanaidanga stations are shown in Figure 2.7 to 2.9 respectively.
