## Case Study – Erosion Damage Blue Gold Program

Water Management for Development

Bangladesh Water Development Board  
Department for Agricultural Extension  
Embassy of the Kingdom of the Netherlands

24 April 2017

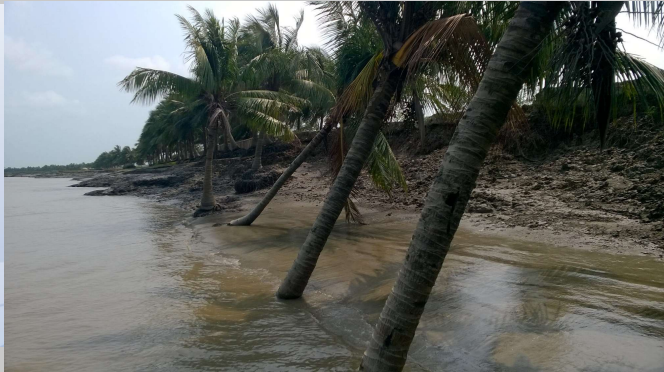
## Polder 34/2, Khulna – 29 March 2017

The photograph shows a coastal area with several palm trees leaning over a body of water. The ground is sandy and eroded, and the water is murky brown. The sky is overcast.

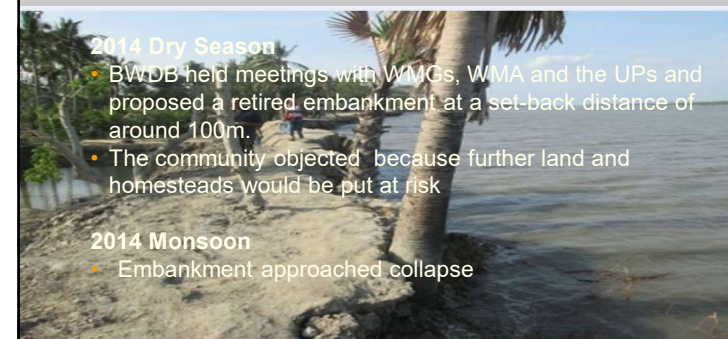
## Recent Timeline 2014

### 2014 Dry Season

- BWDB held meetings with WMGs, WMA and the UPs and proposed a retired embankment at a set-back distance of around 100m.
- The community objected because further land and homesteads would be put at risk

### 2014 Monsoon

- Embankment approached collapse

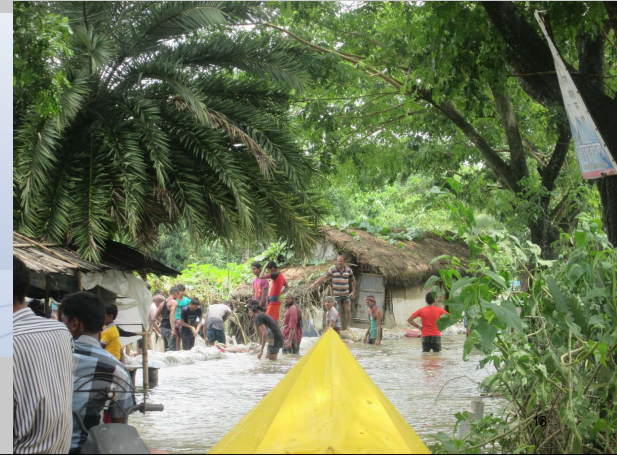
2 August 2015

### 31 July 2015 - Cyclone Komen

- On 30 July 2015 a depression developed in the bay of Bengal, which developed as “Cyclone Komen”, crossing the coastline on 31 July 2015.
- The original embankment breached and developed 3 deep channels across the line of the embankment.
- A large portion of BCG (Britti-Birala-Chandghar-Jaliakhali) and Akra Bahir Akra WMG areas was flooded. According to preliminary reports, 18 villages were affected, 1286 households more or less affected, 404 houses (mud/thatched) fully damaged and 325 houses partially damaged.

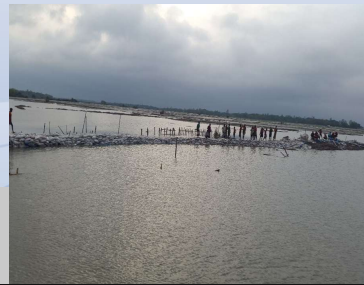
Breach-3: Closed on 13 June

Contractor closes breaches 1 and 2 in early-June but was struggling with breach-3 which was closed on 13 June but failed the next day – and was finally closed on 28 June 2016.
