Final Report on

Development of Digital Elevation Model (DEM) and delineation of
Catchment boundaries for
Polders 43/1A and Polder 43/2F of Blue Gold Program

Barguna O&M Division

November 2016
Dhaka

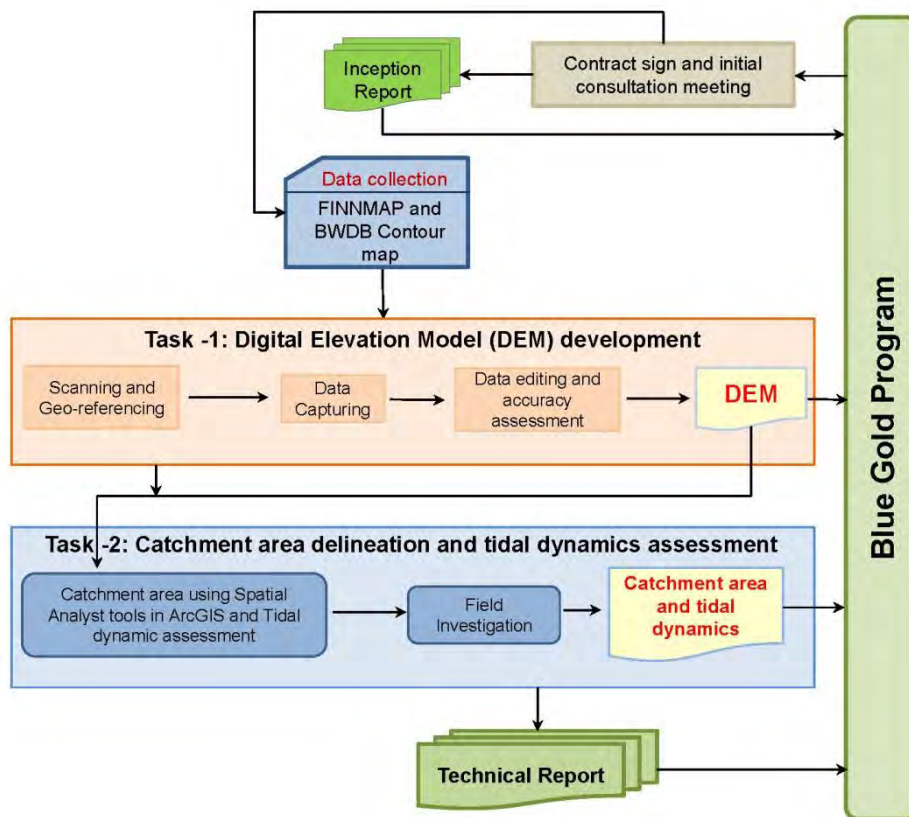
Figure 2.1: Overall methodology of the activities

At the inception phase all works have been identified and a step-by-step approach and methodology has been developed. The major activities are presented in Figure 2.1 and described in the following sections.

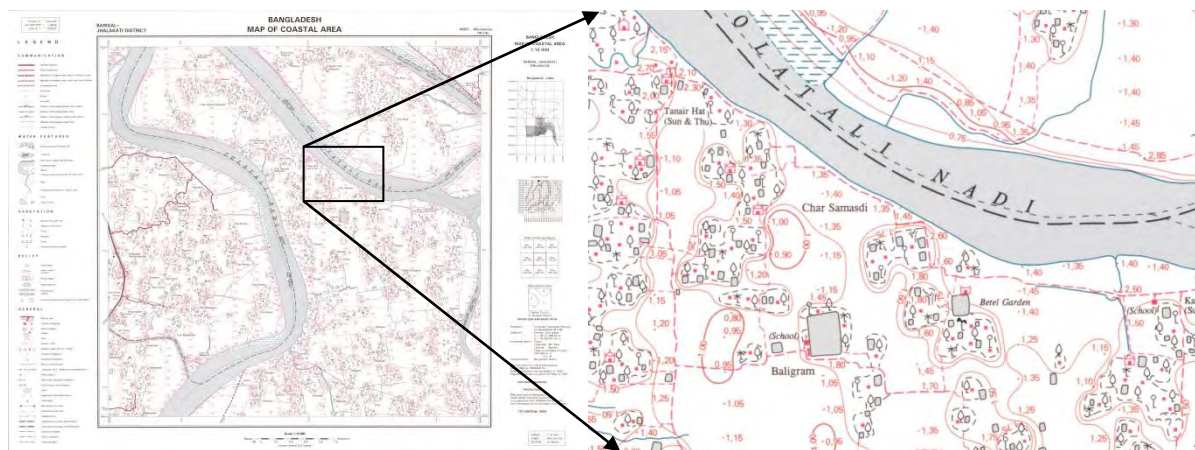
Figure 2.2 : Sample of BIWTA FINNMAP

The contour intervals of FINNMAP is 0.25 m. East-west spacing of spot elevation is about 300 m and spacing in north-south direction is about 100m. Sample of a FINNMAP is shown in Figure 2.2. Rivers and khal networks will be digitized from these maps.

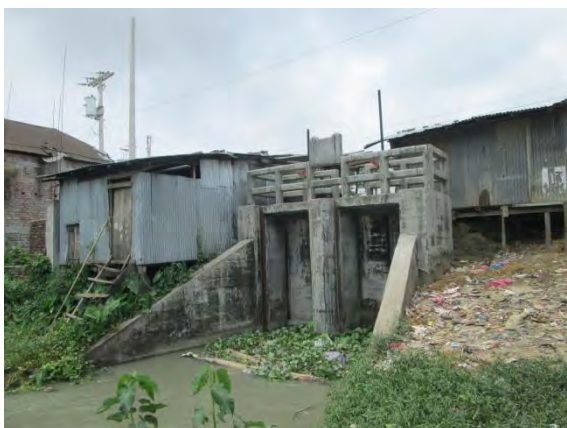
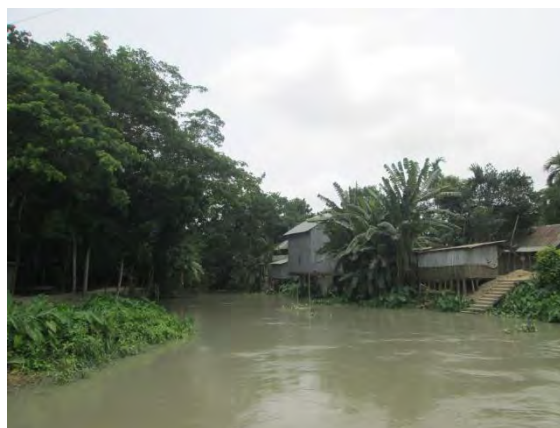
Catchment Name	Cat – 1 (Mohishkata Catchment)
Location	Khagodon (230 ha), Roybala (216 ha), Kukua (105 ha), Keowabunia (84 ha), Purba Chunakhali (78 ha), Atharagashia (57 ha) and Sakharia (12 ha)
Catchment area (ha)	782 ha
Drainage Outlet	Mohishkata Sluice at Ch. 0+000 km (2V- 1.5 m X1.8 m)
Main Drainage Canal	Mohishkata khal
Land elevation of Catchment (m PWD)	Max: 2.77 Min: 1.22
Length of Stream within catchment (Km)	26.78
Drainage Density (m/ha)	34.24
Catchment Description	<ul style="list-style-type: none"> ➤ <i>Outfall</i> <ul style="list-style-type: none"> • Outfall Khal: Kukua River Condition: Partially active (silted up) ➤ <i>Condition of Drainage Khal</i> <ul style="list-style-type: none"> • Main drainage Khal: Partially silted up (<i>proposed for re-excavation under Bluegold program</i>) • Branch khal: Moderately silted up ➤ <i>Drainage Congestion</i> <ul style="list-style-type: none"> • Drainage congestion problem: Moderate (usually takes 3-4 days to properly drain out rain water) • Permanent Water logging: Not found. ➤ <i>Agricultural condition</i> <ul style="list-style-type: none"> • Crop damage: Moderate (Lt Aman and HYV Aman Seed bed affected by drainage congestion) • Water Scarcity: Roybala mauza is affected by water scarcity during winter season (mainly affects Rabi crops); • Re-excavation of Mohishkata khal and Katali Khal may reduce the scarcity of irrigation water for Rabi crops. ➤ <i>Hydraulic structure condition</i> <ul style="list-style-type: none"> • Functional (Flap gate is corroded)

Figure: C/S of Moishkata Sluice

Figure: Moishkata khal

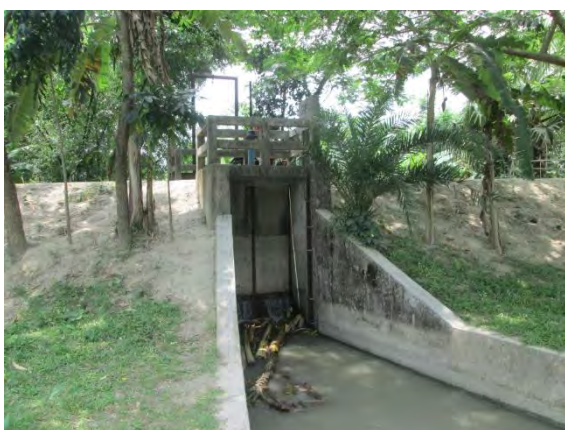
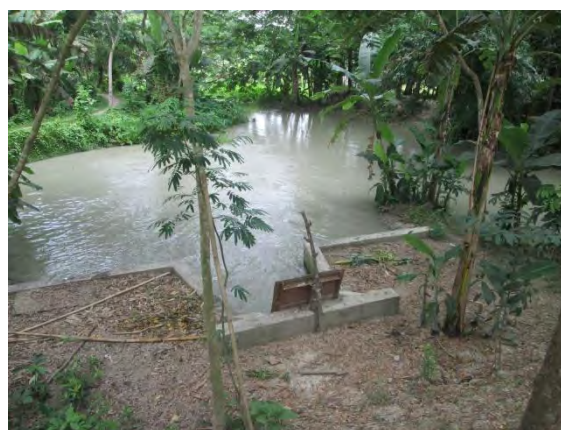
Catchment Name	Cat – 2 (Kewabunia Catchment)
Location	Kewabunia (262 ha), Purba Chunakhali (54 ha) and Bazarghona (12 ha)
Catchment area (ha)	330 ha
Drainage Outlet	Kewabunia Sluice at Ch. 0+440 km (1V- 1.5 m X1.8 m)
Main Drainage Canal	Kewabunia khal
Land elevation of Catchment (m PWD)	Max: 2.96 Min: 1.40
Length of Stream within catchment (Km)	6.78
Drainage Density (m/ha)	20.54
Catchment Description	<ul style="list-style-type: none"> ➤ <i>Outfall</i> <ul style="list-style-type: none"> • Outfall Khal: Kukua River Condition: Highly silted up (Average Bed level of kukua river is about 0.45 mPWD whereas sill level of Kewabunia sluice is (-)1.00 mPWD) ➤ <i>Condition of Drainage Khal</i> <ul style="list-style-type: none"> • Main drainage Khal: Moderately silted up • Branch khal: Moderately silted up ➤ <i>Drainage Congestion</i> <ul style="list-style-type: none"> • Drainage congestion problem: Severe, usually takes 5-7 days to properly drain out rain water as the bed level of Kukua River is higher than the Kewbunai khal. • Re-excavation of Kukua River and Kewbunia khal may reduce the drainage congestion problem • Permanent Water logging: Not found. ➤ <i>Agricultural condition</i>

<ul style="list-style-type: none"> • Crop damage: Severe (Mainly affects Lt Aman and Rabi crops due to drainage congestion) • Water Scarcity: Purbo Kewabunia area is affected by water scarcity during winter season (mainly affects Rabi crops). • Re-excavation of Kewabunia and its connecting branch khal will available irrigation water for Rabi crops. <p>➤ <i>Hydraulic structure condition</i></p> <ul style="list-style-type: none"> • Functional
--	--

Figure: C/S of Kewabunia Sluice

Figure: Outfall of Kewabunia catchment

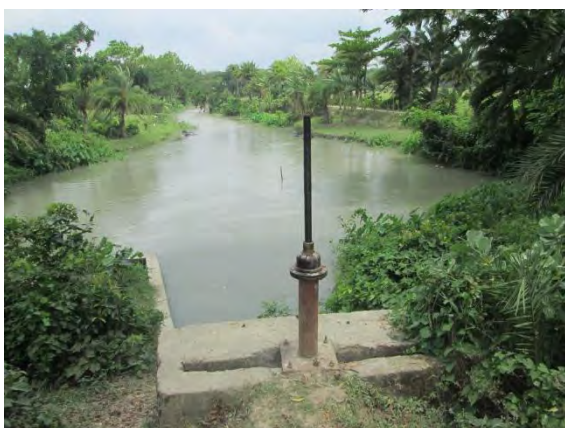
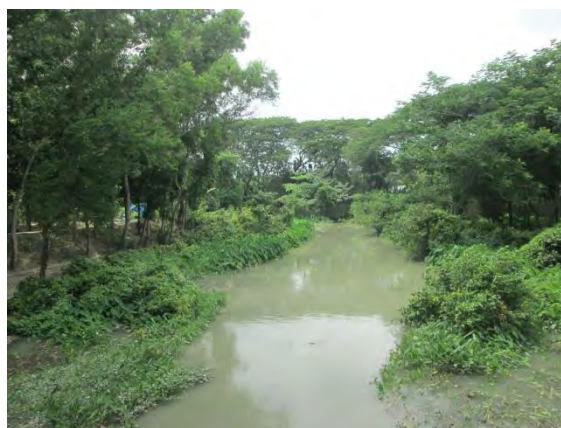
Catchment Name	Cat – 3 (Gulbunia Catchment)
Location	Kewabunia (262 ha), Purba Chunakhali (54 ha) and Bazarghona (12 ha)
Catchment area (ha)	330 ha
Drainage Outlet	Gulbunia Sluice at Ch. 6+155 km (1V- 1.5 m X1.8 m)
Main Drainage Canal	Gulbunia khal
Land elevation of Catchment (m PWD)	Max: 3.25 Min: 1.27
Length of Stream within catchment (Km)	13.25
Drainage Density (m/ha)	40.14
	<p>➤ <i>Outfall</i></p> <ul style="list-style-type: none"> • Outfall Khal: Kukua River Condition: Highly silted up <p>➤ <i>Condition of Drainage Khal</i></p> <ul style="list-style-type: none"> • Main drainage Khal: Partially silted up (Average bed level is 0.3 to 0.4 mPWD) • Branch khal: Partially silted up

Catchment Description	<ul style="list-style-type: none"> ➤ <i>Drainage Congestion</i> <ul style="list-style-type: none"> • Drainage congestion problem: Severe (usually takes 5-7 days to properly drain out rain water as the bed level of Kukua River is high) • Re-excavation of Kukua River may reduce the drainage congestion problem • Permanent Water logging: Not found. ➤ <i>Agricultural condition</i> <ul style="list-style-type: none"> • Crop damage: Severe (Mainly affects Lt Aman and Rabi crops due to drainage congestion) • Water Scarcity: Not found ➤ <i>Hydraulic structure condition</i> <ul style="list-style-type: none"> • Functional
------------------------------	---

Figure: C/S of Gulbunia Sluice

Figure: Outfall of Gulbunia catchment

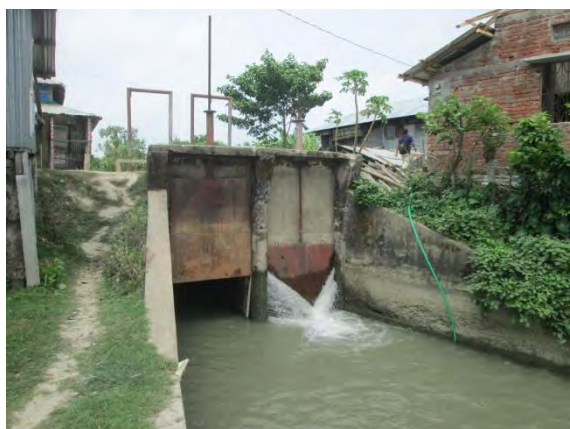
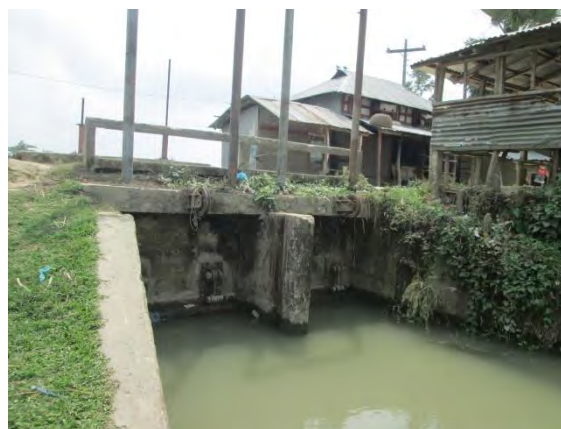
Catchment Description	<ul style="list-style-type: none"> ➤ <i>Outfall</i> <ul style="list-style-type: none"> • Outfall Khal: Nauli River Condition: Active ➤ <i>Condition of Drainage Khal</i> <ul style="list-style-type: none"> • Main drainage Khal: Partially silted up • Branch khal: Moderately silted up (Khatasia khal is proposed for re-excavation) ➤ <i>Drainage Congestion</i> <ul style="list-style-type: none"> • Drainage congestion problem: Moderate (usually takes 3-4 days to properly drain out rain water) • Permanent Water logging: Not found. ➤ <i>Agricultural condition</i> <ul style="list-style-type: none"> • Crop damage: Minor • Water Scarcity: Northern part of Khatasia khal is affected by water scarcity during winter season (mainly affects Rabi crops) as the bed level of this khal is higher; • Re-excavation of Khatasia khal may available irrigation water for Rabi crops. ➤ <i>Hydraulic structure condition</i> <ul style="list-style-type: none"> • Functional

Figure: C/S of Chowla Sluice

Figure: Outfall of Chowla catchment

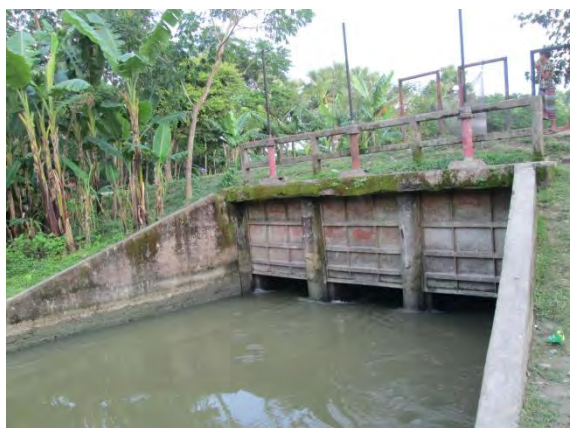
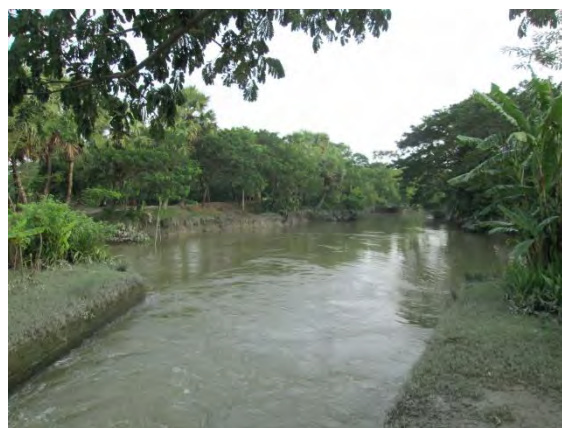
Catchment Name	Cat – 5 (Amtola Catchment)
Location	Atharagashia (336 ha), Gerabunia (18 ha), Kukua (31 ha), Sonakhali (712 ha) and Bara Gabua (30 ha)
Catchment area (ha)	1127 ha
Drainage Outlet	Amtola Sluice at Ch. 25+970 km (3V- 1.5 m X1.8 m)
Main Drainage Canal	Amtola khal
Land elevation of Catchment (m PWD)	Max: 3.18 Min: 1.08

Length of Stream within catchment (Km)	27.29
Drainage Density (m/ha)	25.98
Catchment Description	<ul style="list-style-type: none"> ➤ <i>Outfall</i> <ul style="list-style-type: none"> • Outfall Khal: Gazipura khal Condition: Active ➤ <i>Condition of Drainage Khal</i> <ul style="list-style-type: none"> • Main drainage Khal: Partially silted up • Branch khal: Moderately silted up ➤ <i>Drainage Congestion</i> <ul style="list-style-type: none"> • Drainage congestion problem: Minor (usually takes 2-3 days to properly drain out rain water) • Permanent Water logging: About 16 ha area near Hazartakar bandh remains waterlogged from October to December. ➤ <i>Agricultural condition</i> <ul style="list-style-type: none"> • Crop damage: Minor • Water Scarcity: Not found ➤ <i>Hydraulic structure condition</i> <ul style="list-style-type: none"> • Functional

Figure: R/S of Amtola Sluice

Figure: Outfall of Amtola catchment

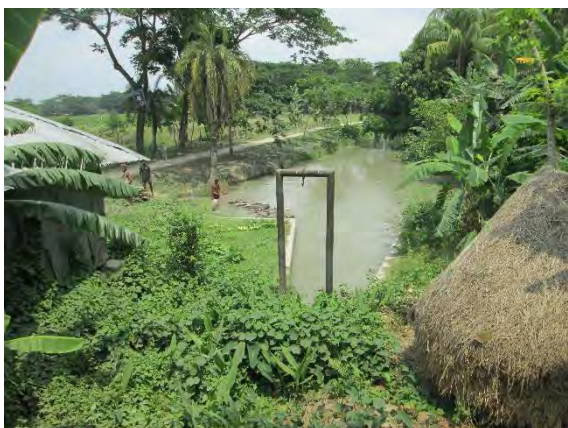
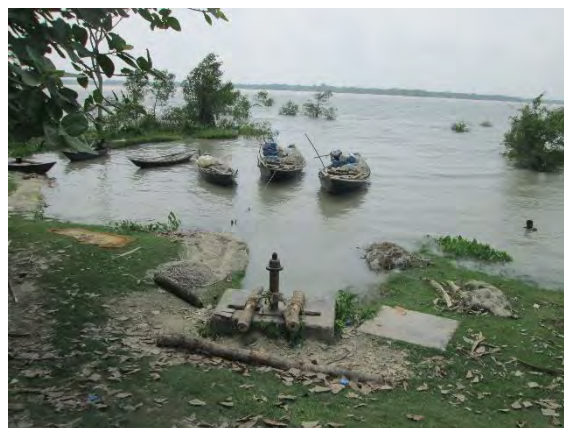
Catchment Name	Cat – 1 (Kanta Catchment)
Location (mauza wise)	Western part of Khekuani mauza (100 ha)
Catchment area (ha)	100 ha
Drainage Outlet	Kanta Sluice at Ch. 3+447 km (1V- 0.9 m X1.2 m)
Main Drainage Canal	Kanta khal
Land elevation of Catchment (m PWD)	Max: 3.28 Min: 1.81
Length of Stream within catchment (Km)	2.725
Drainage Density (m/ha)	27.25
Catchment Description	<ul style="list-style-type: none"> ➤ <i>Outfall</i> <ul style="list-style-type: none"> • Outfall Khal: Payra River Condition: Active ➤ <i>Condition of Drainage Khal</i> <ul style="list-style-type: none"> • Main drainage Khal: Moderately silted up (<i>about 2.0 km of kanta khal is proposed for re-excavation under Bluegold program during 2016-2017 fiscal year</i>) • Branch khal: Moderately silted up ➤ <i>Drainage Congestion</i> <ul style="list-style-type: none"> • Drainage congestion problem: Moderate (usually takes 3-4 days to properly drain out rain water) • Re-excavation of Kanta khal will reduce the drainage congestion problem • Permanent Water logging: Not found. ➤ <i>Agricultural condition</i> <ul style="list-style-type: none"> • Crop damage: Minor • Water Scarcity: Not found. ➤ <i>Structure Condition</i> <ul style="list-style-type: none"> • Functional (Gates are corroded)

Figure: C/S of Kanta Sluice

Figure: R/S of Kanta Sluice

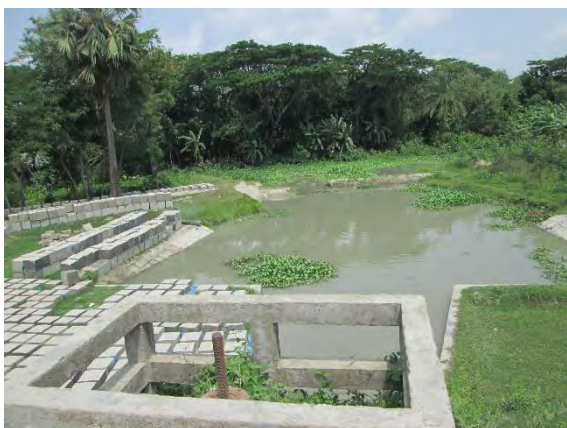
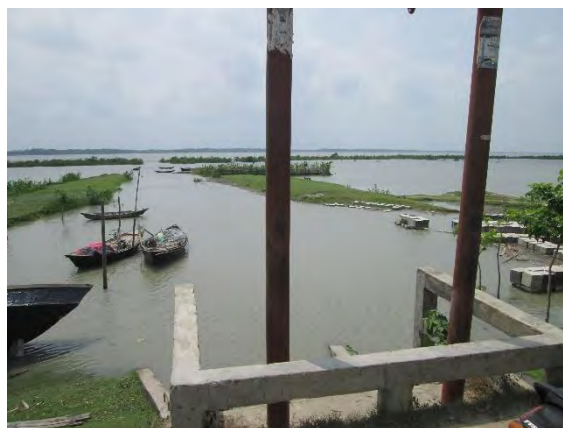
Catchment Name	Cat – 2 (Angulkata Catchment)
Location (mauza wise)	Gojkhali (60 ha), Khekuani (235 ha) and Ghotkhali (19 ha)
Catchment area (ha)	314 ha
Drainage Outlet	Angulkata Sluice at Ch. 4+483 km (1V- 1.5 m X1.8 m)
Main Drainage Canal	Angulkata khal
Land elevation of Catchment (m PWD)	Max: 3.05 Min: 1.27
Length of Stream within catchment (Km)	6.86
Drainage Density (m/ha)	21.85
Catchment Description	<ul style="list-style-type: none"> ➤ <i>Outfall</i> <ul style="list-style-type: none"> • Outfall Khal: Payra River Condition: Active ➤ <i>Condition of Drainage Khal</i> <ul style="list-style-type: none"> • Main drainage Khal: Partially silted up • Branch khal: Moderately silted up ➤ <i>Drainage Congestion</i> <ul style="list-style-type: none"> • Drainage congestion problem: Minor (usually takes 2-3 days to properly drain out rain water) • Permanent Water logging: Not found. ➤ <i>Agricultural condition</i> <ul style="list-style-type: none"> • Crop damage: Minor • Water Scarcity: Not found. ➤ <i>Structure Condition</i> <ul style="list-style-type: none"> • Functional (C/S and R/S loose apron is damaged) • Block pitching and gate repairing (mechanical) work is ongoing under Bluegold program.

Figure: C/S of Angulkata Sluice

Figure: Outfall of Angulkata catchment

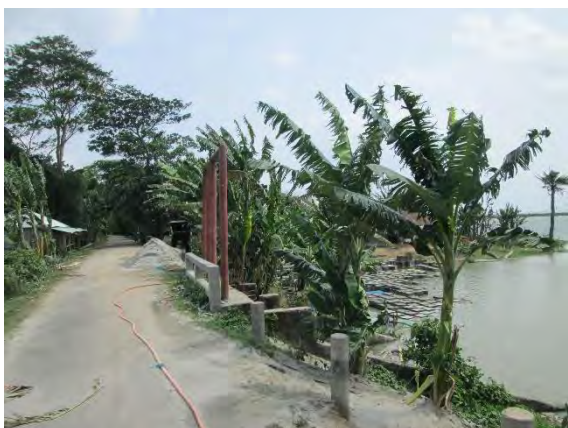
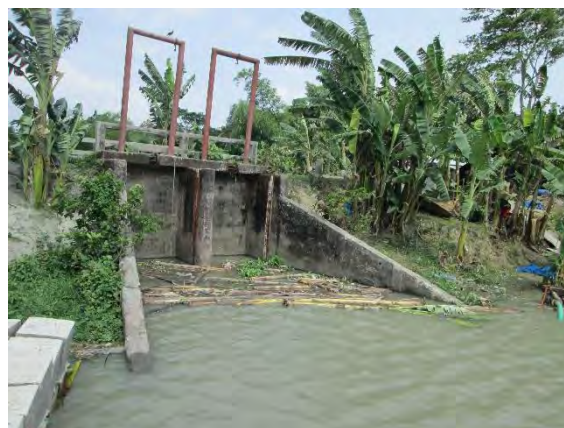
Catchment Name	Cat – 3 (Dalachhara Catchment)
Location (mauza wise)	Gulisakhali (166 ha), Gojkhali (374 ha)
Catchment area (ha)	543 ha
Drainage Outlet	Dalachhara Sluice at Ch. 5+226 km (2V- 1.5 m X1.8 m)
Main Drainage Canal	Dalachhara khal
Land elevation of Catchment (m PWD)	Max: 3.42 Min: 1.44
Length of Stream within catchment (Km)	30.04
Drainage Density (m/ha)	
Catchment Description	<ul style="list-style-type: none"> ➤ <i>Outfall</i> <ul style="list-style-type: none"> • Outfall Khal: Payra River Condition: Active ➤ <i>Condition of Drainage Khal</i> <ul style="list-style-type: none"> • Main drainage Khal: Partially silted up • Branch khal: Moderately silted up ➤ <i>Drainage Congestion</i> <ul style="list-style-type: none"> • Drainage congestion problem: Minor (usually takes 2-3 days to properly drain out rain water) • Permanent Water logging: Not found. ➤ <i>Agricultural condition</i> <ul style="list-style-type: none"> • Crop damage: Minor • Water Scarcity: Not found. ➤ <i>Structure Condition</i> <ul style="list-style-type: none"> • Functional (C/S and R/S loose apron is damaged) • Block pitching and gate repairing (mechanical) work is ongoing under Bluegold program.

Figure: On-going Block pitching work of Dalachhara Sluice

Figure: R/S of Dalachhara Sluice

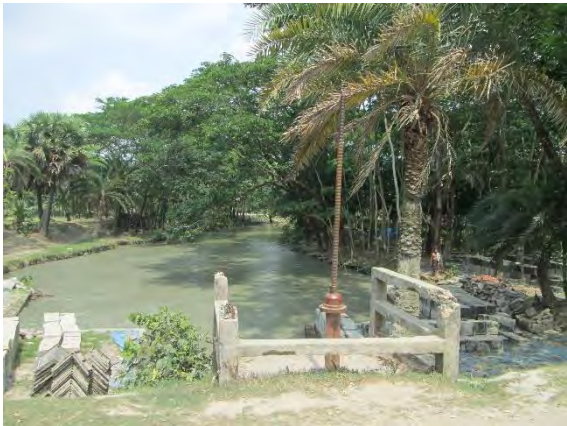
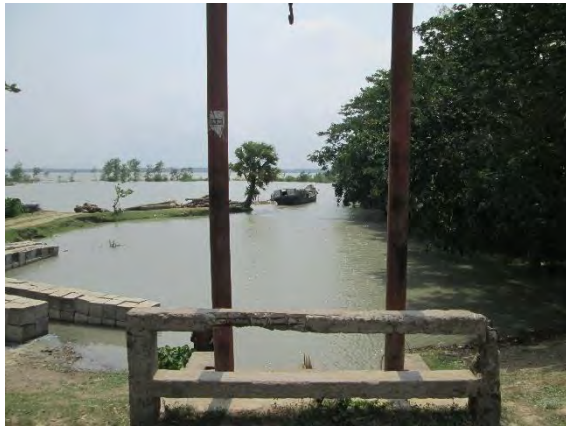
Catchment Name	Cat – 4 (Gulishakhali Catchment)
Location (mauza wise)	Gulishakhali (188 ha) and Fakirkhali (10 ha)
Catchment area (ha)	197 ha
Drainage Outlet	Gulishakhali Sluice at Ch. 6+648 km (1V- 1.5 m X1.8 m)
Main Drainage Canal	Gulishakhali khal
Land elevation of Catchment (m PWD)	Max: 2.94 Min: 1.52
Length of Stream within catchment (Km)	5.39
Drainage Density (m/ha)	27.36
Catchment Description	<ul style="list-style-type: none"> ➤ <i>Outfall</i> <ul style="list-style-type: none"> • Outfall Khal: Payra River Condition: Active ➤ <i>Condition of Drainage Khal</i> <ul style="list-style-type: none"> • Main drainage Khal: Moderately silted up (about 2.0 km of Gulishakhali khal is proposed for re-excavation under Bluegold program during 2016-2017 fiscal year) • Branch khal: Moderately silted up ➤ <i>Drainage Congestion</i> <ul style="list-style-type: none"> • Drainage congestion problem: Moderate (usually takes 3-4 days to properly drain out rain water) • Re-excavation of Gulishakhali khal will reduce the drainage congestion problem • Permanent Water logging: Not found. ➤ <i>Agricultural condition</i> <ul style="list-style-type: none"> • Crop damage: Minor

<ul style="list-style-type: none"> • Water Scarcity: Not found. ➤ <i>Structure Condition</i> <ul style="list-style-type: none"> • Functional (C/S & R/S loose apron are damaged and vertical lift and flap gates are corroded) • Block pitching and gate repairing (mechanical) work is in progress under Bluegold program.

Figure: C/S of Gulishakhali Sluice	Figure: Outfall of Gulishakhali catchment

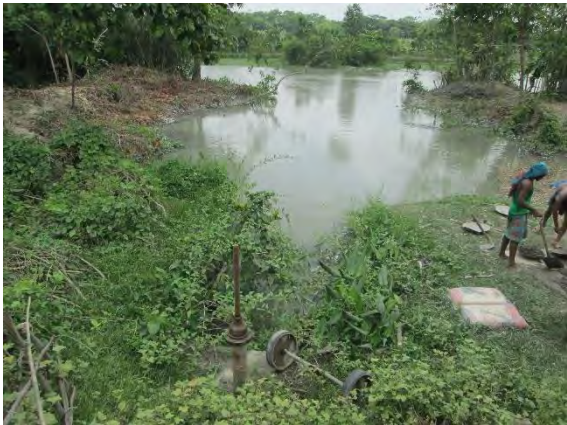
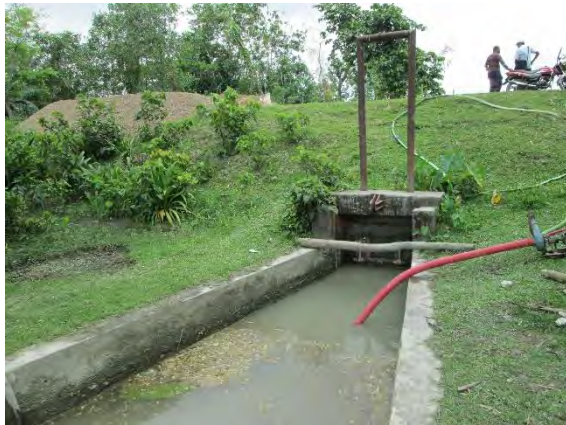
Catchment Name	Cat – 5 (Chunakhali Catchment)
Location (mauza wise)	Gulisakhali (61 ha)
Catchment area (ha)	61 ha
Drainage Outlet	Chunakhali Sluice at Ch. 8+448 km (1V- 0.9 m X1.2 m)
Main Drainage Canal	Chunakhali khal
Land elevation of Catchment (m PWD)	Max: 3.10 Min: 1.66
Length of Stream within catchment (Km)	0.236
Drainage Density (m/ha)	3.77
Catchment Description	<ul style="list-style-type: none"> ➤ <i>Outfall</i> <ul style="list-style-type: none"> • Outfall Khal: Gulishakhali River Condition: Active ➤ <i>Condition of Drainage Khal</i> <ul style="list-style-type: none"> • Main drainage Khal: Highly silted up • Branch khal: Highly silted up ➤ <i>Drainage Congestion</i> <ul style="list-style-type: none"> • Drainage congestion problem: Minor (usually takes 2-3 days to properly drain out rain water) • Permanent Water logging: Not found. ➤ <i>Agricultural condition</i> <ul style="list-style-type: none"> • Crop damage: Minor

<ul style="list-style-type: none"> • Water Scarcity: Not found. ➤ <i>Structure Condition</i> <ul style="list-style-type: none"> • Functional

Figure: R/S of Chunakhali Sluice	Figure: C/S of Chunakhali Sluice

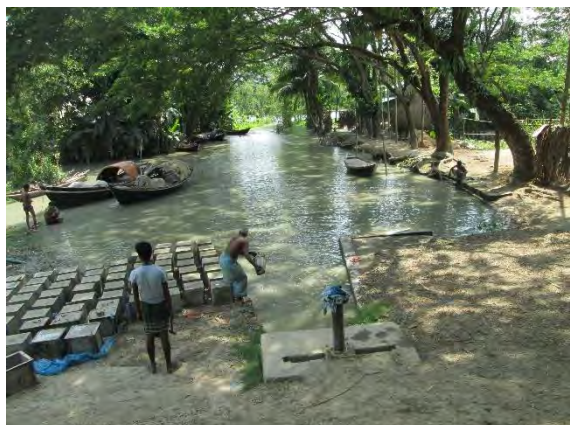
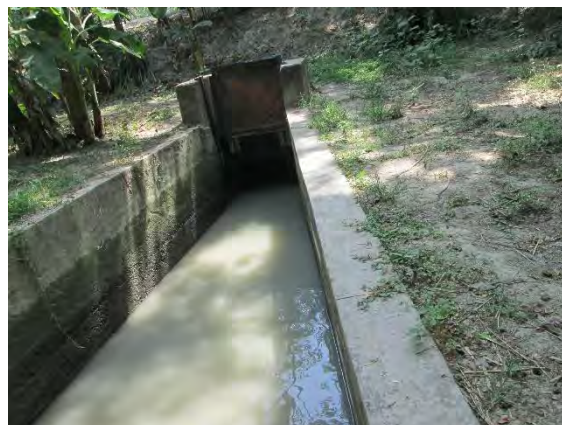
Catchment Name	Cat – 6 (Haridrataria Catchment)
Location (mauza wise)	Gulisakhali (71 ha)
Catchment area (ha)	71 ha
Drainage Outlet	Haridrataria Sluice at Ch. 11+403 km (1V- 0.9 m X1.2 m)
Main Drainage Canal	Haridrataria khal
Land elevation of Catchment (m PWD)	Max: 2.46 Min: 1.66
Length of Stream within catchment (Km)	2.02
Drainage Density (m/ha)	28.45
Catchment Description	<ul style="list-style-type: none"> ➤ <i>Outfall</i> <ul style="list-style-type: none"> • Outfall Khal: Gulishakhali River Condition: Active ➤ <i>Condition of Drainage Khal</i> <ul style="list-style-type: none"> • Main drainage Khal: Moderately silted up (<i>about 2.0 km of Haridrataria khal is proposed for re-excavation under Bluegold program during 2016-2017 fiscal year</i>) • Branch khal: Moderately silted up ➤ <i>Drainage Congestion</i> <ul style="list-style-type: none"> • Drainage congestion problem: Moderate (usually takes 3-4 days to properly drain out rain water) • Re-excavation of Haridrataria khal will reduce the drainage congestion problem

<ul style="list-style-type: none"> • Permanent Water logging: Not found. ➤ <i>Agricultural condition</i> <ul style="list-style-type: none"> • Crop damage: Minor • Water Scarcity: Not found. ➤ <i>Structure Condition</i> <ul style="list-style-type: none"> • Functional (C/S & R/S loose apron are damaged and vertical lift and flap gates are corroded) • Block pitching and gate repairing (mechanical) work is in progress under Bluegold program.
--	--

Figure: R/S of Haridrabarua Sluice

Figure: C/S of Haridrabarua Sluice

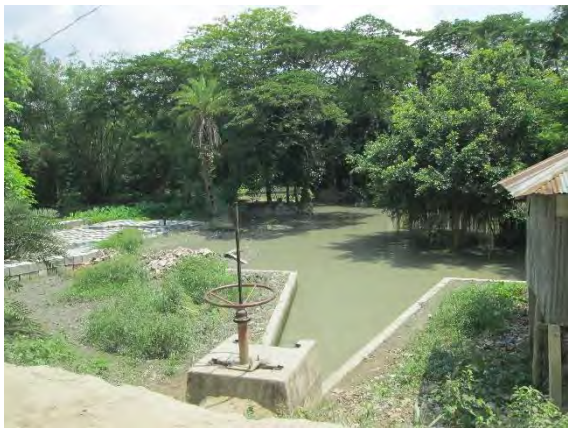
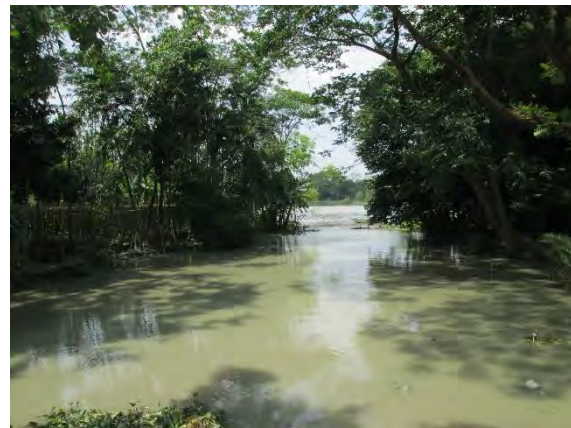
Catchment Name	Cat – 7 (Solohowlader Catchment)
Location (mauza wise)	Kalagachhia (195 ha)
Catchment area (ha)	195 ha
Drainage Outlet	Solohowlader Sluice at Ch. 14+542 km (1V- 0.9 m X1.2 m)
Main Drainage Canal	Solohowlader khal
Land elevation of Catchment (m PWD)	Max: 2.60 Min: 1.32
Length of Stream within catchment (Km)	6.39
Drainage Density (m/ha)	32.76
Catchment Description	<ul style="list-style-type: none"> ➤ <i>Outfall</i> <ul style="list-style-type: none"> • Outfall Khal: Gulishakhali River Condition: Active ➤ <i>Condition of Drainage Khal</i> <ul style="list-style-type: none"> • Main drainage Khal: Moderately silted up (about 3.0 km of Solohowlader khal is proposed for re-excavation under Bluegold program during 2016-2017 fiscal year) • Branch khal: Partially silted up

<ul style="list-style-type: none"> ➤ <i>Drainage Congestion</i> <ul style="list-style-type: none"> • Drainage congestion problem: Moderate (usually takes 3-4 days to properly drain out rain water) • Re-excavation of Solohowlader khal will reduce the drainage congestion problem • Permanent Water logging: Not found. ➤ <i>Agricultural condition</i> <ul style="list-style-type: none"> • Crop damage: Moderate (Lt Aman and HYV Aman Seed bed affected by drainage congestion) • Water Scarcity: Not found. ➤ <i>Structure Condition</i> <ul style="list-style-type: none"> • Functional (C/S & R/S loose apron are damaged and vertical lift and flap gates are corroded) • Block pitching and gate repairing (mechanical) work is in progress under Bluegold program.
--	---

Figure: C/S of Solohowlader Sluice

Figure: Outfall of Solohowlader catchment

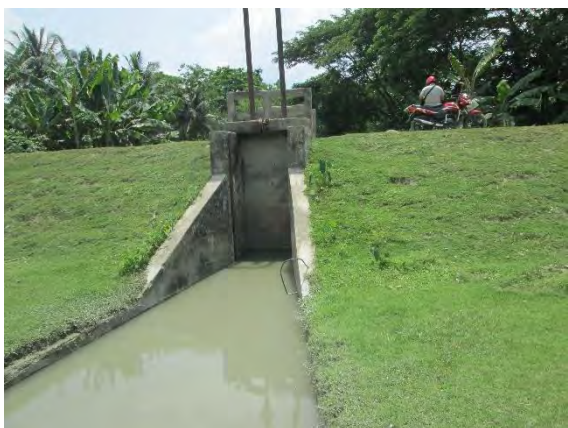
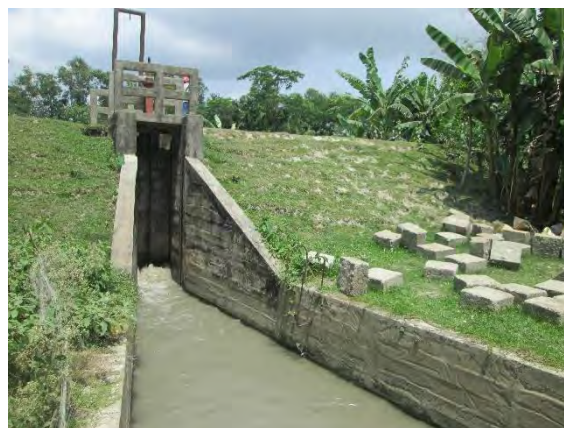
Catchment Description	<ul style="list-style-type: none"> ➤ <i>Outfall</i> <ul style="list-style-type: none"> • Outfall Khal: Kukua River Condition: Partially silted up ➤ <i>Condition of Drainage Khal</i> <ul style="list-style-type: none"> • Main drainage Khal: Partially silted up • Branch khal: Partially silted up ➤ <i>Drainage Congestion</i> <ul style="list-style-type: none"> • Drainage congestion problem: Moderate (usually takes 3-4 days to properly drain out rain water) • Permanent Water logging: Not found. ➤ <i>Agricultural condition</i> <ul style="list-style-type: none"> • Crop damage: Moderate (Lt Aman and HYV Aman Seed bed affected by drainage congestion. • Water Scarcity: Not found. ➤ <i>Structure Condition</i> <ul style="list-style-type: none"> • Functional
------------------------------	---

Figure: C/S of Doachara Sluice

Figure: R/S of Doachara Sluice

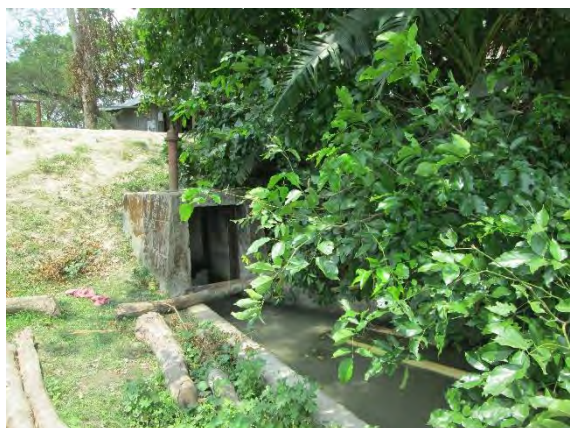
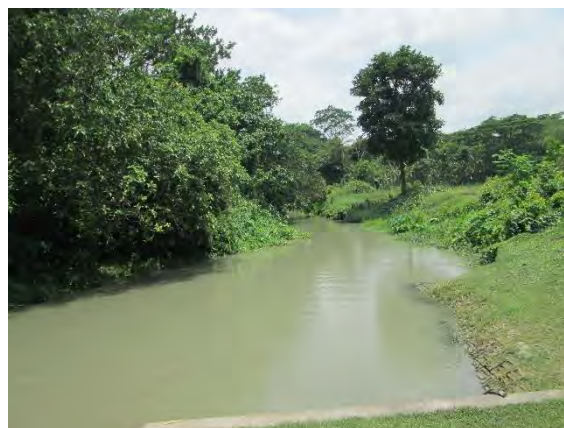
Catchment Description	<ul style="list-style-type: none"> ➤ <i>Outfall</i> <ul style="list-style-type: none"> • Outfall Khal: Kukua River Condition: Partially silted up ➤ <i>Condition of Drainage Khal</i> <ul style="list-style-type: none"> • Main drainage Khal: Partially silted up • Branch khal: Partially silted up ➤ <i>Drainage Congestion</i> <ul style="list-style-type: none"> • Drainage congestion problem: Moderate (usually takes 3-4 days to properly drain out rain water) • Permanent Water logging: Not found. ➤ <i>Agricultural condition</i> <ul style="list-style-type: none"> • Crop damage: Moderate (Lt Aman and HYV Aman Seed bed affected by drainage congestion) • Water Scarcity: Not found. ➤ <i>Structure Condition</i> <ul style="list-style-type: none"> • Functional (Gates are corroded)
------------------------------	--

Figure: C/S of Moradhana Sluice

Figure: Moradhana khal

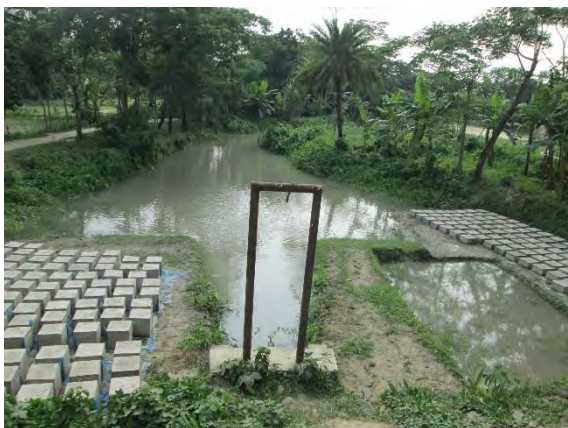
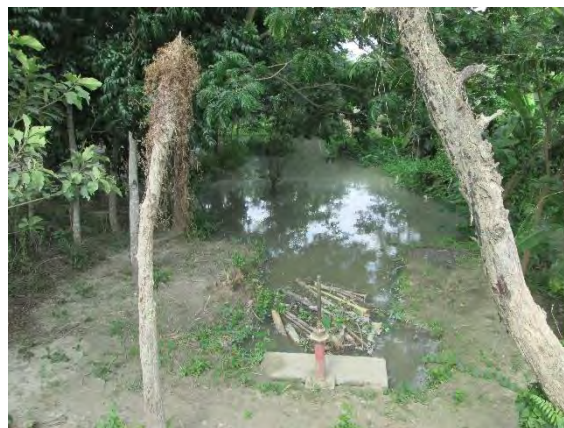
- **Outfall**
 - Outfall Khal: **Chatua River**
Condition: **Partially** silted up
- **Condition of Drainage Khal**
 - Main drainage Khal: **Partially** silted up

- Permanent Water logging: **Not found.**
- **Agricultural condition**
 - Crop damage: **Moderate** (Lt Aman and HYV Aman Seed bed affected by drainage congestion)

- Water Scarcity: **Not found.**
- **Structure Condition**
 - **Functional** (C/S & R/S loose apron and vertical lift and flap gates are damaged)
 - Block pitching and gate repairing (mechanical) work is in progress.

Figure: C/S of Borachi Sluice

Figure: R/S of Borachi Sluice

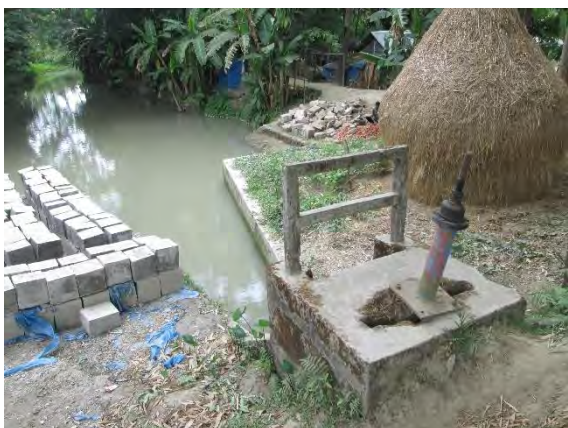
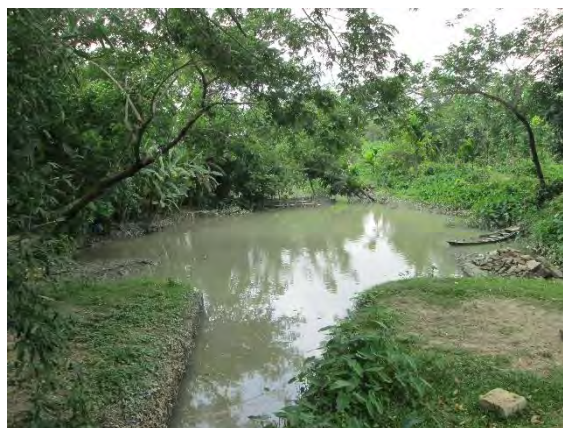
Catchment Name	Cat – 11 (Kalibari Catchment)
Location (mauza wise)	Kalibari (186 ha), Bazarghona (25 ha), Charkhali (13 ha), Paschim Chunakhali (13 ha) and Fakirkhali (11 ha)
Catchment area (ha)	249 ha
Drainage Outlet	Kalibari Sluice at Ch. 8+448 km (1V- 0.9 m X1.2 m)
Main Drainage Canal	Kalibari khal
Land elevation of Catchment (m PWD)	Max: 2.86 Min: 1.41
Length of Stream within catchment (Km)	10.267
Drainage Density (m/ha)	41.23
Catchment Description	<ul style="list-style-type: none"> ➤ <i>Outfall</i> <ul style="list-style-type: none"> • Outfall Khal: Chatua River Condition: Partially silted up ➤ <i>Condition of Drainage Khal</i> <ul style="list-style-type: none"> • Main drainage Khal: Highly silted up • Branch khal: Moderately silted up ➤ <i>Drainage Congestion</i> <ul style="list-style-type: none"> • Drainage congestion problem: Moderate (usually takes 4-5 days to properly drain out rain water) • Re-excavation of Kalibari khal will reduce the drainage congestion problem • Permanent Water logging: Not found. ➤ <i>Agricultural condition</i> <ul style="list-style-type: none"> • Crop damage: Moderate (Lt Aman and HYV Aman Seed bed affected by drainage congestion) • Water Scarcity: Not found. ➤ <i>Structure Condition</i> <ul style="list-style-type: none"> • Functional (C/S & R/S loose apron and vertical lift and flap gates are damaged) • Block pitching and gate repairing (mechanical) work is in progress. (Gates are corroded)

Figure: C/S of Kalibari Sluice

Figure: Outfall of Kalibari catchment

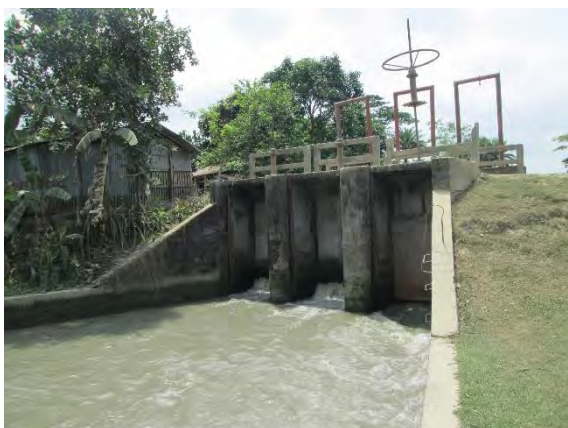
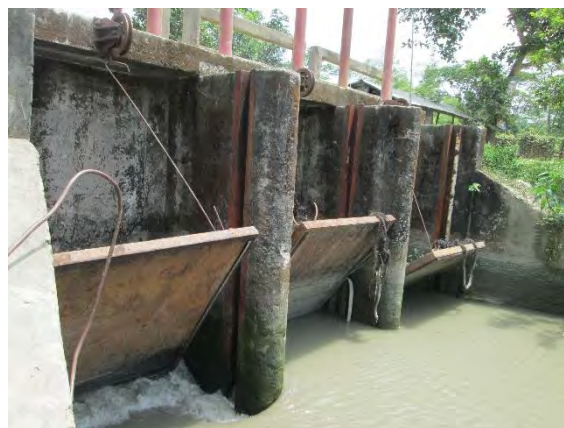
Catchment Name	Cat – 12 (Gojkhali Catchment)
Location (mauza wise)	Fakirkhali (557 ha), Kalagachhia (213 ha), Gulisakhali (118 ha), Gojkhali (111 ha), Kalibari (44 ha) and Charkhali (6 ha)
Catchment area (ha)	1049 ha
Drainage Outlet	Gojkhali Sluice at Ch. 26+921 km (3V- 1.5 m X1.8 m)
Main Drainage Canal	Ronachanda khal
Land elevation of Catchment (m PWD)	Max: 3.31 Min: 1.32
Length of Stream within catchment (Km)	35.873
Drainage Density (m/ha)	34.19
Catchment Description	<ul style="list-style-type: none"> ➤ <i>Outfall</i> <ul style="list-style-type: none"> • Outfall Khal: Chatua River Condition: Active ➤ <i>Condition of Drainage Khal</i> <ul style="list-style-type: none"> • Main drainage Khal: Active • Branch khal: Partially silted up ➤ <i>Drainage Congestion</i> <ul style="list-style-type: none"> • Drainage congestion problem: Minor (usually takes 2-3 days to properly drain out rain water) • Permanent Water logging: Not found. ➤ <i>Agricultural condition</i> <ul style="list-style-type: none"> • Crop damage: Minor • Water Scarcity: Not found. ➤ <i>Structure Condition</i> <ul style="list-style-type: none"> • Functional (C/S & R/S loose apron are damaged)

Figure: C/S of Gojkhali Sluice

Figure: Flap gate of Gojkhali Sluice

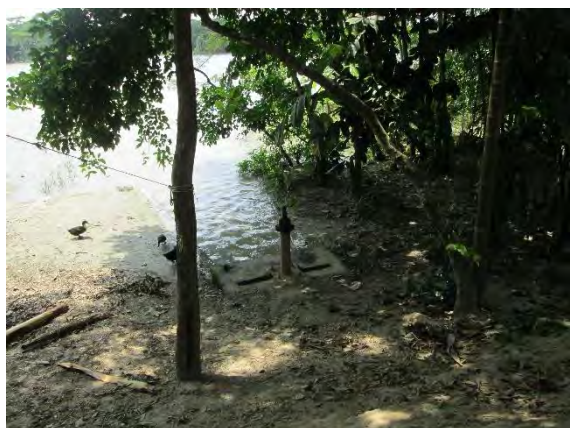
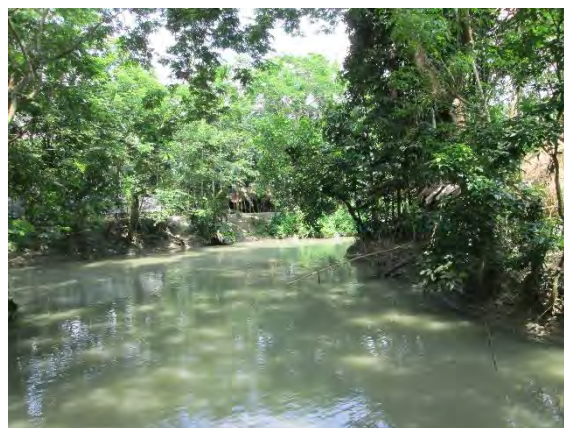
Catchment Name	Cat – 13 (Debpur Catchment)
Location (mauza wise)	Gojkhali (154 ha)
Catchment area (ha)	154 ha
Drainage Outlet	Gojkhali Sluice at Ch. 27+872 km (1V- 0.9 m X1.2 m)
Main Drainage Canal	Debpur khal
Land elevation of Catchment (m PWD)	Max: 2.69 Min: 1.42
Length of Stream within catchment (Km)	4.112
Drainage Density (m/ha)	26.70
Catchment Description	<ul style="list-style-type: none"> ➤ <i>Outfall</i> <ul style="list-style-type: none"> • Outfall Khal: Chatua River Condition: Active ➤ <i>Condition of Drainage Khal</i> <ul style="list-style-type: none"> • Main drainage Khal: Moderately silted up (<i>about 2.0 km of Deppur khal is proposed for re-excavation under Bluegold program during 2016-2017 fiscal year</i>) • Branch khal: Partially silted up ➤ <i>Drainage Congestion</i> <ul style="list-style-type: none"> • Drainage congestion problem: Minor (usually takes 2-3 days to properly drain out rain water) • Permanent Water logging: Not found. ➤ <i>Agricultural condition</i> <ul style="list-style-type: none"> • Crop damage: Minor • Water Scarcity: Not found. ➤ <i>Structure Condition</i> <ul style="list-style-type: none"> • Functional

Figure: R/S of Debpur Sluice

Figure: Debpur khal

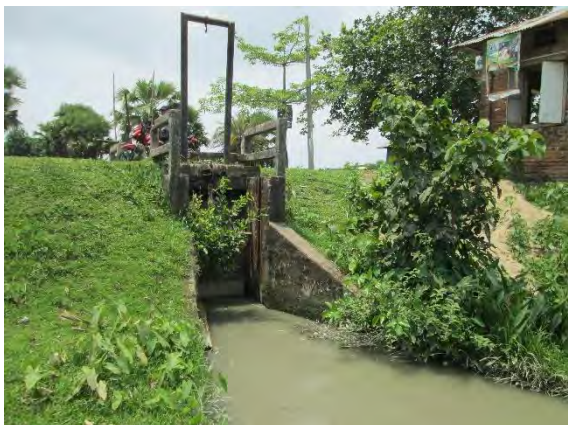
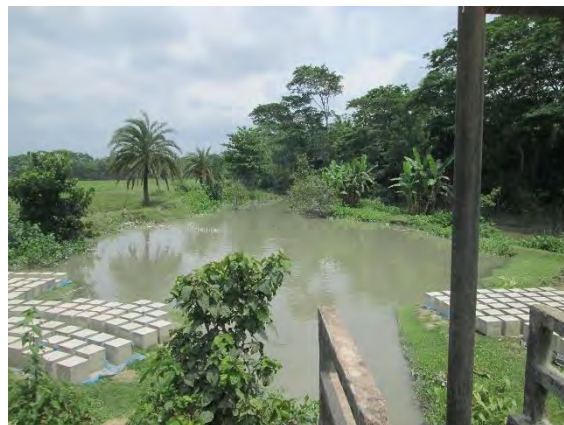
Catchment Name	Cat – 15 (Bazarkhali Catchment)
Location (mauza wise)	Gojkhali (95 ha) and Khekuani (52 ha)
Catchment area (ha)	147 ha
Drainage Outlet	Bazarkhali Sluice at Ch. 30+277 km (1V- 0.9 m X1.2 m)
Main Drainage Canal	Bazarkhali khal
Land elevation of Catchment (m PWD)	Max: 2.98 Min: 1.24
Length of Stream within catchment (Km)	4.728
Drainage Density (m/ha)	32.16
Catchment Description	<ul style="list-style-type: none"> ➤ <i>Outfall</i> <ul style="list-style-type: none"> • Outfall Khal: Chatua River Condition: Active ➤ <i>Condition of Drainage Khal</i> <ul style="list-style-type: none"> • Main drainage Khal: Partially silted up • Branch khal: Partially silted up ➤ <i>Drainage Congestion</i> <ul style="list-style-type: none"> • Drainage congestion problem: Minor (usually takes 2-3 days to properly drain out rain water) • Permanent Water logging: Not found. ➤ <i>Agricultural condition</i> <ul style="list-style-type: none"> • Crop damage: Minor • Water Scarcity: Not found. ➤ <i>Structure Condition</i> <ul style="list-style-type: none"> • Functional (C/S & R/S loose apron and vertical lift and flap gates are damaged) • Block pitching and gate repairing (mechanical) work is in progress. (Gates are corroded)

Figure: R/S of Bazarkhali Sluice

Figure: Outfall of Bazarkhali catchment

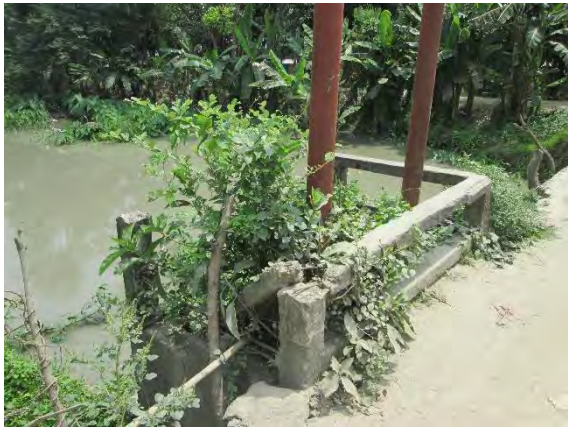
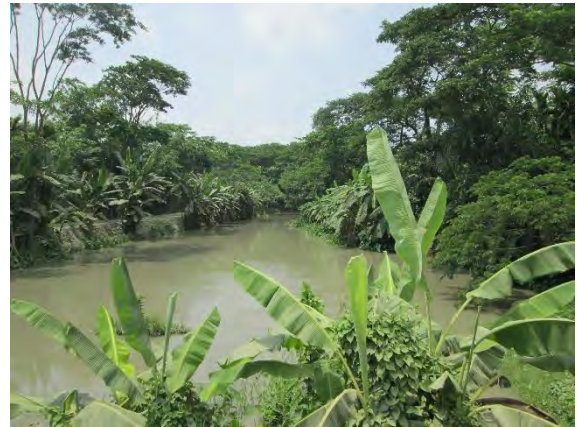
Catchment Name	Cat – 16 (Khekuani Catchment)
Location (mauza wise)	Khekuani (333 ha)
Catchment area (ha)	333 ha
Drainage Outlet	Khekuani Sluice at Ch. 32+778 km (1V- 1.5 m X1.8 m)
Main Drainage Canal	Khekuani khal
Land elevation of Catchment (m PWD)	Max: 3.25 Min: 1.24
Length of Stream within catchment (Km)	7.135
Drainage Density (m/ha)	21.42
Catchment Description	<ul style="list-style-type: none"> ➤ <i>Outfall</i> <ul style="list-style-type: none"> • Outfall Khal: Chatua River Condition: Active ➤ <i>Condition of Drainage Khal</i> <ul style="list-style-type: none"> • Main drainage Khal: Moderately silted up (<i>about 3.0 km of khekuani khal is proposed for re-excavation under Bluegold program during 2016-2017 fiscal year</i>) • Branch khal: Moderately silted up ➤ <i>Drainage Congestion</i> <ul style="list-style-type: none"> • Drainage congestion problem: Moderate (usually takes 3-4 days to properly drain out rain water) • Re-excavation of Khekuani khal will reduce the drainage congestion problem • Permanent Water logging: Not found. ➤ <i>Agricultural condition</i> <ul style="list-style-type: none"> • Crop damage: Moderate (Lt Aman and HYV Aman Seed bed affected by drainage congestion. • Water Scarcity: Not found. ➤ <i>Structure Condition</i> <ul style="list-style-type: none"> • Damaged <ul style="list-style-type: none"> ▪ Main structure partially settled down ▪ Gates are corroded and rubber seals are damaged which caused leakage ▪ Hoisting arrangement of both R/S and C/S gates are damaged ▪ Operation deke slab and railing are broken • Major repairing/construction of new Sluice with adequate vent size is required

Figure: Khekuani Sluice

Figure: Outfall of Khekuani catchment

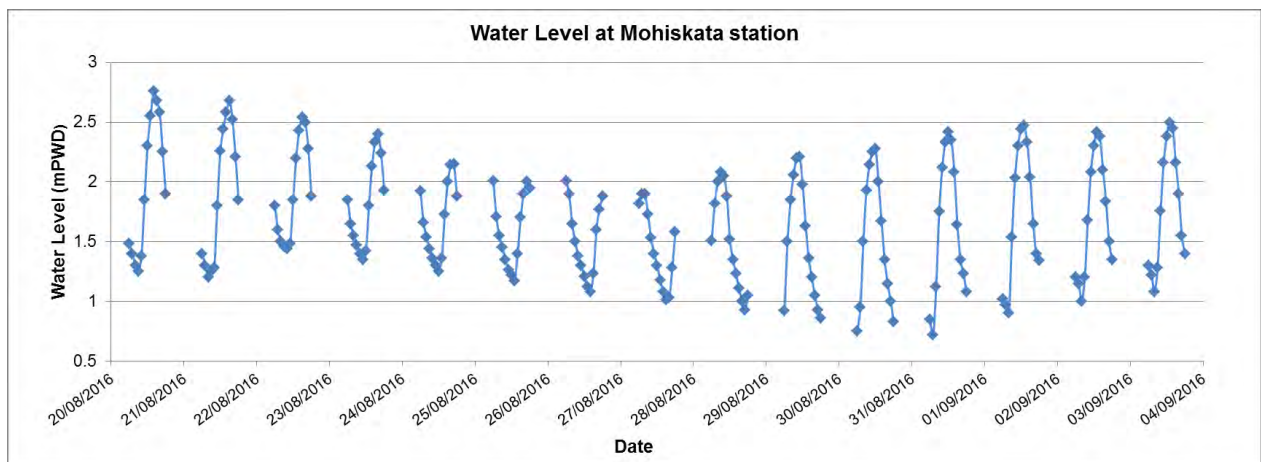
Figure 2.14: Water level analysis at Mohishkata station

Daily water level data were collected on an hourly basis. Water level hydrographs were plotted as water level versus time. The water level hydrograph at Mohishkata, Titkata and Kanta stations are shown in Figure 2.30 to 2.32 respectively.
