**Blue Gold Program  
Lower Bhadra River Erosion Damage  
Breach to Polder 29 near Chandghar Village  
Briefing Note**

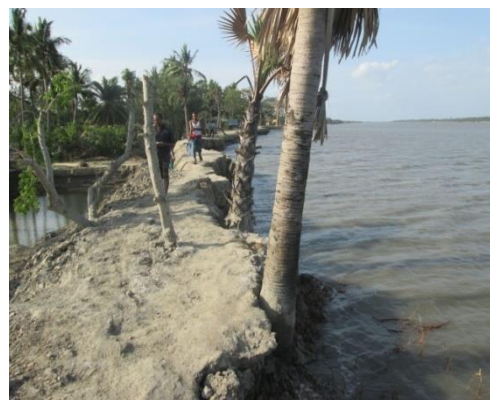
Figure-2: Continued Erosion in 2014

During this year erosion was getting worse. Local people appealed to the local MP and Minister for Fisheries & Livestocks, who gave them some hope of concrete block protection. As reported he also assured them that the fund was almost there and the work would be done soon. When Blue Gold Program became operational in April 2014, this issue was of primary importance to Blue Gold Program. Blue Gold had several meetings with WMGs, WMA and UPs regarding probable action that could be taken. Blue Gold proposed that since this program does not have provision for concrete block protection, it can go for a retired embankment at a sufficient setback distance (min. 100m). But the people were not ready to accept embankment retirement as they have already lost huge

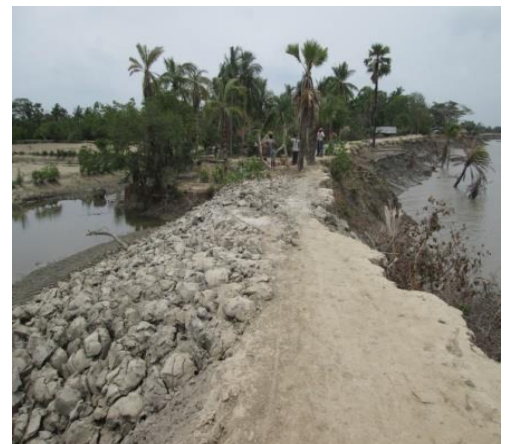
**Figure-5: Backing of Embankment-Local Initiative**

In the meantime apprehending probable danger the local UP did some backing of the embankment in several reaches (Figure-5).

In some places they also used porcupines using BWDB designs. Local people also tried with different indigenous methods but nothing worked well. There was almost an imminent breach at one location and apprehending the danger BWDB constructed a ring dike in the countryside of this point (Figure-6).

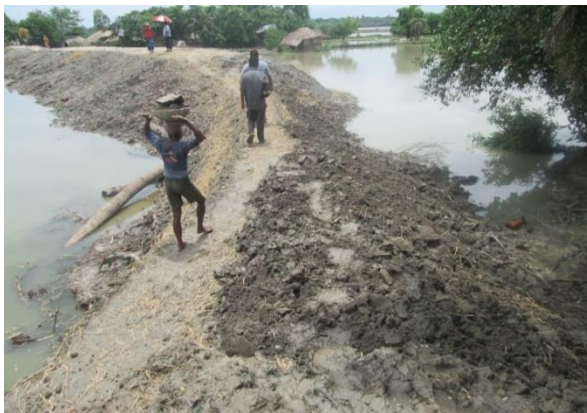
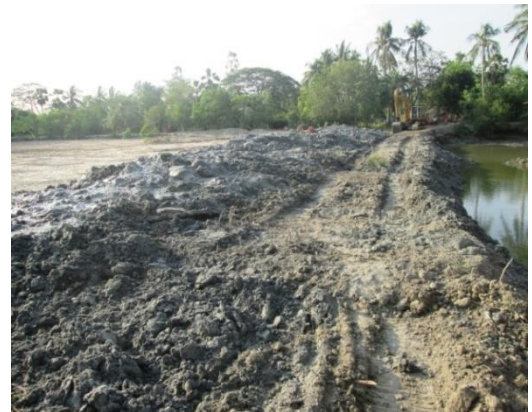
The contractor was progressing very slowly and in an unplanned manner. He started piecemeal works at different reaches (Figure-7 & 8). Though it was almost end of July, full monsoon, he could not even put a dwarf dike to cover entire the alignment.

**Figure-7: Under-Construction Embankment (not full section)**

**Figure-8: Under- Construction Embankment (Base Layer)**

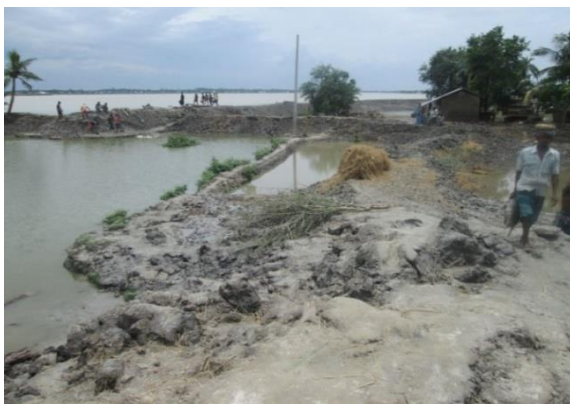
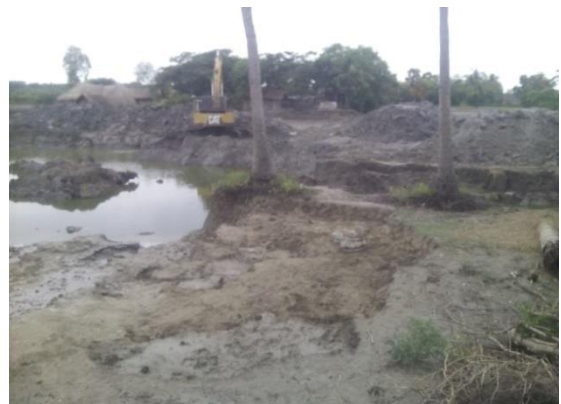
Some reaches of the embankment were just touched or have not been touched even during the last week of July 2015. Two of such reaches as shown in Figures-9 and 10 triggered the breaches and developed three deep channels, making way for huge floods entering the polder area during the cyclone Komen on 31<sup>st</sup> July 2015.

**Figure-9: Vulnerable Reach Causing Breach & Channel Development**

**Figure-10: Vulnerable Reach Causing Breach & Channel Development**

23 July 2015: Site visit by BWDB/TA identifies physical progress of the ongoing work was approximately 14%, poor quality earthwork too close to river bank (apprx. 20m) – community opposition to BWDB/TA (contrasted with measures provided by CEIP). After that the contractor was repeatedly asked to increase his labor and equipment at least to close Baintola khal and develop a moderate section covering the entire alignment, but there was not much effort on his side. The assessed overall progress on 30 July 2015 was around 18%, still with gaps and vulnerable reaches (Figures-9 & 10).

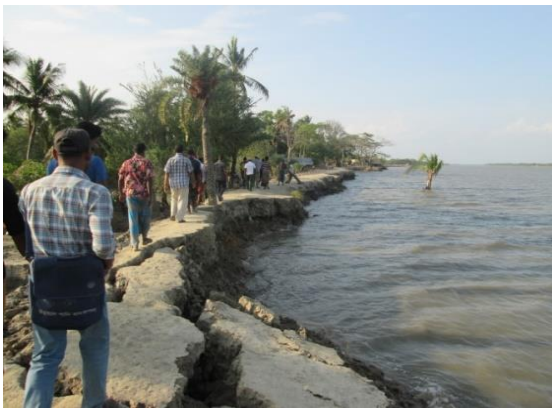
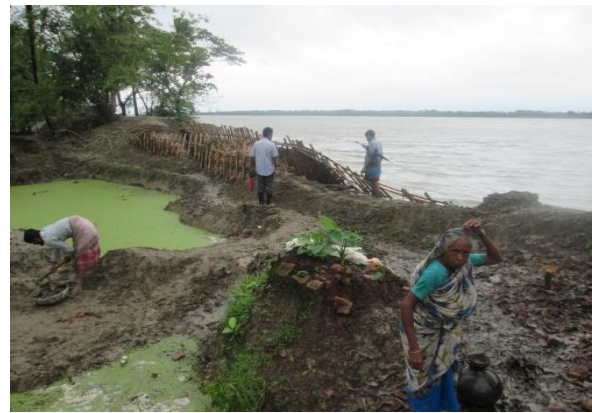
During July 2015 the condition of the original embankment along the river bank was deteriorating further, at some points almost on the verge of failure, and increasing threats to the under-construction embankment just several ten meters inside the eroding banks (Figure-11 & 12).

Figure-11: Severe Erosion – on the Verge of Failure

Figure-12: Severe Erosion- with Last Struggle to Save

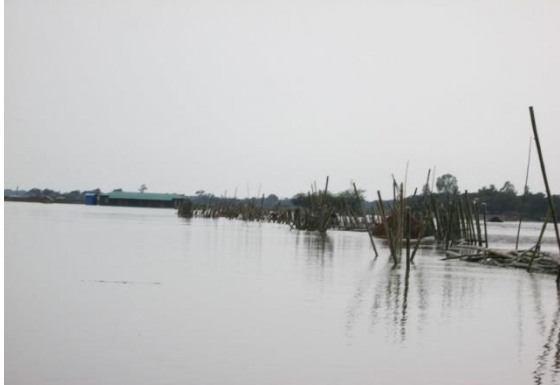
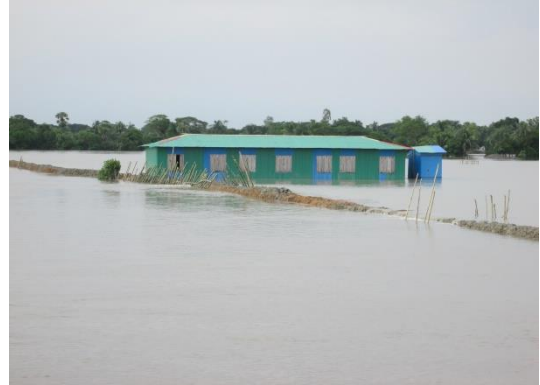
Emergency measures taken up by Union Parishad: to protect Chandghar region, Sharappur Union Parishad and local people with the help of WMA and BWDB started constructing a ring dike at the country side of the existing embankment (Figures-13 & 14). Although the local people and the contractor tried their best at that moment to close the breach, their efforts ended in vain due to high velocity of water in the river. Moreover, breaches occurred at two more locations due to the high velocities during high tide. A large portion of Sundarmahal, BCG and Akra Bahir Akra WMG areas were flooded.

**Figure-13: Rows of Bamboo Pins to Make Ring Dike**

**Figure-14: Flooded and Damaged Ring Dike**

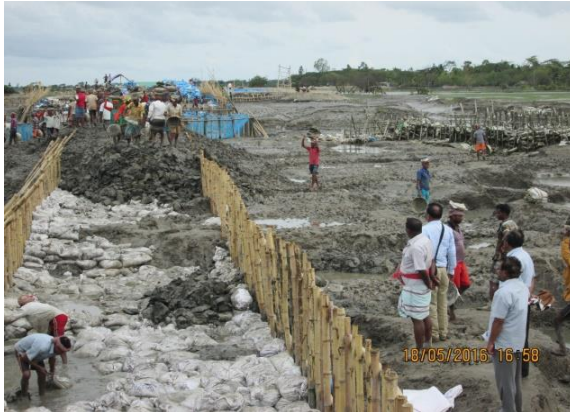
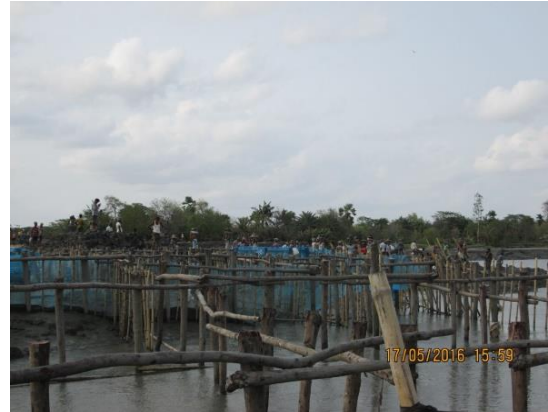
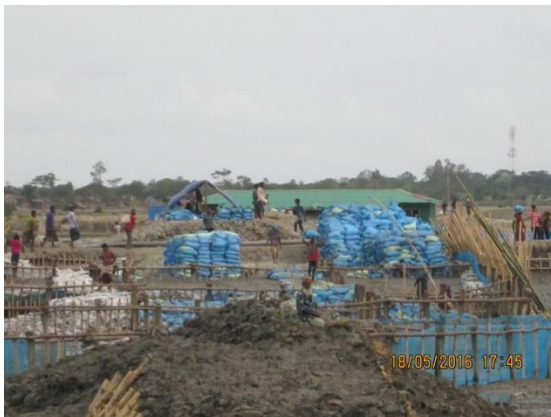
There were repeated attempts by contractor to close main channel (cross dam 3 on Figure-15) but failed as the velocity was too high. The last breach was finally closed on 28 June 2016. The main embankment was still very weak but intact. Bamboo pins, Bandalings and sand bags used for closing the main breaches (2 & 3) are shown in Figures-16, 17 & 18. The under-construction embankment is shown in figure-19.

**Figure-16: Closing of Second Breach with Bamboo Pins, Sand Bags and Earth (Cross Dam-2)**

**Figure-17: Wooden Bandaling for the Third Breach (Cross Dam-3)**

**Figure-18: Sand Filled Synthetic Bags for Cross Dam -3**
