# Memo

Re: Site visit on 13 March 2017

## 1 Introduction

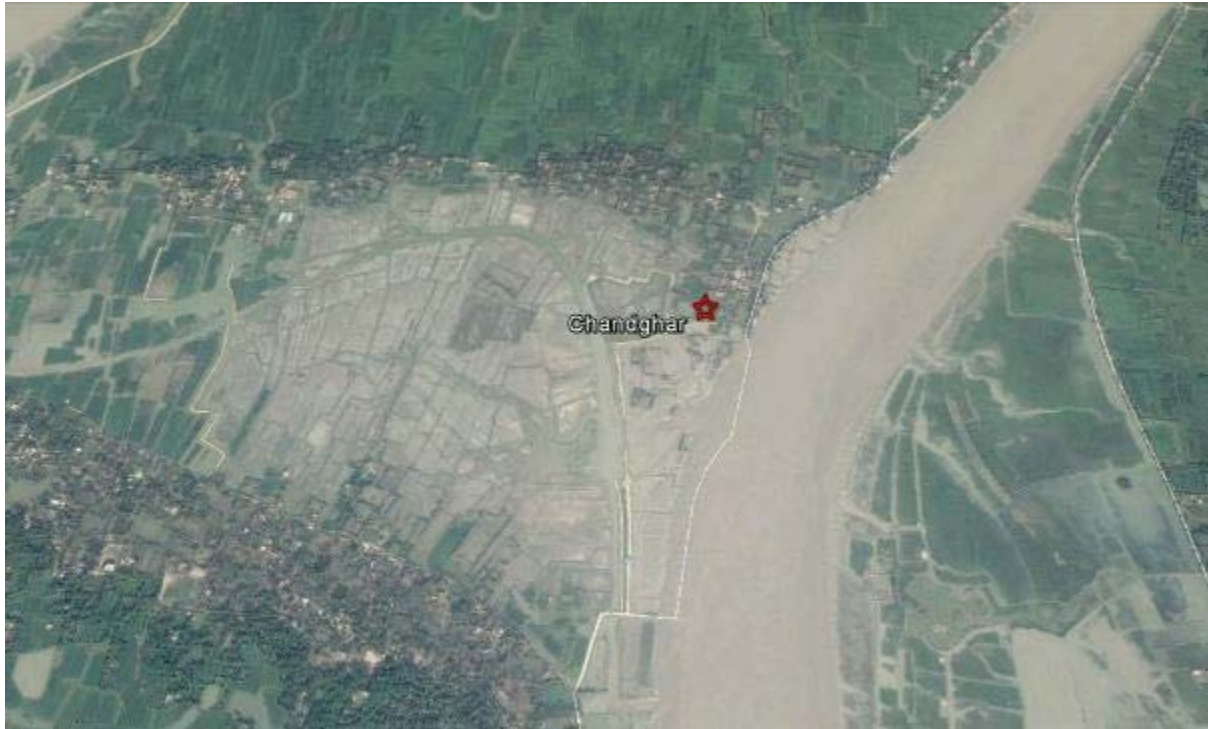
*Figure 1-1: Areal view of the Chandghar area of Polder 29, where the embankments breached (Image from Google Earth, November 15<sup>th</sup>, 2016)*

The team assessed the breached embankments in Polder 29 (Figure 1-1) where the application of "semi-permeable spurs" has been proposed as pilot works to secure the site against erosion, as well as the geotechnical failure of the embankment at Polder 22. Apart from information pertaining to the pilot works, general design and construction experience about BWDB design and construction works were exchanged and are reflected in this memo. In addition, emergency measures, a part of both projects, were discussed.

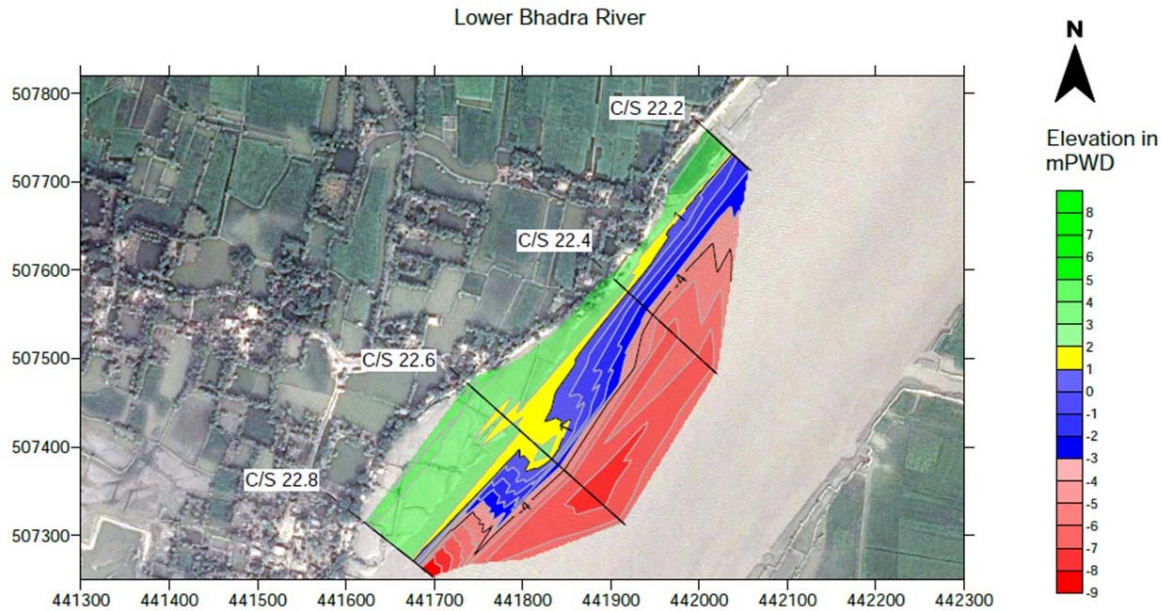
- (i) Bathymetric and flow data, collected by IWM in May 2015, used as an input for their modelling activities<sup>1</sup>.
- (ii) Cross sectional data collected by the BWDB field office in November 2016. These four cross sections have been processed in the FRERMIP office using triangular interpolation because of the limited data points available. (Figure 2-1). This survey image could be improved with more cross sections; however, this limited survey gives an idea of the elevation of the river bed in the area.

Figure 2-1 Bathymetric map from BWDB cross sectional data of the Lower Bhadra River

We recommend to compare both data sets and show the result in a differential map.

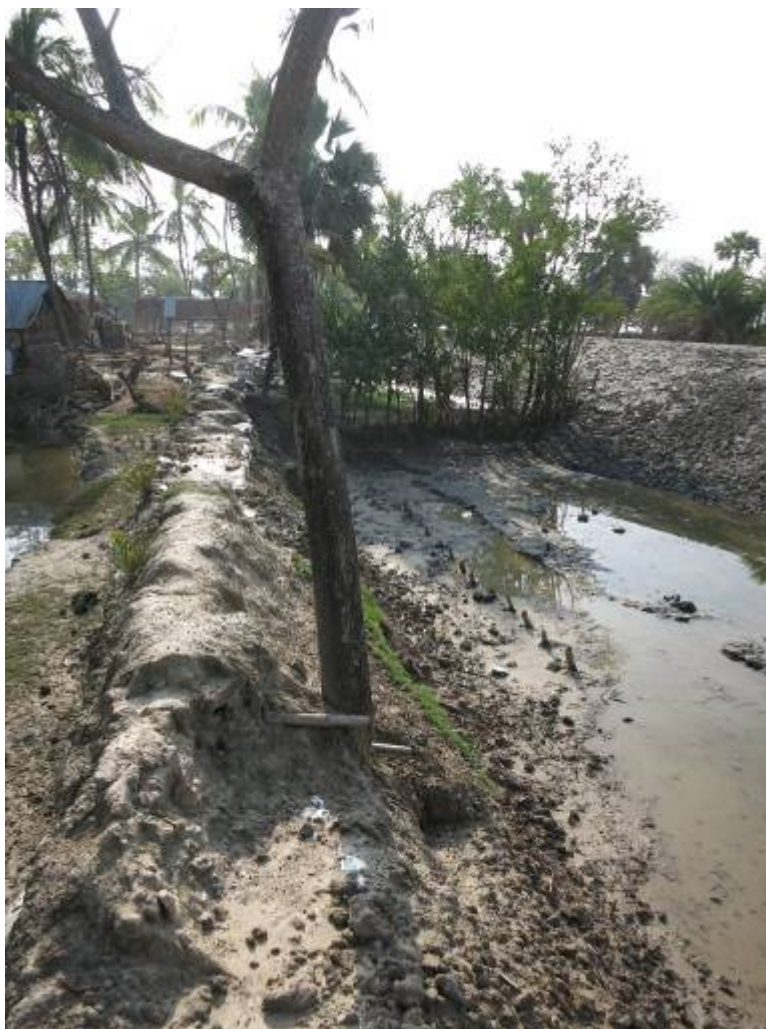
The flood embankment has been breached prior to the 2016 flood season and temporarily repaired ( Figure 3-1). A new embankment, under construction since June 2016 is expected to close the breach reliably, however the embankment has a number of weaknesses:

Figure 3-1 Temporary flood embankment (left hand side) and new flood embankment (background right)

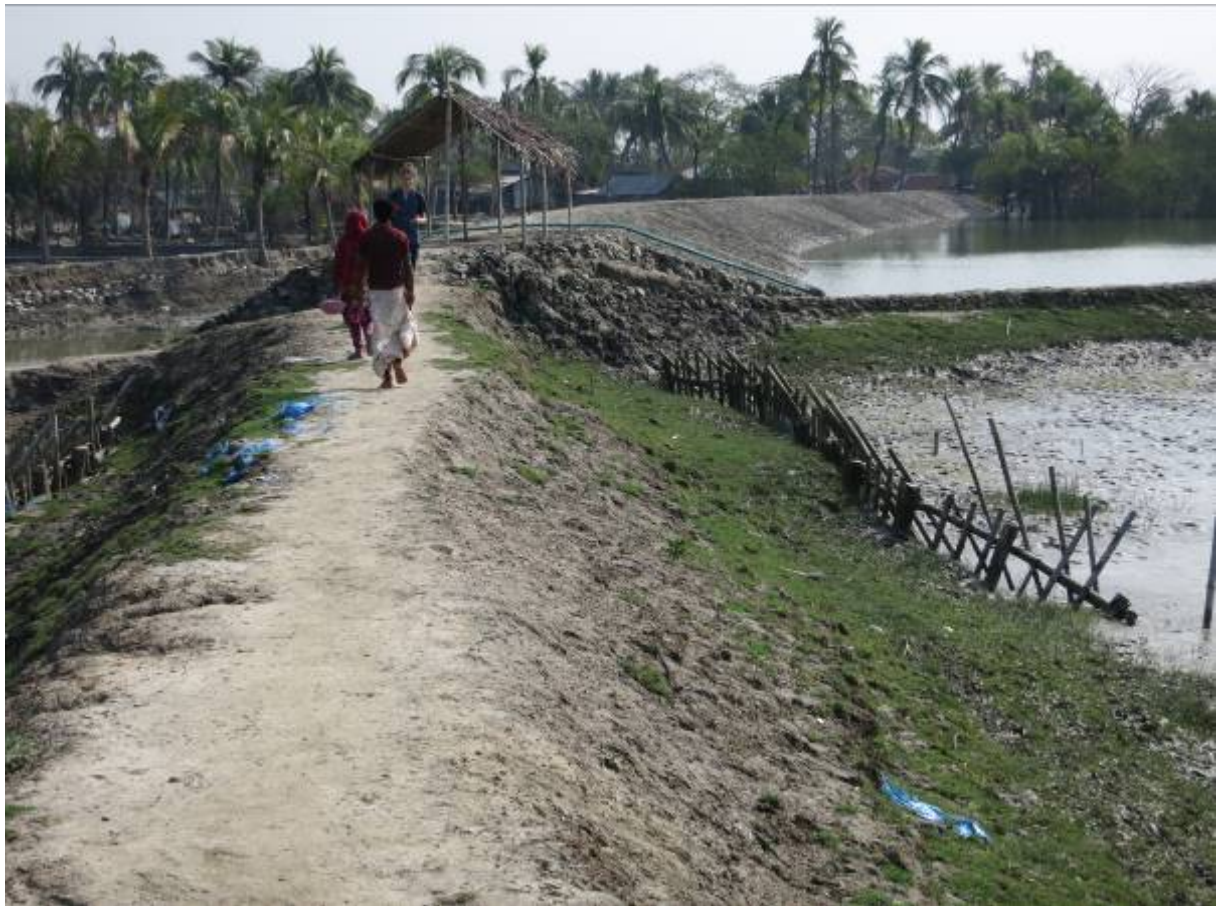
- (i) Some areas are not constructed to design level, especially the closures of breaches (Figure 3-2).
- (ii) In the deep part of the breaches, with bed levels below water level, no berms are constructed, which weakens the cross section substantially and in one place already results in piping, inviting future potential catastrophic failure (Figure 3-3 and Figure 3-4).
- (iii) The new embankment is not compacted, which results in potentially 15 to 20% voids (Figure 3-5), and as a consequence the contractor saves this amount of money (payment for air in the cross section).
- (iv) The land acquisition process is slow and results in a gap in the cross section where a school is located (Figure 3-6). Here the intergovernmental transfer delays the provision of reliable infrastructure.

Figure 3-2 *partial closure of upstream breach without attaining the final crest level*

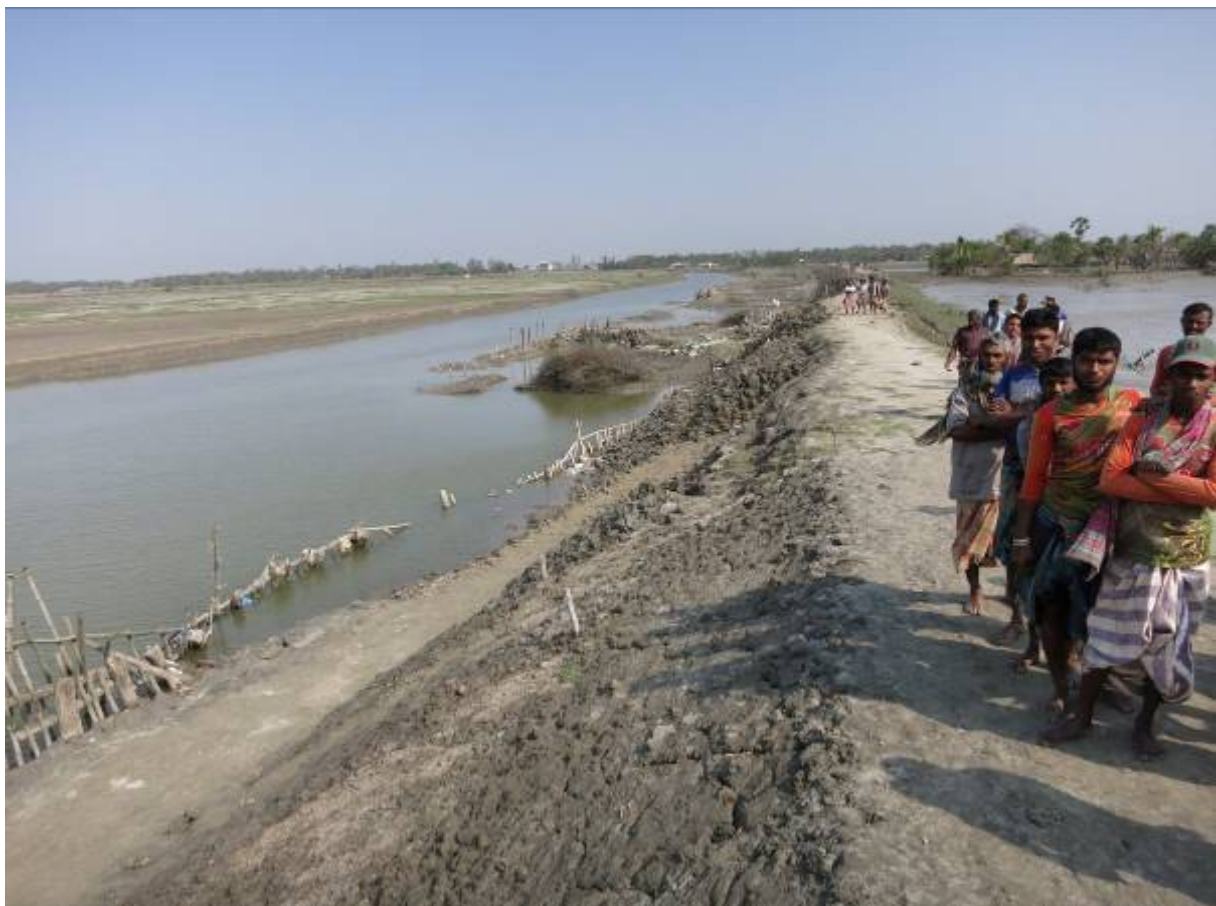
Figure 3-3 *Missing berm at the main breach closure (country side view)*

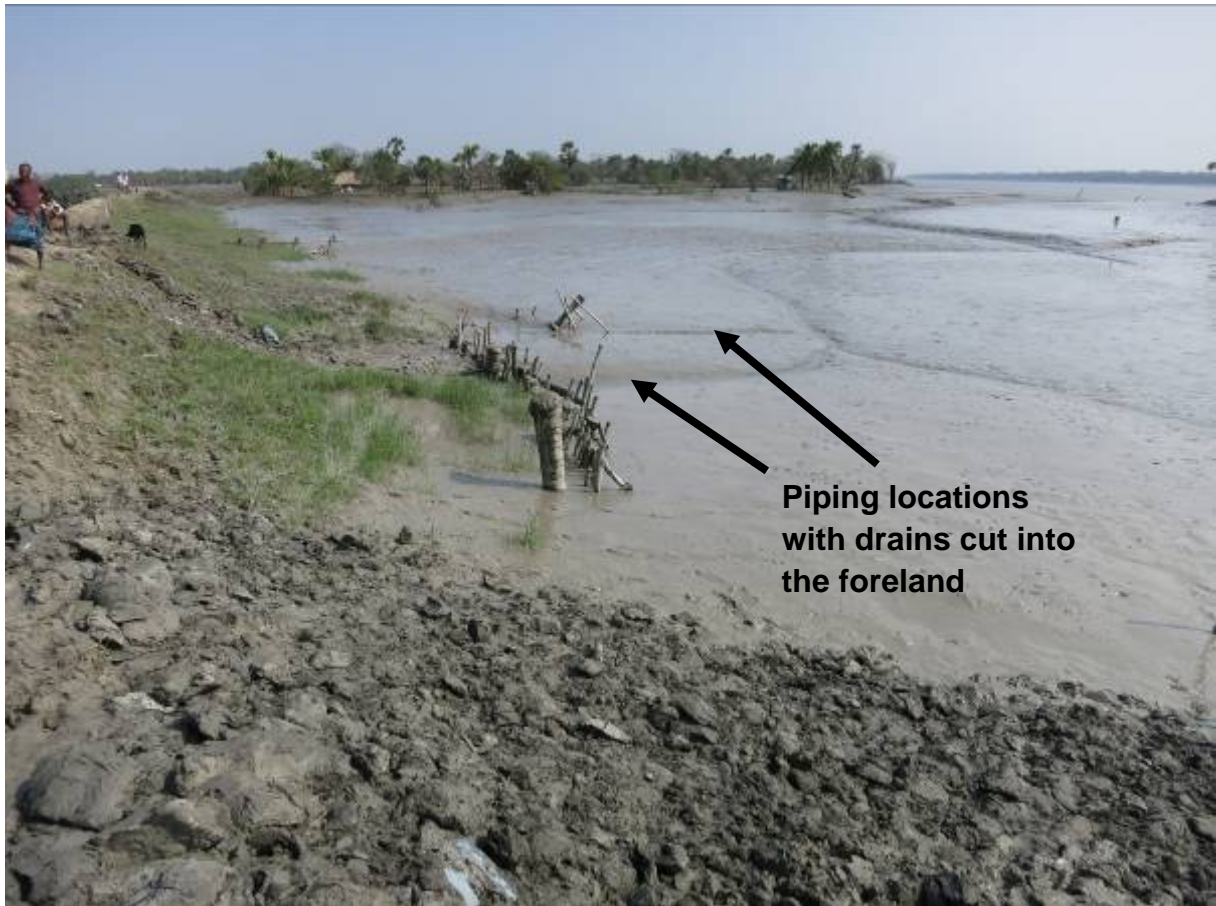
Figure 3-4 *Piping through the embankment (riverside view)*

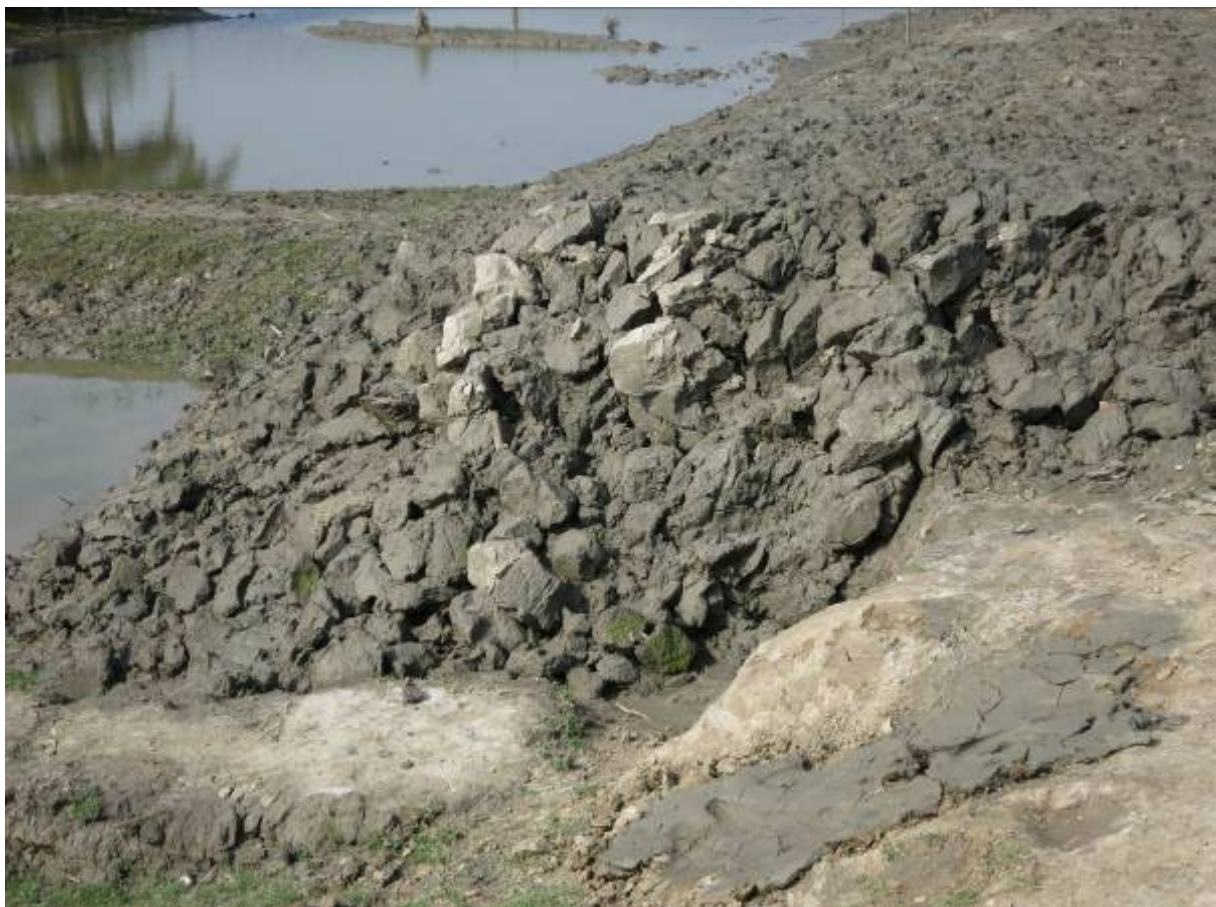
Figure 3-5 *Uncompact embankment fill*

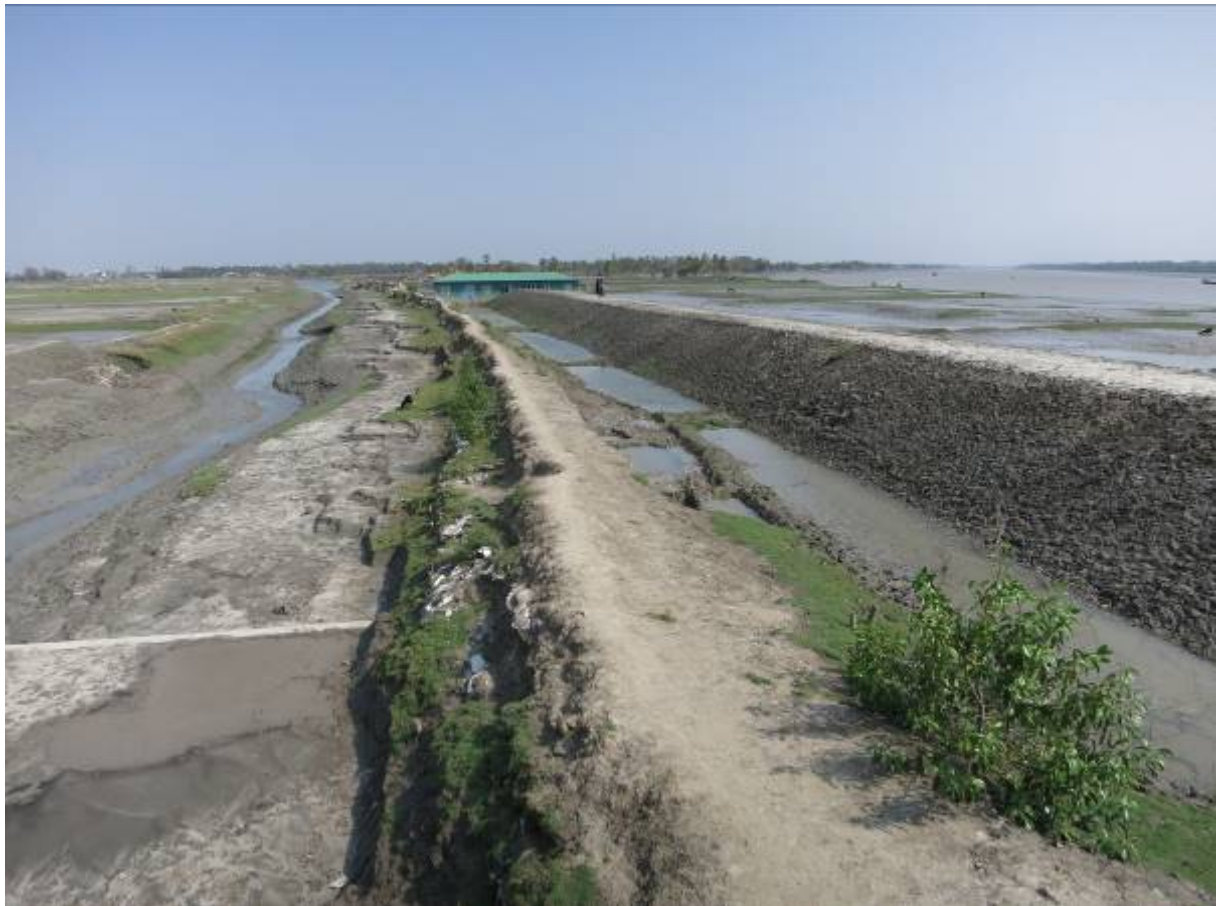
Figure 3-6 School building (in background) preventing the completion of the new embankment (to the right) with the emergency embankment in the center close to a major drainage khal on the left

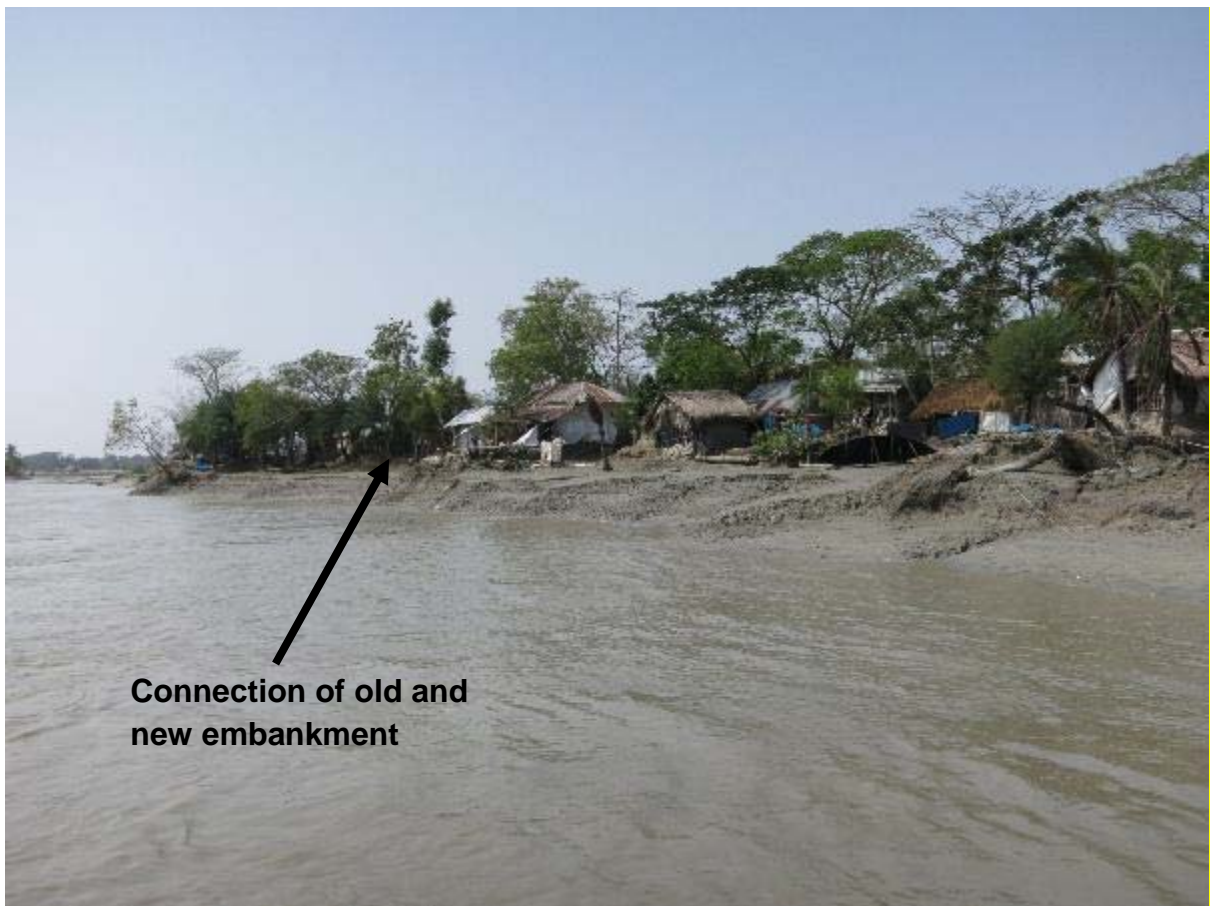
While the new embankment has some 100m setback distance to the river, the upstream connection with the old embankment is quite close to the eroding bank and situated in a densely populated area (Figure 3-7 and Figure 3-8). This location, together with the poor workmanship of the existing embankment, further aggravated by unfinished sections, results in a high risk of a renewed embankment breach during the 2017 flood season, either due to erosion, piping, or overtopping.

Figure 3-7 Eroding river upstream of the breached embankment (looking downstream)

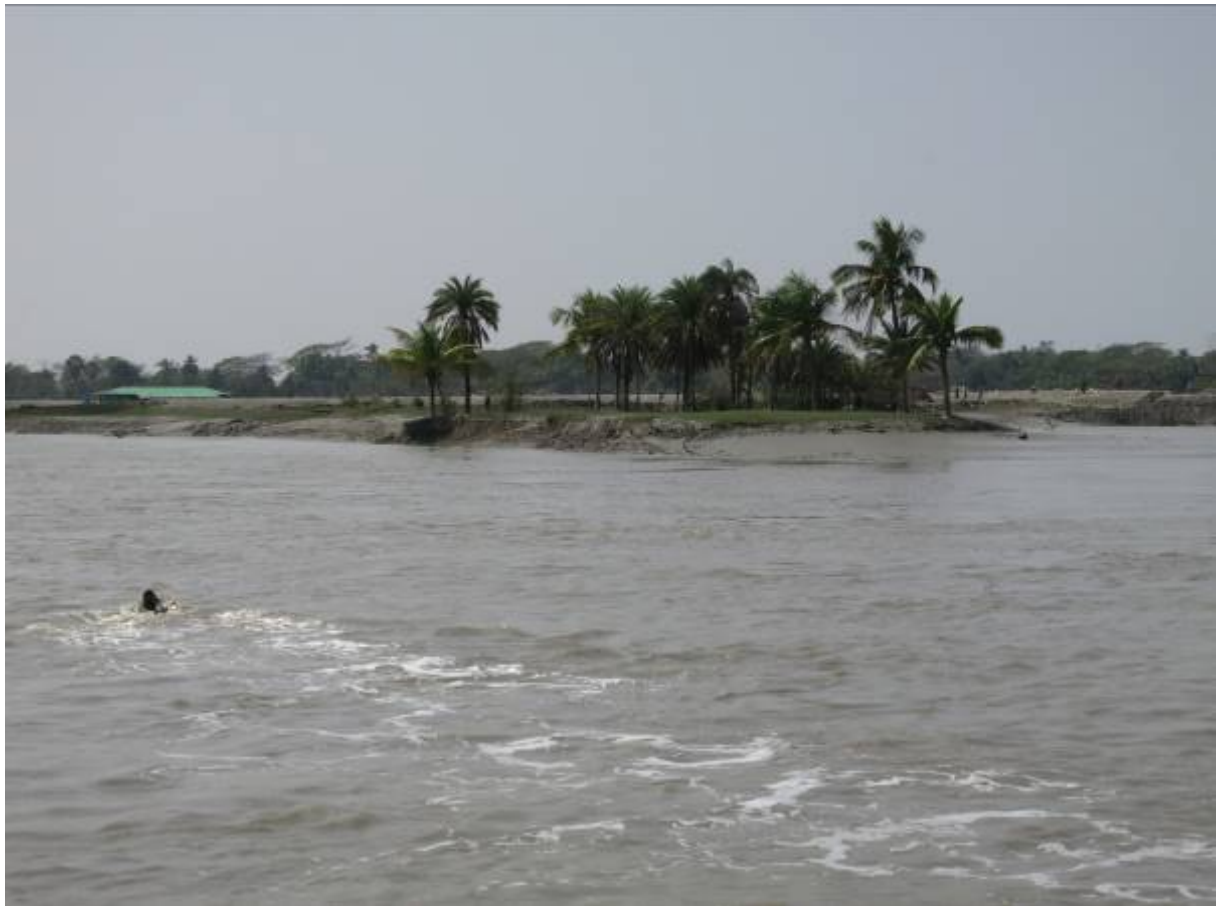
During the field trip, it could be observed that the thalweg of the incoming spring tide flows close to the riverbank in the area of the breached embankment. Even during the dry season, the flow velocities appeared quite high (Figure 3-9). It was not possible to observe the outgoing flow due to the timing of the visit. We recommend to conduct float track measurements during the next spring tide to get a first grasp on the current flow situation and the location of the thalweg with respect to the bankline.

Figure 3-9 High flow velocities of incoming tide close to the bankline

The overall situation indicates the need for emergency riverbank protection, to control the riverbank. An easy solution is to provide a sufficiently large amount of sand-filled geotextile bags along the bank. These bags, once undercut from erosion slide down the underwater slope and protect the slope against further erosion, as the sand-fill acts as filter against the fine clayey and silty subsoils. Importantly, this type of emergency design has limitations, which need to be further investigated:

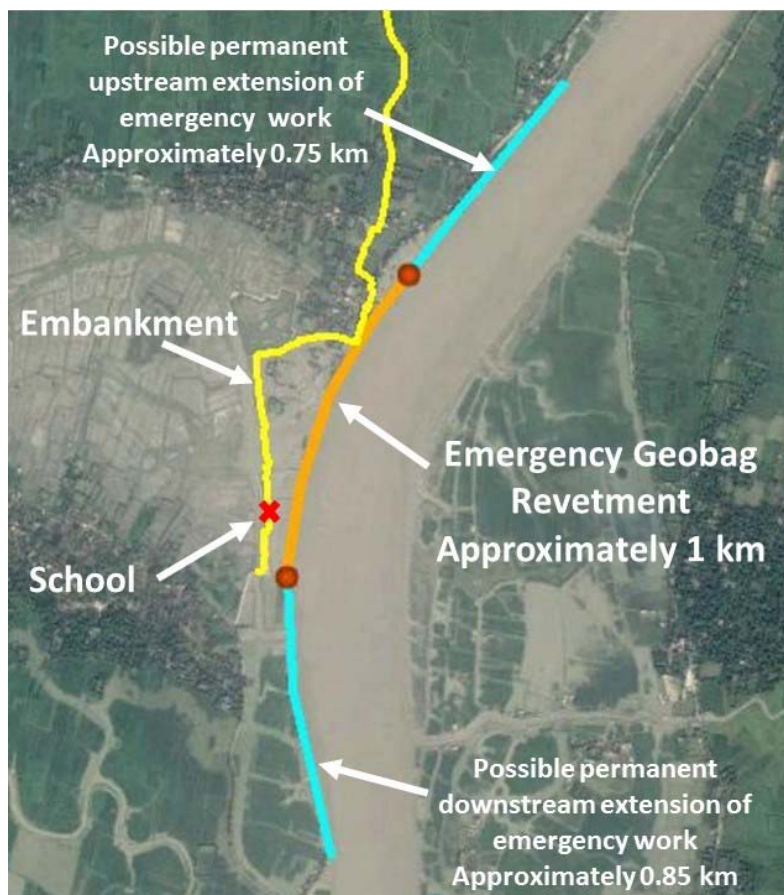
Figure 3-10 Estimated location and length of emergency works (image from Google Earth, November 15<sup>th</sup>, 2016)

A tentative rough estimate, assuming a river depth of around 15m with 35m underwater slope length (1V:2H), results in the need of 35 250kg bags per linear meter. This translates into 35,000 bags per km, which at cost of 6 USD per bag, requires 210,000 USD per kilometer. The estimated length, taken during the site visit is around 1 km, shown in Figure 3-10.

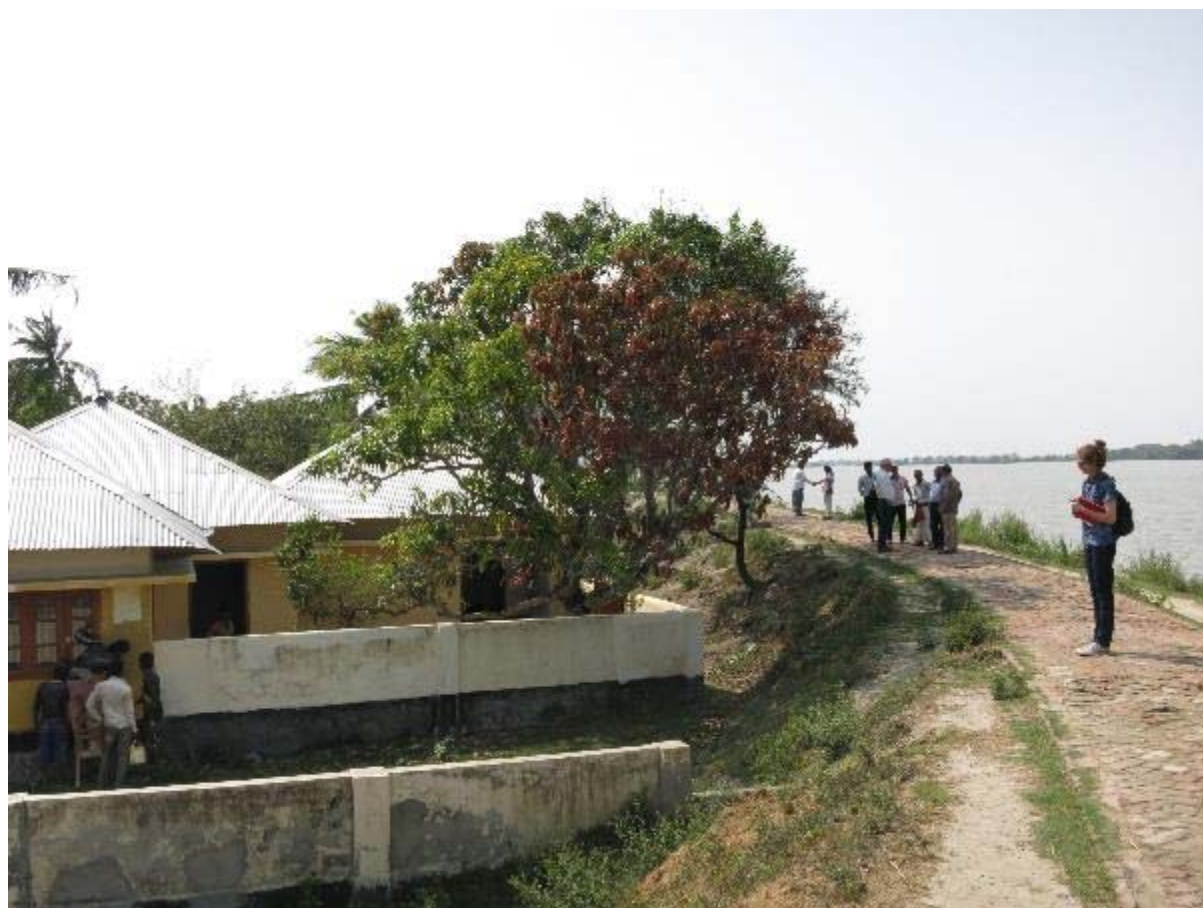
The embankment is partly collapsed and will very likely fail during the coming flood season. Immediately behind the embankment is the Blue Gold training center, currently under renovation (Figure 3-11). The existing embankment alignment indicates a relocation of the embankment in earlier times. The embankment needs to be setback from the river to avoid catastrophic geotechnical failure during the flood season. The highest risk of failure is towards the end of the flood season, when water levels recede quickly, called “rapid draw-down”, and the saturated soil of riverbank and embankment is weakest.

Figure 3-11 Training center of Polder 29 under rehabilitation with earlier realigned embankment

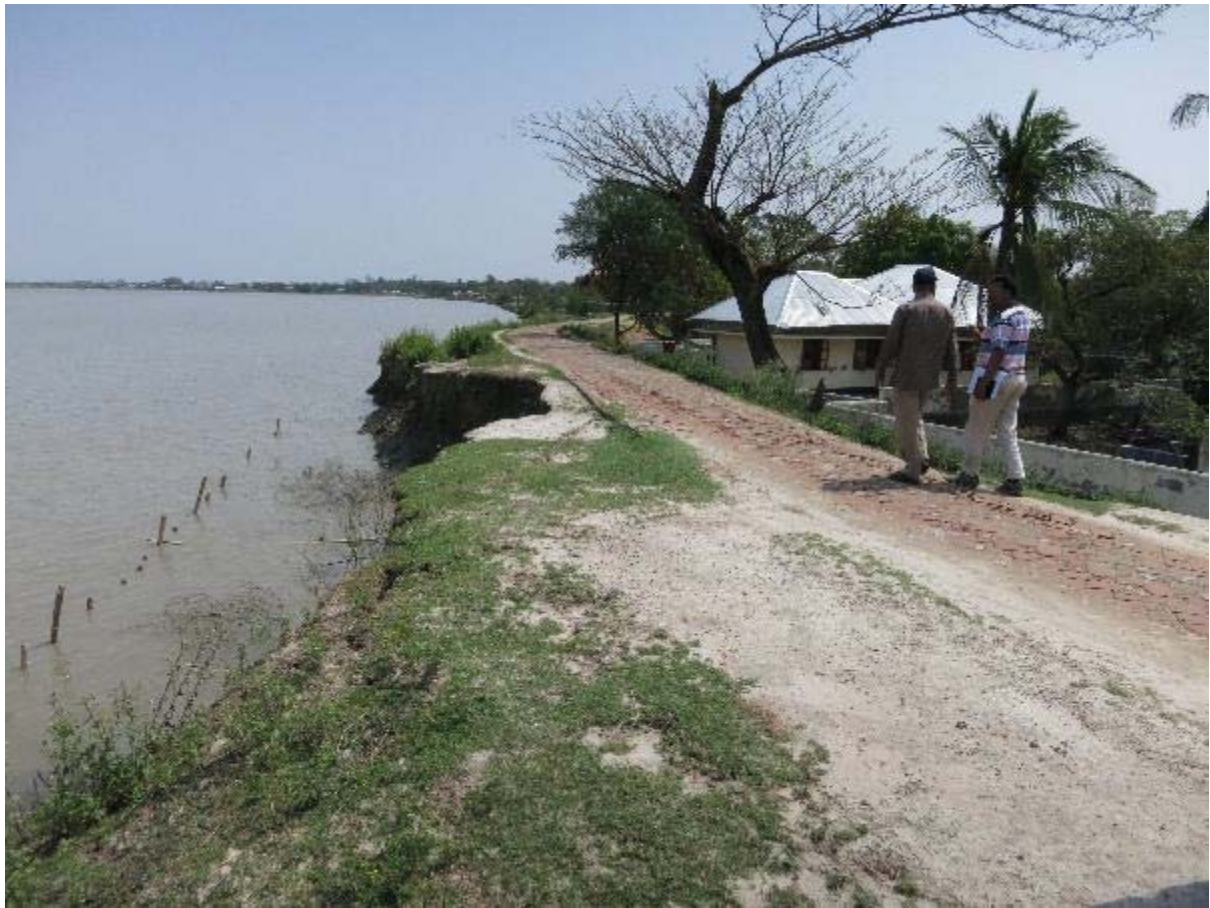
There was no data collected during the field visit that allowed quantification of the river depth; however, temporary bamboo fencing and the clayey soils indicate that the river could be quite deep and the slopes rather steep at the bank (Figure 3-12). It is advisable to conduct a bathymetric survey with float tracking to understand the river depth, the location of the thalweg, and the flow velocities. We estimate that around 400m emergency riverbank protection could temporarily remediate the situation.

*Figure 3-12 eroding riverbank with some temporary bamboo fencing*

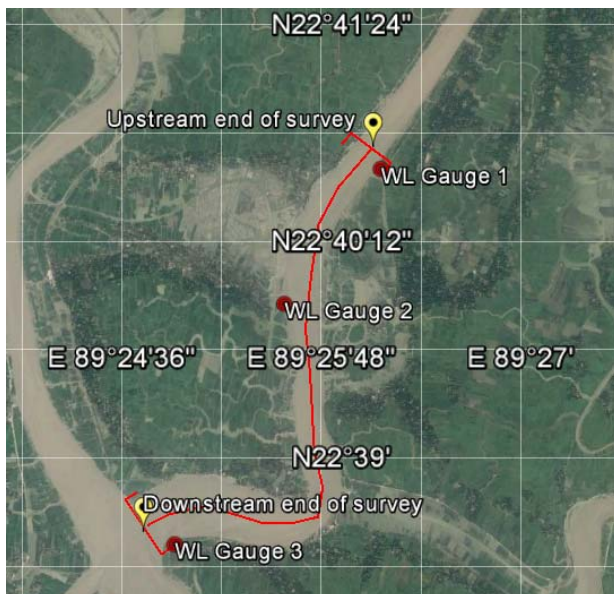
Figure 5-3 WL gauges locations

A total of three water level gauges, connected to known benchmarks in the area, should be installed at the locations indicated in Figure 5-3. The water level gauges shall be set up on the day before the first survey and read and noted twice daily, during high and low tide, until the day after the last survey.
