# The Promises of Roads for Polder Water Management and Flood Protection

Opportunity Study

Roads for Water

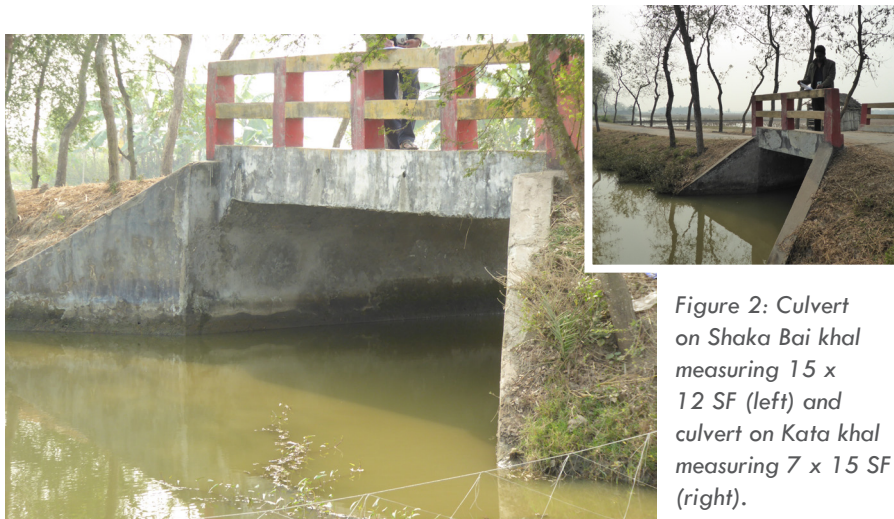
Figure 2: Culvert on Shaka Bai khal measuring 15 x 12 SF (left) and culvert on Kata khal measuring 7 x 15 SF (right).

One is located at the intersection between Shaka Bai khal and the Union Road, the second is situated where the road intersects Kata khal (Figure 2). As a consequence of few water crossings, large areas of farmland on the East side of the main road are waterlogged (Figure 3).

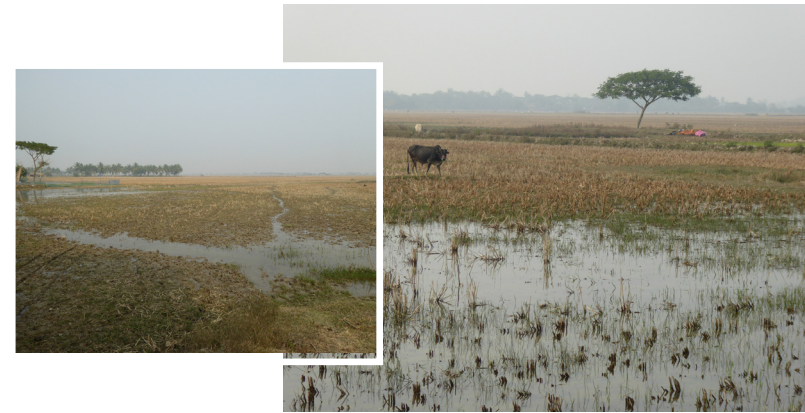
Figure 3: Waterlogged areas on the East of the main Union Road. These photos were taken in March 2017, during the dry season.

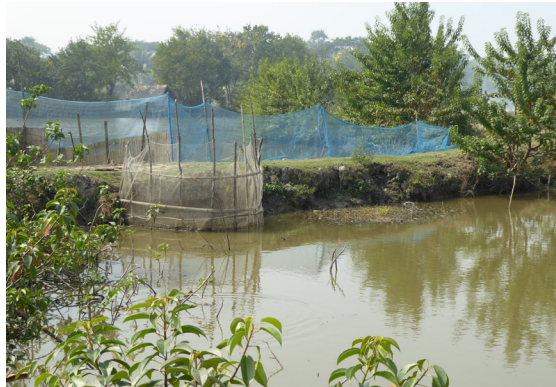
Figure 4: Earthen road constructed by local people across Ziler khal for communication for around 45 families. A culvert is needed to maintain the connectivity of this khal.

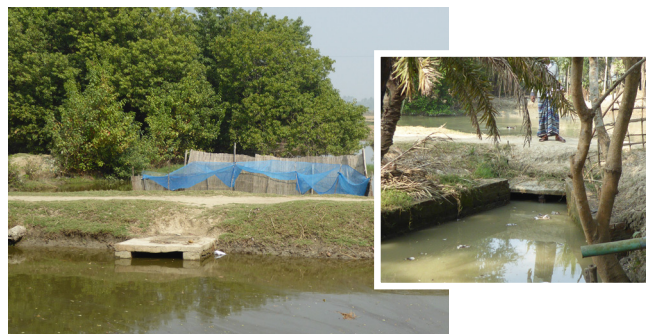
Figure 5: The box culvert upon Dangar Khal is very narrow (right). Culvert on Boyersing khal connects two khals. If Boyersing khal will be re-excavated as by plans, then the capacity of the existing culvert too low to convey the water. in March 2017, during the dry season.

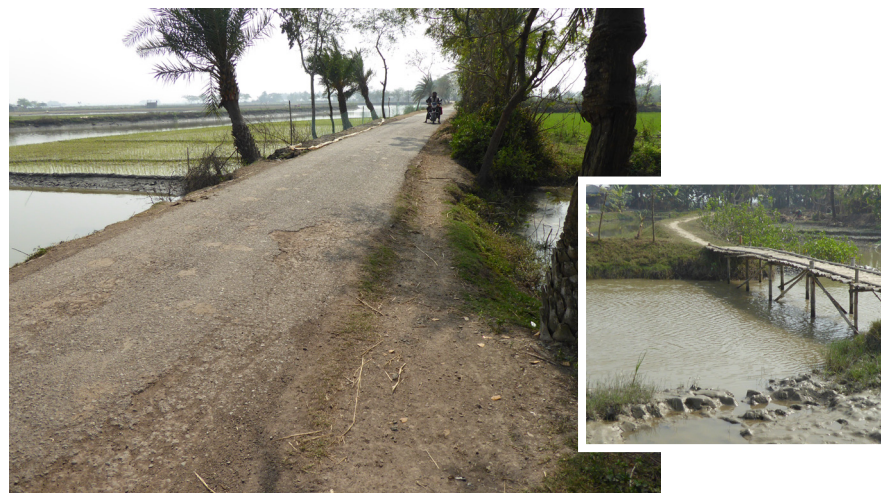
Figure 7: Main pucca Union Road cuts the Shaka Bai khal. Connectivity shall be restored by providing a large culvert on this road (left). A bridge is needed near Baloijakhi Sluice. People use a bamboo bridge to transport goods (right).

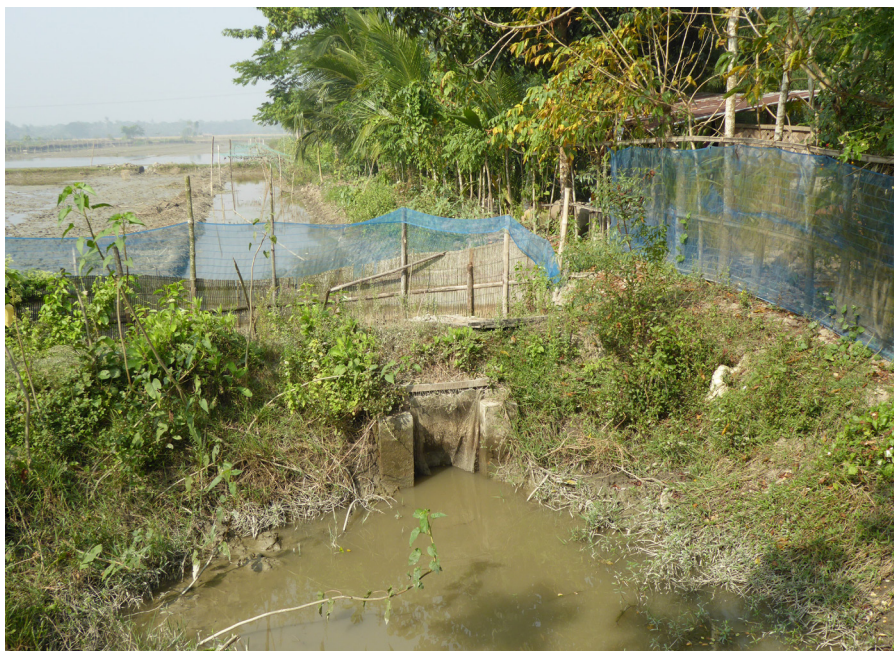
*Figure 8: A fishing net in front of the opening of a culvert is encroaching on the khal system creating obstacles to the natural flowing of water and disrupting drainage connectivity.*

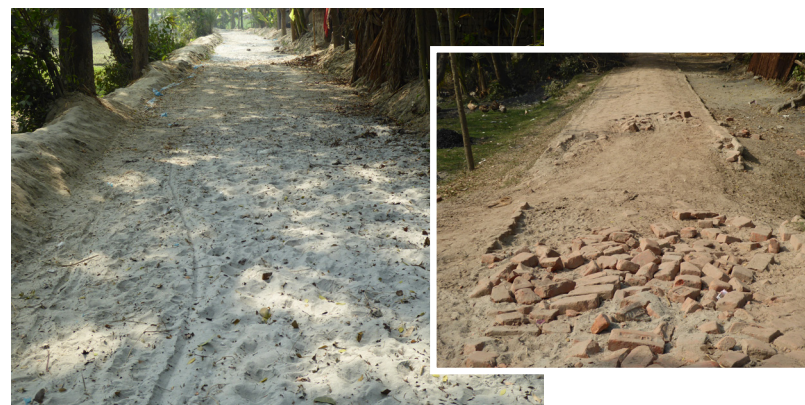
Figure 10: Earth and brick roads deteriorate rapidly and create many challenges to communication and transport

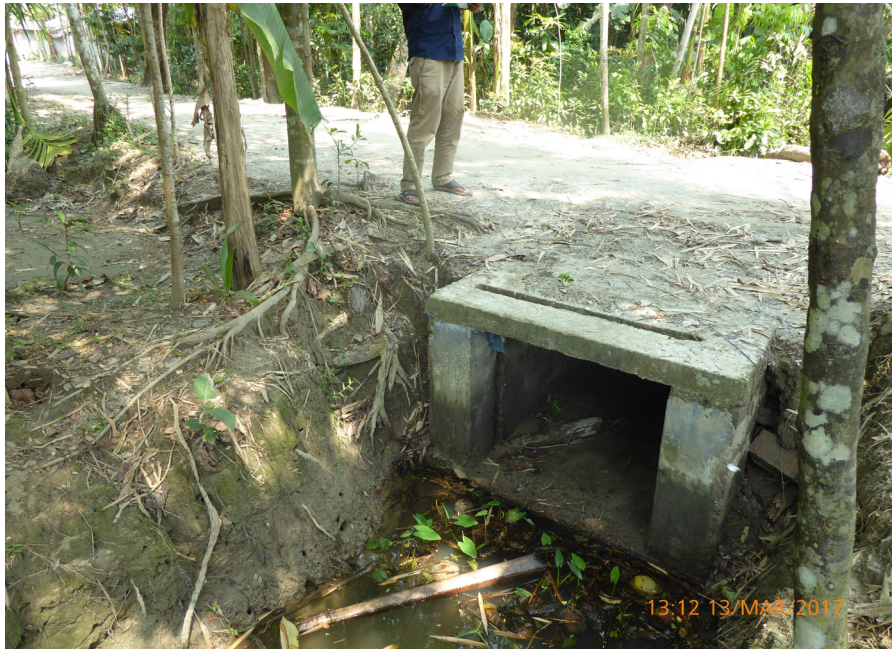
Figure 14: Gated culvert to control water flow and water levels at water crossings.

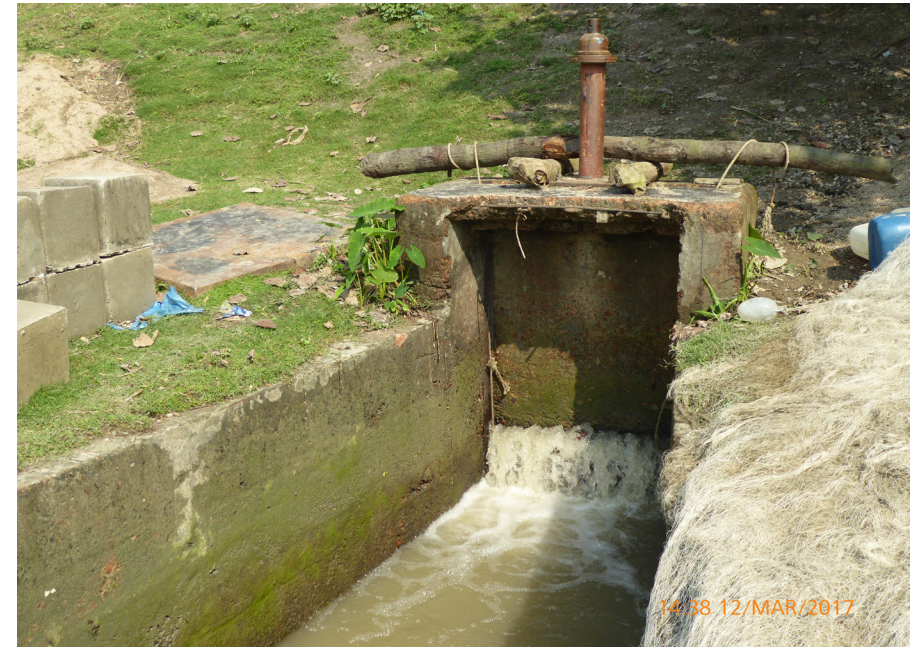
Figure 15: Defective sluice gate: this gate can neither retain water when it is needed (water losses) nor block water from entering when it is not needed (flooding).

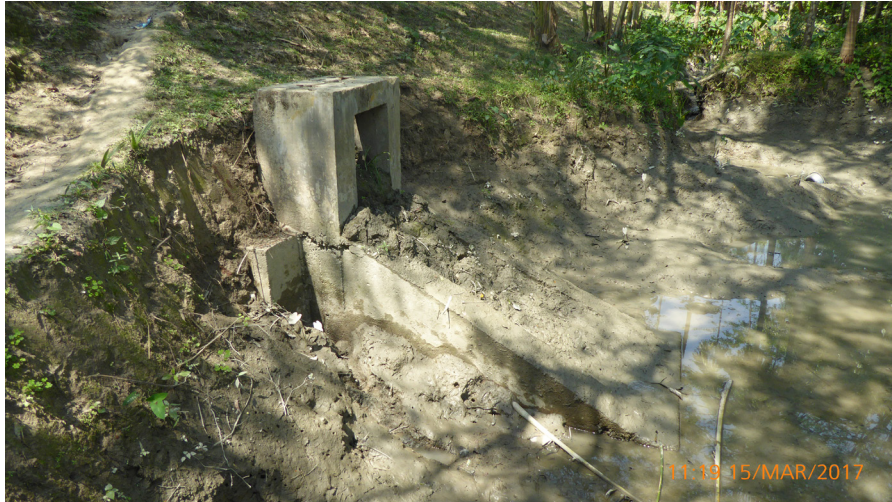
Figure 16: Inlet blocked by mud and devoid of vertical metal gate.

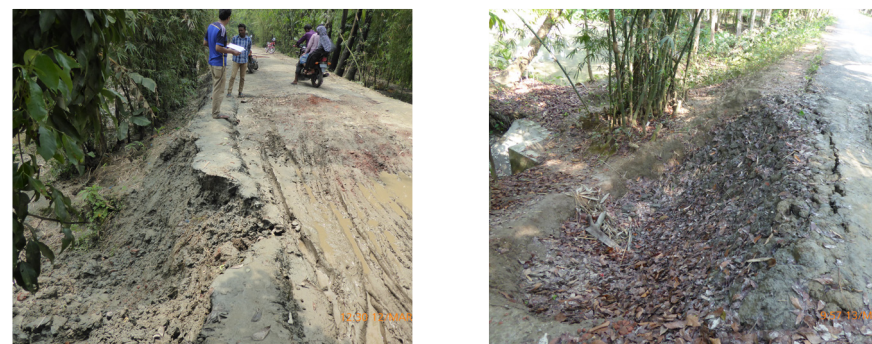
Figure 18: Two examples of erosion and degradation of embankment roads in correspondence of inlets.

The length of the pipe barrel of inlets and outlets along the embankment is a design characteristic that has a huge impact on the durability and stability of the portion of embankment or embankment roads above the structure. It has been observed that in several cases, the length of the inlet or outlet is smaller than the width of the embankment as often, the design length is not chosen in view of future widening of the embankment that accompanies the carpeting of an embankment road. Water entering or leaving the polder through the pipe gets in contact with the sides of the embankment and erodes them. This reduces the stability and height of the embankment and reduces flood protection (Figures 18 and 19).

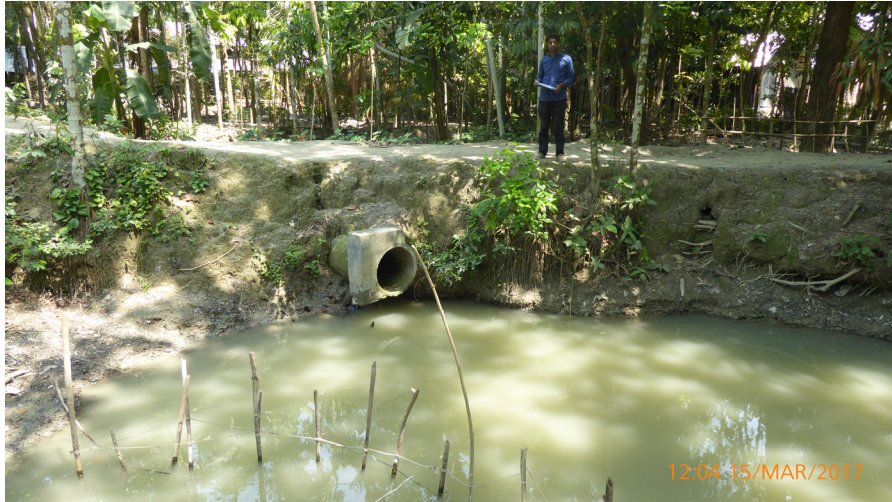
Figure 19: Erosion of an embankment section in correspondence of a pipe inlet.

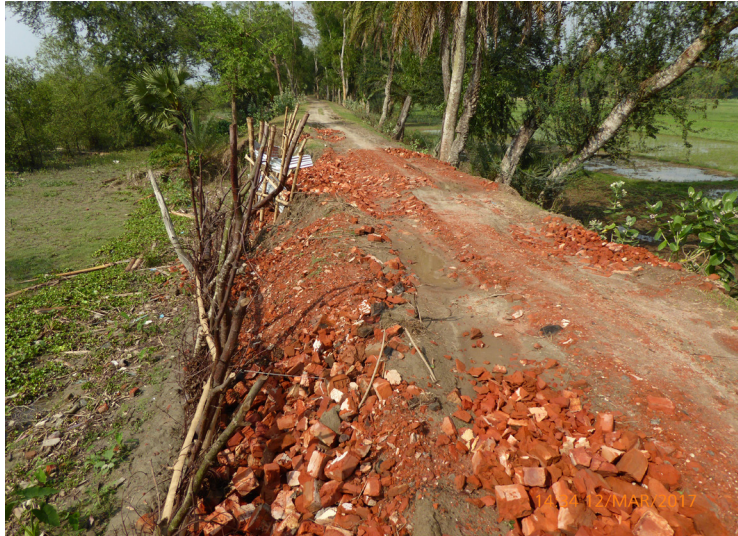
Figure 20: Low embankment section where carpeting has already started.

The risk of river flooding is higher in Polder 43 2F than in Polder 26 because the polder is surrounded by rivers, one being a very large one and very close to its embankment. The perception among the majority of household respondents, is that the embankments do not protect them sufficiently from river surges. It was observed in several cases that the carpeting of an embankment affects the height of the embankment and reduces thus flood protection. In 4 of the 5 carpeted embankment sections surveyed, the height of the embankment was found to be lower than the other embankment sections (Figure 20).

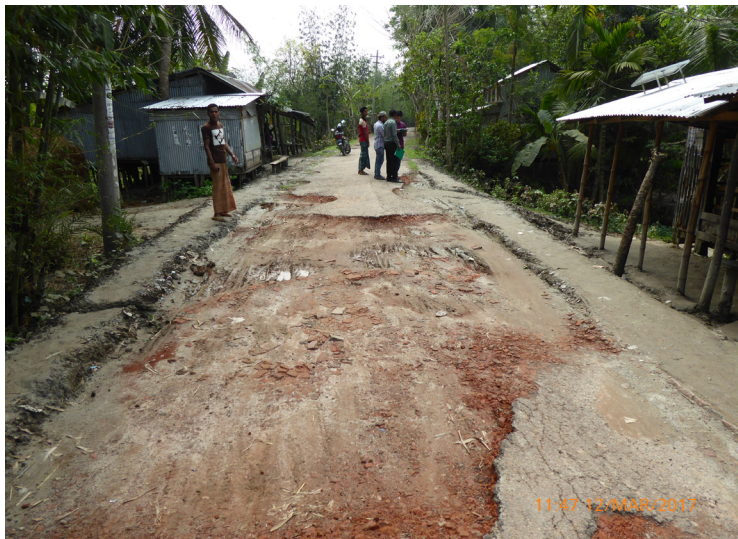
Figure 21: Poor quality embankment road.

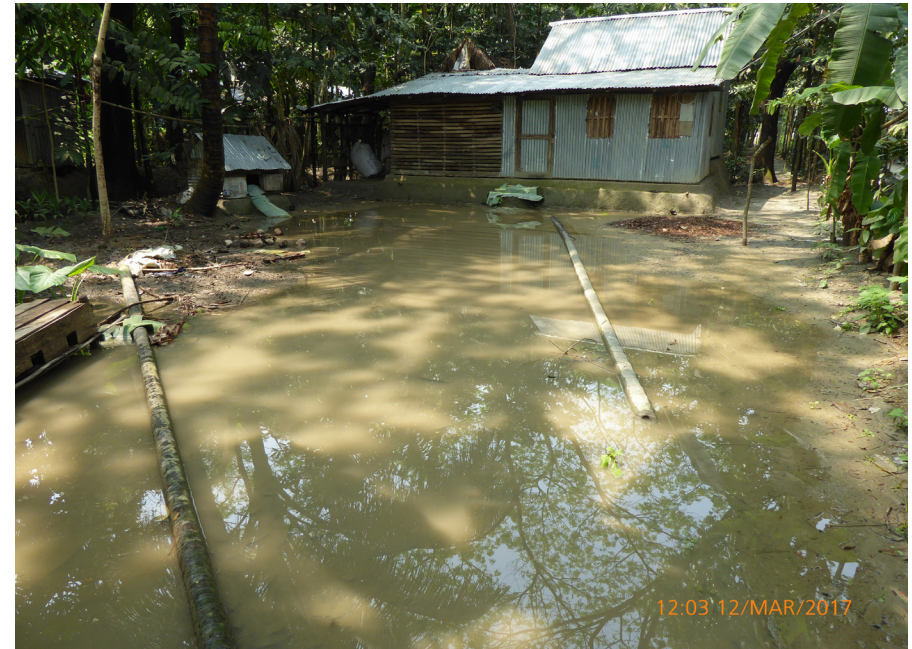
Figure 22: Drainage congestion around a house. This photo was taken in March 2017 during the dry season, 2-3 days after a rain event.
