# 11 Investments for Polder Safety and Water Management

From Blue Gold Program Wiki

# Case Study: Polder 29 at Chadghar in the Lower Bhadra River, Khulna District[edit | edit source]

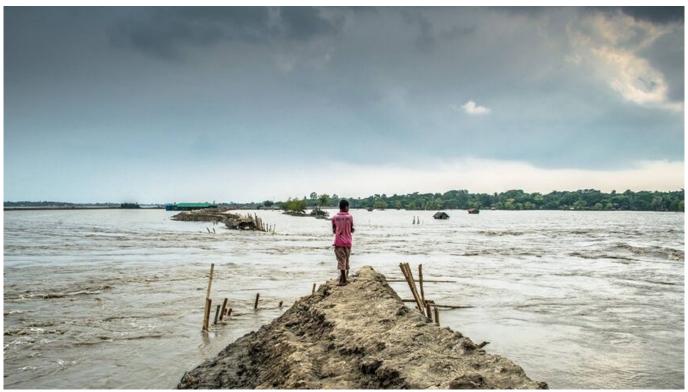
**July 2015:** Early in the month, BWDB and TA visited the site and estimated physical progress to be around 20%, noting poor-quality uncompacted earthwork in an embankment which was aligned only 20m from the riverbank. There was fierce community hostility towards BWDB/TA. On 30 July 2015, a depression developed in the Bay of Bengal becoming 'Cyclone Komen' which crossed the shoreline on 31 July 2015. The original embankment breached at the end point Baintala khal during high tide compounded by effects of cyclone Komen accompanied with heavy rainfall, resulting in flooding and damage to houses and crops. The breach also developed three deep channels across the alignment of the partially-constructed retired embankment, making continuation of the work very difficult.

Photo 11.1 The third breach in the realigned embankment (August 2015)

Emergency Measures: The Union Parishad (UP) and WMA, with technical advice from BWDB, mobilised the local community to construct a ring dike around the country-side of the existing embankment. Although all efforts were made to close the breach, they were prevented by high velocity flows. Photo 11.1 shows one of the three breaches through the realigned embankment at Chadghar, showing: (a) the high velocity flows leading to high tide; (b) the failed attempts – bamboo bandals and narrow earthen embankment - by the local community to close the breach; and (c) a child from one of the families whose home was on the original embankment.

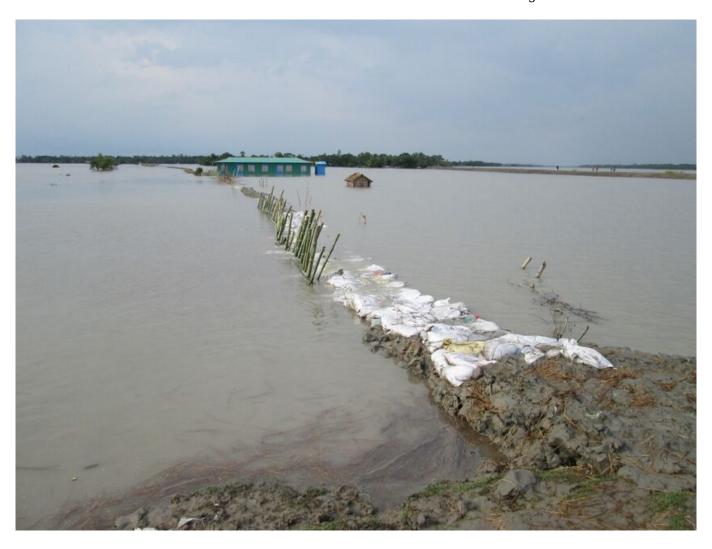
Photo 11.2 provides more detail of the failed attempts by the local community to close the breach, with bamboo bandals and narrow earthen embankment formed from sandbags.

### Photo 11.2 Emergency embankment (August 2015)

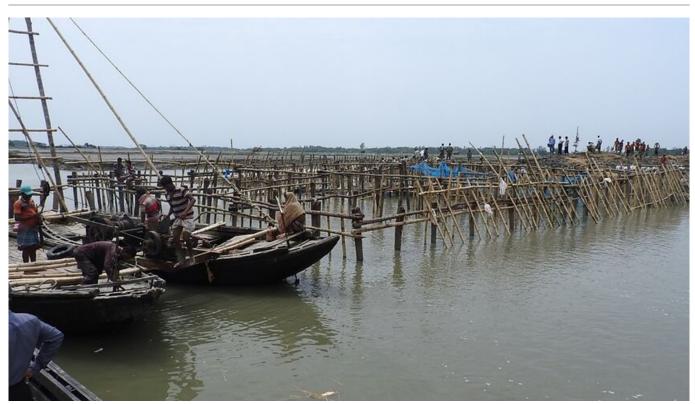
Photo 11.3 Driving bullah piles in Breach 3 to provide a framework for sand-filled geobags

**2016 Dry Season:** To close the three breaches (deep channels/creeks) formed during monsoon 2015 and to protect Chadghar, BWDB's Design Circle designed a new embankment with three closures provided with a minimum set-back distance of 100m. A contract for the works was awarded in February 2016. Two of the three breaches were closed by the contractor. For the closure of the third creek "breach 3", an immense amount of work was required to drive bullah piles which would provide the framework for the sand-filled geobags which would close the breach. In late-May and early-June, repeated attempts to close the channel of the third creek failed as the inter-tidal velocities were too high. It was finally closed on 28 June 2016. The main embankment was still very weak but intact. The embankment withstood the 2016 floods.
