**Blue Gold Program
Lower Bhadra River Erosion Damage
Breach to Polder 29 near Chandghar Village
Briefing Note**

Background

Background note to breach in Polder 29

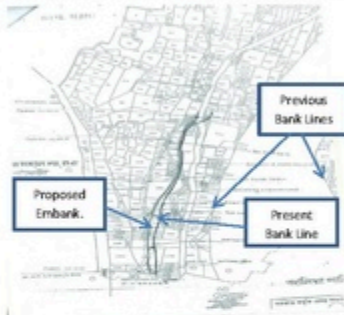
Figure-1: Location of Present River Bank in Mouza Map

The considerable area that has been eroded in the vicinity of Chandghar is shown in Figure-1 (Mouza Map) comparing the alignment of the river bank at the time of surveying the Mouza map (unknown) and the sketched alignment of the river bank in March 2015.
